# Bulkhead Observation Report

**Morgan Creek Harbor  
Isle of Palms, South Carolina**

March 3, 2022

Terracon Project No. 73055027

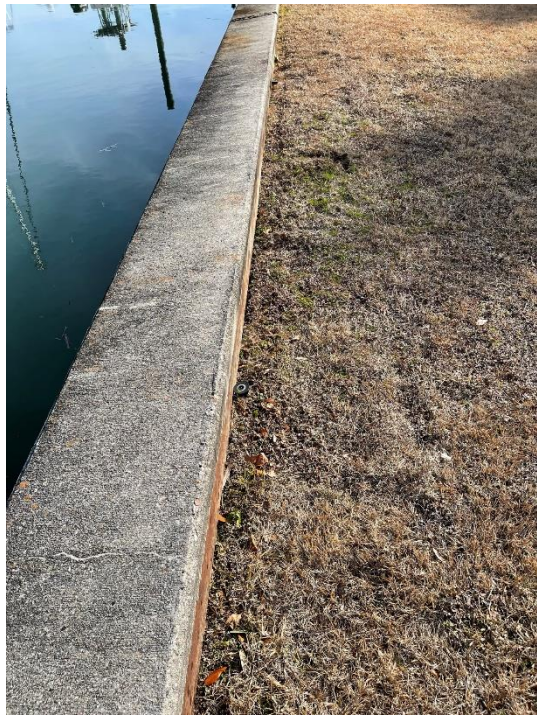
Station Number	Description
59+00/60+00	Multiple locations, 4+ inches deep, about 10' long
57+00/58+00	Multiple locations, 3+ inches deep, about 10' long
57+30	6+/- inch deep, about 15' long
47+55	6+/- inch deep, about 5' long
43+00/45+00/41+50	Multiple locations, 3 to 4 inches deep, about 10' long

001-backfill subsidence, multiple locations (typ), Stations 59+00/60+00

<b>General Assessments and Recommendations</b>	<p>We recommend that inspections of the bulkhead, backfill conditions, flapper gates, etc. continue to be made as these inspections are important to the long-term performance of the bulkhead.</p> <p>The summary of backfill subsidence observed during this inspection are provided in Tables 1 and 2, below. Photographs documenting the subsidence are included in the appendices. These areas should be periodically inspected</p>

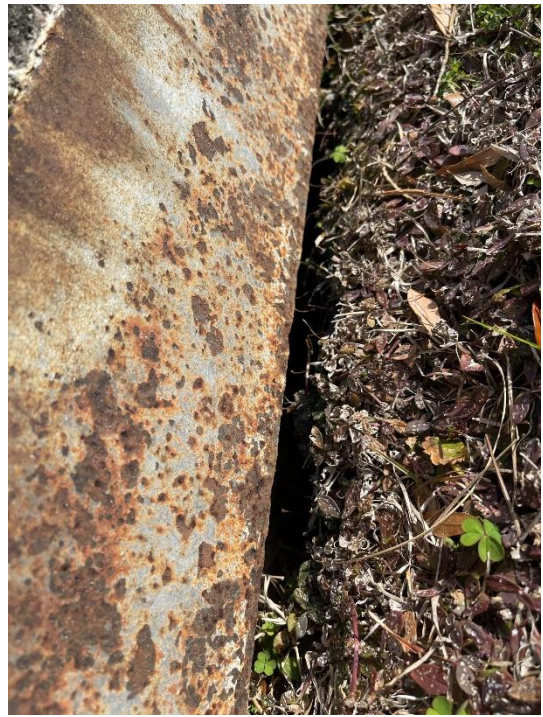
002-backfill subsidence, note the soil loss near the back of the wall, Station 59+75

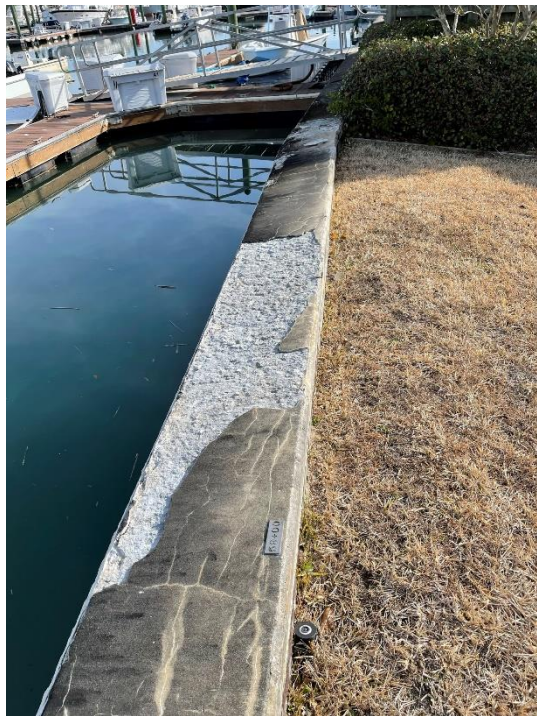
<b>Concrete Cap</b>	The concrete filled cap for most part appears to be in fair condition with several areas of surface damage, irregular cracks and joint spalling, exposed aggregate and age-related deterioration. The cap should be repaired as part of upcoming maintenance program.
<b>Flapper Valves</b>	<p>The flapper valves appeared to be in good condition and functioning as intended at the time of our inspection. We did not notice any missing valves or clogged outlet gates.</p> <p>The inspection was performed during mid to low tide. During this time, the valves were noted to be opening and closing as intended.</p>
<b>Tieback system</b>	The tieback heads at the +4-level including the bearing plates, patch plates, rods and nuts show a great deal of rust and surface corrosion. Marine growth is more abundant than in previous years and, in some cases, obscures the

003-deterioration concrete cap, aggregate exposed Station 59+00

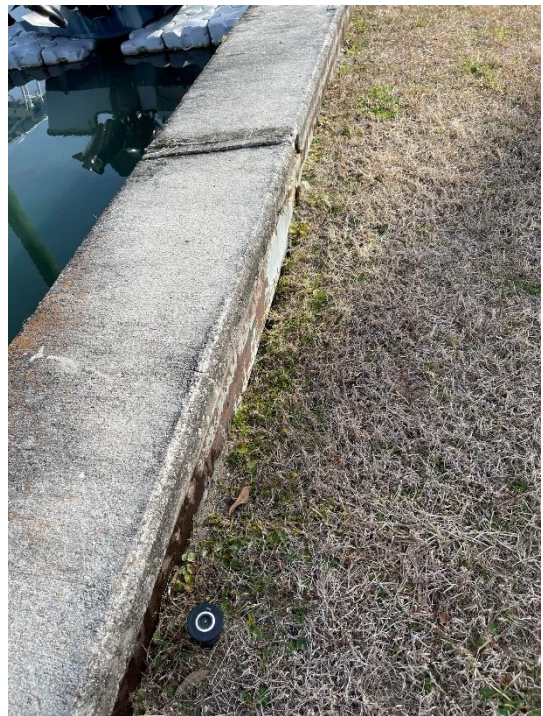
004-backfill subsidence, some soil loss near the wall. Note sprinkle head near the wall Station 57+50

Topic	Overview Statement
	<p>and filled as necessary. Considerations should be given to locating future irrigation heads away from the bulkhead to minimize backfill subsidence.</p> <p>Construction materials (stacked plywood) are stored near the wall at approximately Station 36+00. Although we did not observe any abnormal wall performance in this area, we recommend avoiding storing materials near the wall for an extended period of time to prevent additional surcharge loads being imposed on the wall.</p> <p>The wall measurements and other observations were made for the 5<sup>th</sup> time since the 2012/2013 dredging. It appears that the dredging has not negatively impacted the wall. The pre-post dredging measurements as compared to recent readings do not indicate any abnormal wall performance.</p> <p>As noted previously, several locations indicated wall movements of greater than 1 inch (inward or outward) when compared to earlier readings. The movements however had not changed or had only changed slightly (&lt; 0.50 inch) when compared to the last three readings. Regardless, we recommend that wall measurements be continued annually to check for abnormal movements.</p> <p>Corrosion continues to be major issue and should be addressed to improve life expectancy of the bulkhead.</p> <p>Trees and shrubs should not be planted near the wall to maintain drainage for the wall and to allow for proper inspection and measurements.</p> <p>The Association has a sizeable investment in the bulkhead, and in order to maintain it, periodic observations are necessary. It is recommended that continued maintenance along with periodic inspections continue to be conducted as it will help to extend the life of the bulkhead. Any unusual conditions should be reported to Terracon immediately.</p> <p>We understand that a Cathodic Protection System will be installed along the wall in coming months. The system includes drilling a deep well (8 inch diameter hole ) to depths of 130 feet behind wall to install sacrificial anodes. The installation will require a heavy drill rig and other construction equipment operating near the bulkhead. We recommend that the bulkhead be monitored periodically during the system installation to check for any signs of instability or excessive deflection. Additional temporary monitoring monuments may need to be established to check for signs excessive wall movement/deflection. Also, extreme precautions should be made not to damage the tie back and drainage system behind the wall.</p>

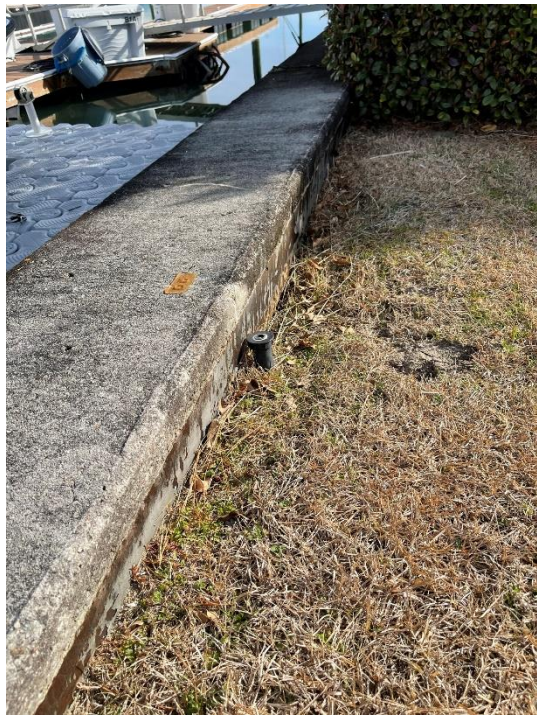
005-backfill subsidence, near sprinkler head  
Station 57+30

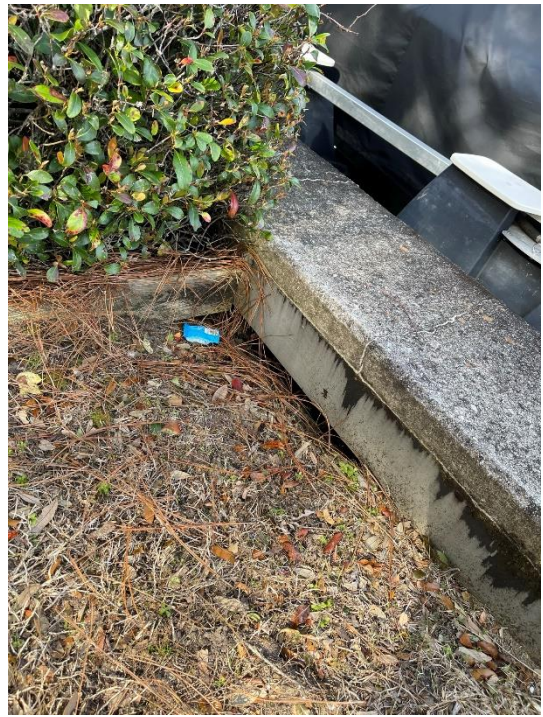
006-backfill subsidence and some soil loss near the back of the wall  
Station 47+50

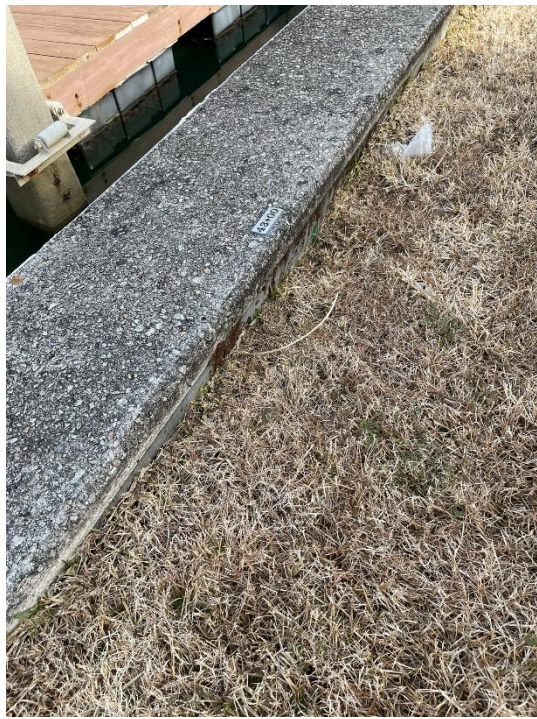
007-backfill subsidence  
Station 43+00

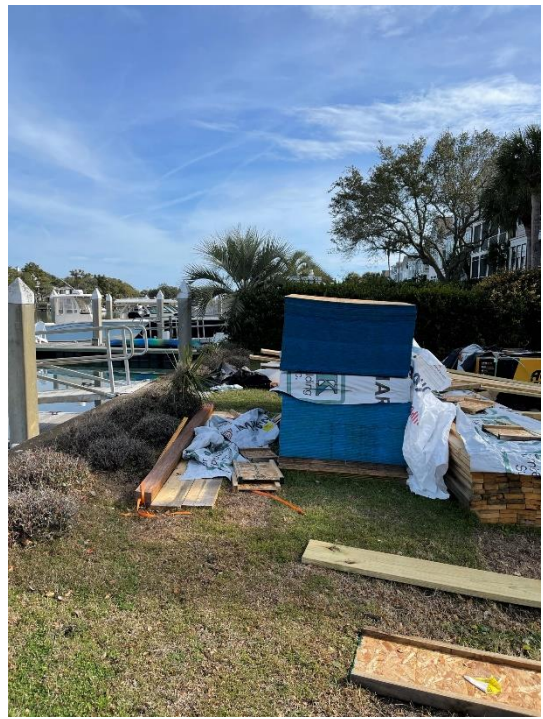
008-stockpile of construction material near the wall  
Station 36+00

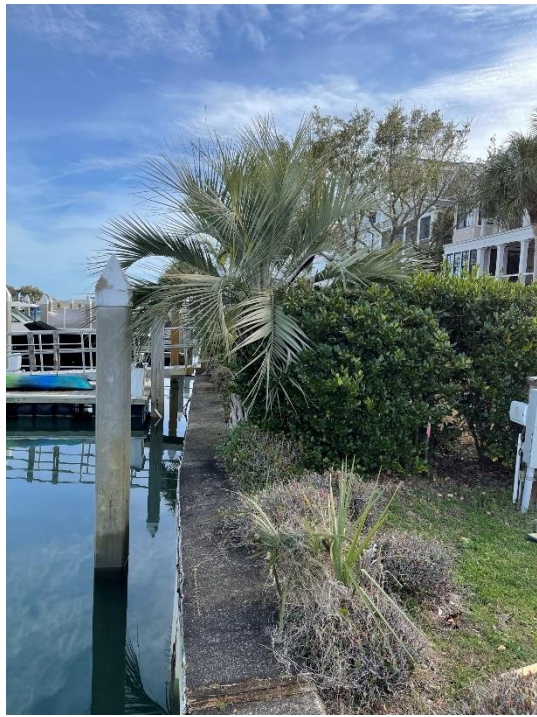
009-heavy vegetation behind the wall  
Station 36+00

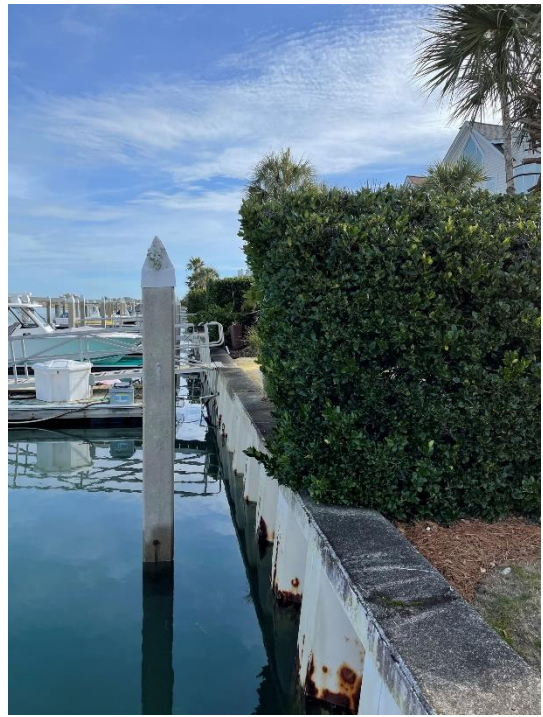
010-heavy vegetation behind the wall  
Station 33+00

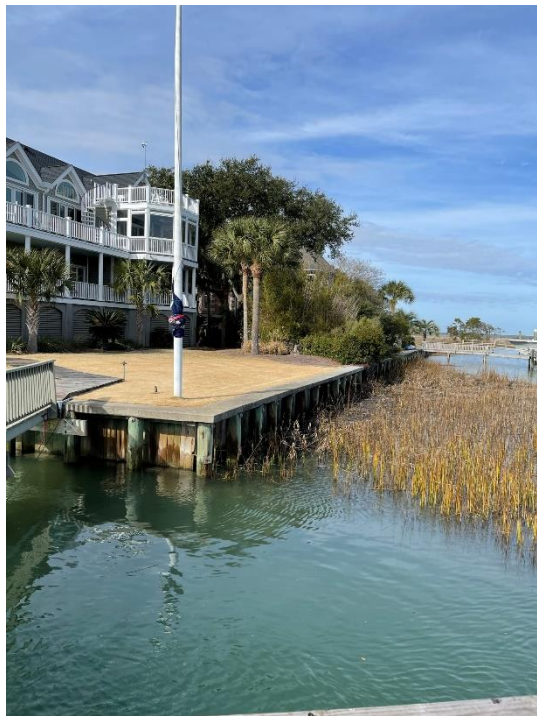
011-timber bulkhead, 2 WWI, conditions unchanged from 2021  
inspection

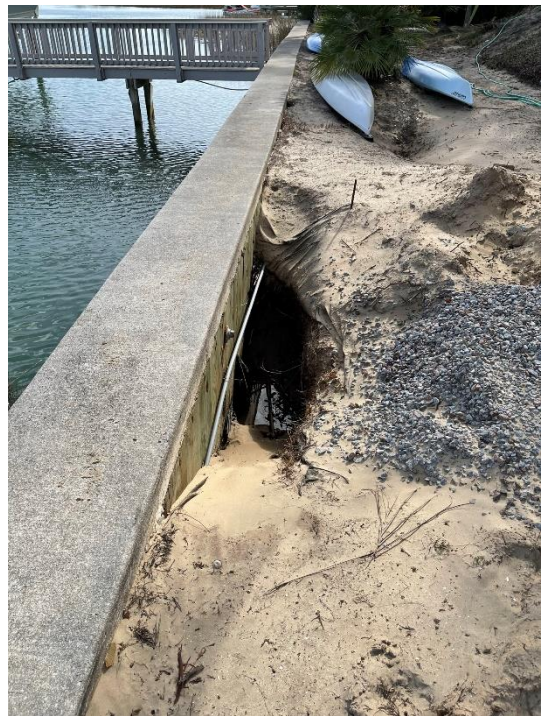
<b>Timber Bulkhead, 2, 3 and 32 WWI</b>	<p>At the time of our site visit, pool construction and landscaping work at 3 WWI were in progress but the subsidence repair behind the bulkhead had not started yet. The landscaping work on 32 WWI noted during 2021 inspection had been completed.</p> <p>We visually checked the timber bulkhead at these locations and did not notice any evidence of wall distress at any of the locations. The overall condition of the walls appeared unchanged from the 2021 inspection.</p>
<b>House Keeping</b>	<p>As has been mentioned in previous inspection reports, shrubs, trees, and heavy privacy landscaping have been planted very close to the wall in Morgan Place between Station Markers 30+50 to 33+00. The wall has a granular drainage system which allows relief of hydrostatic pressure behind the wall. Heavy roots growing into the drainage media behind the wall impedes drainage which may result in excessive hydrostatic pressure on the wall, impacting its stability. Also, vegetation near the wall prevents closer inspection and makes it difficult to conduct wall movement measurements. Considerations should be given to limit the vegetation within 10 feet of wall to grass only, if possible.</p> <p>Also, construction materials, stockpiles, etc. should not be stored within 10 feet of wall to limit the impact of surcharge loads on the wall.</p>

012-timber bulkhead, 3 WWI, landscaping and repair of backfill  
subsidence in progress

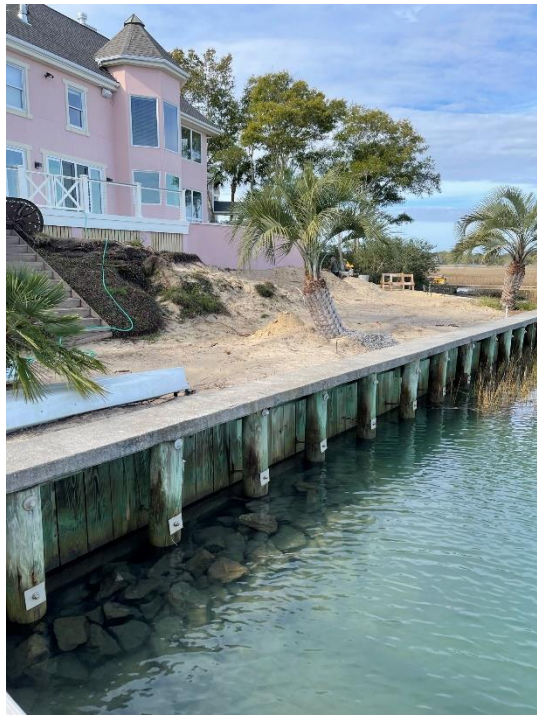
013-timber bulkhead, 3 WWI, construction work underway

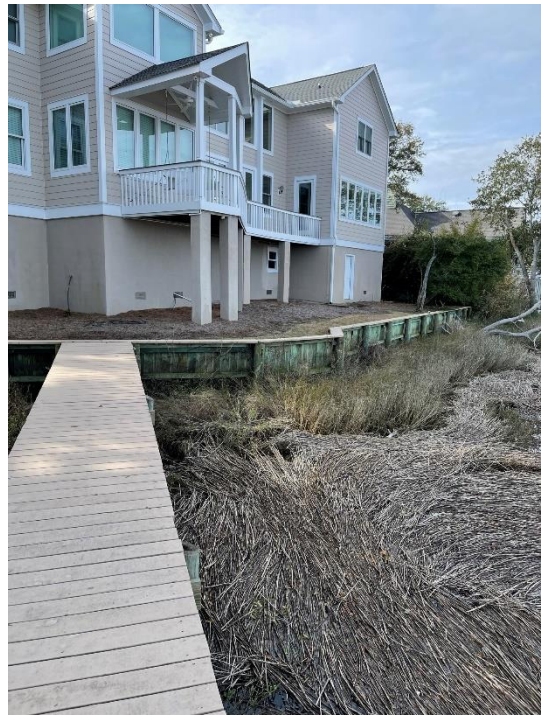
014-timber bulkhead, 4 WWI, conditions unchanged since 2021 inspection

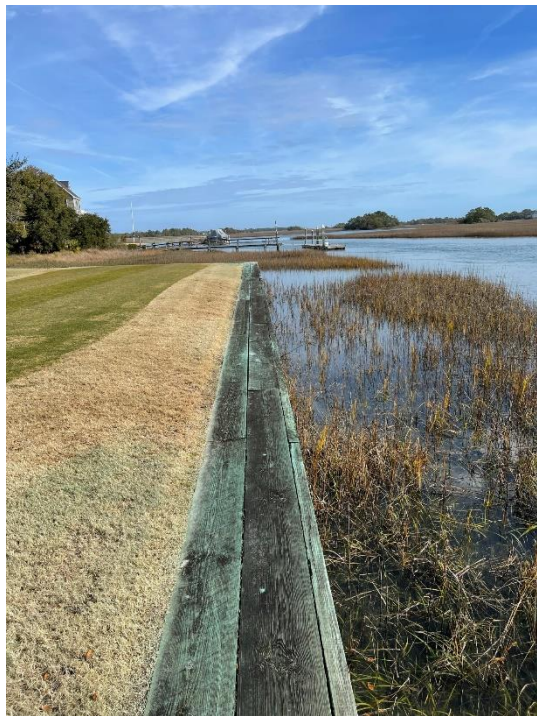
015-1 WWI, the shoreline is covered with well-established vegetation. No evidence of erosion along shoreline

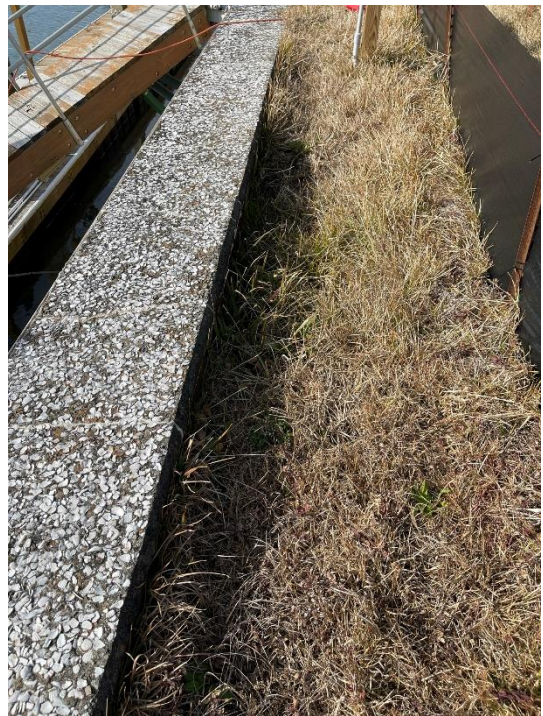
016-backfill subsidence and concrete pile cap deterioration Station 20+50

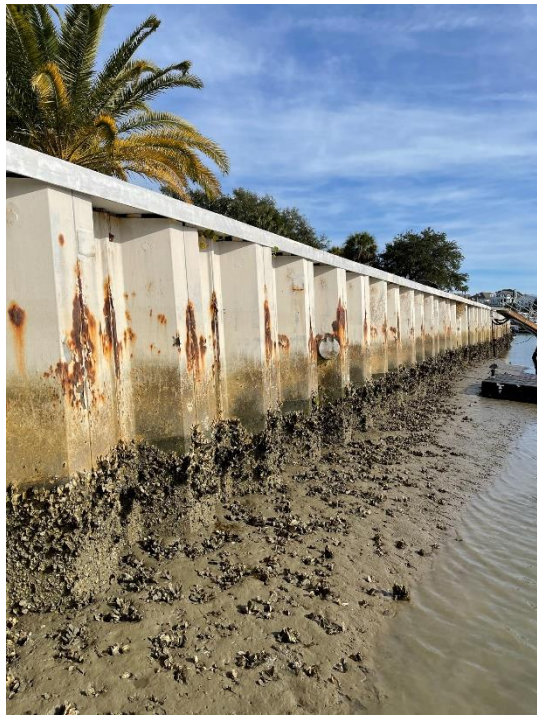
017-view of bulkhead at low tide, note marine growth and corrosion  
Station 22+00

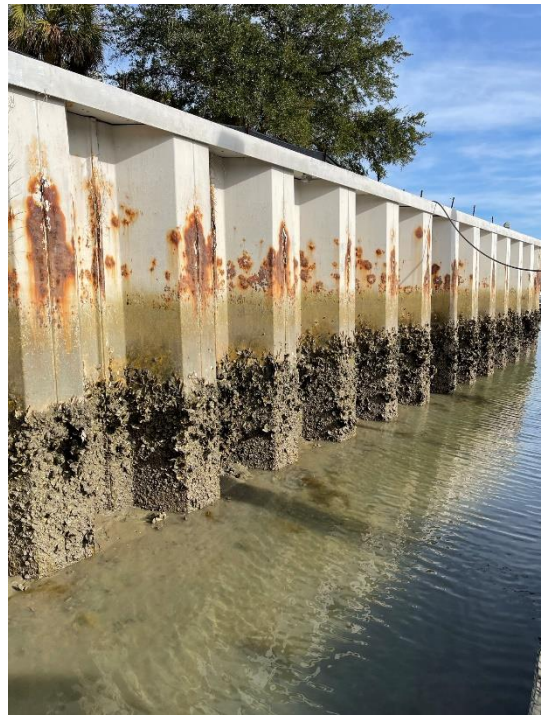
018-view of bulkhead at low tide, note marine growth and corrosion  
Station 22+00

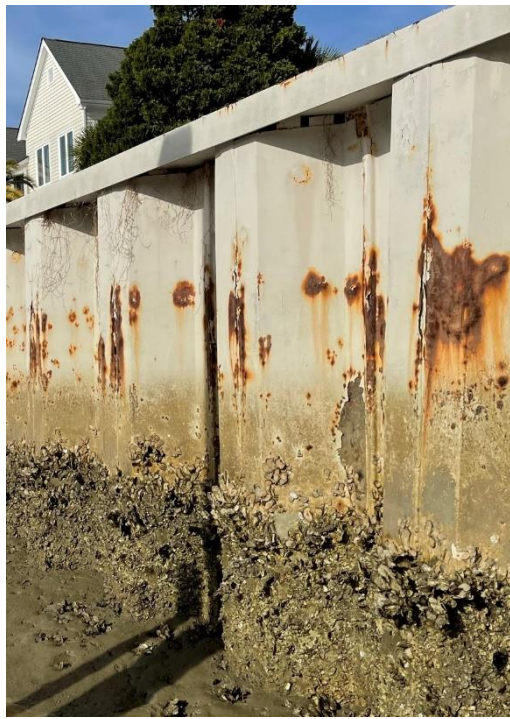
019-closeup view of corrosion and some pin holes  
Station 22+00

Topic	Overview Statement
	<p>heads of the tiebacks at the zero level. This prevents a closer inspection of some of the zero level tiebacks and head assemblies. We did not notice any slippage of head assemblies or bearing plates. Some minor leakage around bearing plates was noticed at several locations due to likely excessive corrosion. The corrosion has gotten worse since last inspection, as expected. Also, some pin holes have developed around several of the bearing plates that will require patching/repair.</p>
<b>Corrosion</b>	<p>As has been stated in our previous monitoring reports, corrosion is an on-going issue that requires constant maintenance and attention. Corrosion appears to be more severe on the south side (A to J and Med Docks) as compared to the north side. The corrosion has gotten worse in last several years with development of new pin holes and enlargement of existing holes. We understand that MCHA has been working with a corrosion consultant to address the corrosion issues. Southern Cathodic Protection Company has been retained by MCHA to design and install a cathodic protection system. The work is anticipated to begin sometime later in Spring of 2022. In addition, the bulkhead will be recoated, and pin holes patched.</p>

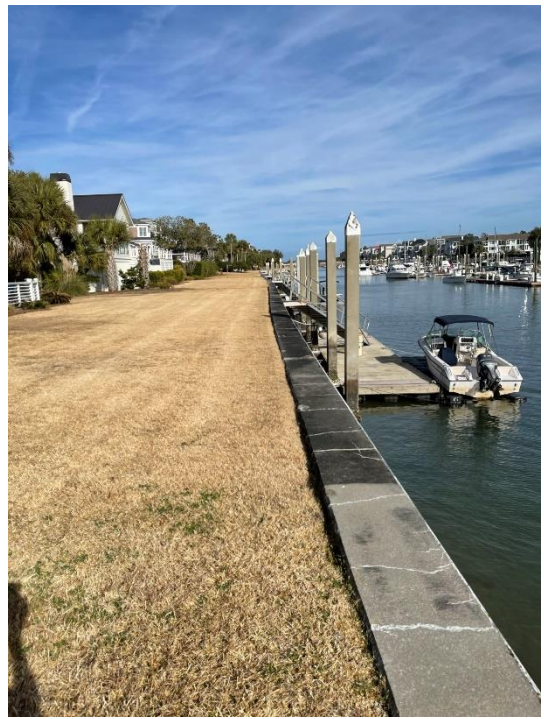
020-view of backfill and bulkhead, Water Way Island

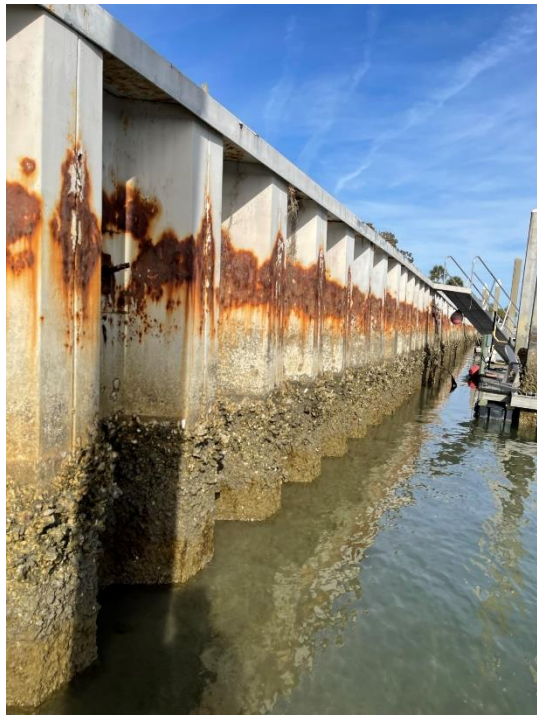
021-marine growth and corrosion, WWI, typical  
Station 18+00

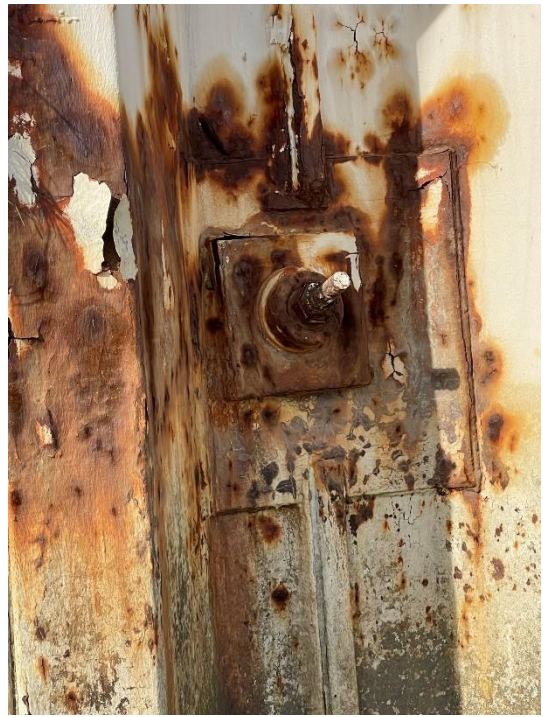
022-corrosion of bulkhead and bearing plate, WWI  
typical

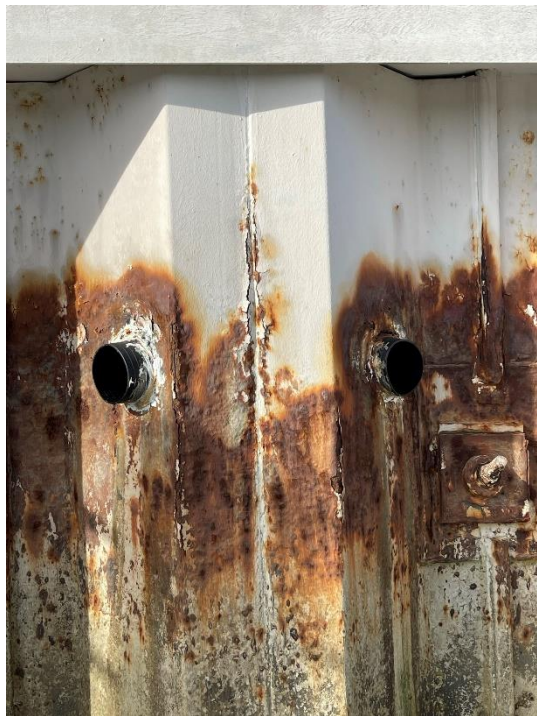
023-closeup, penetrations and corrosion  
Station 18+00

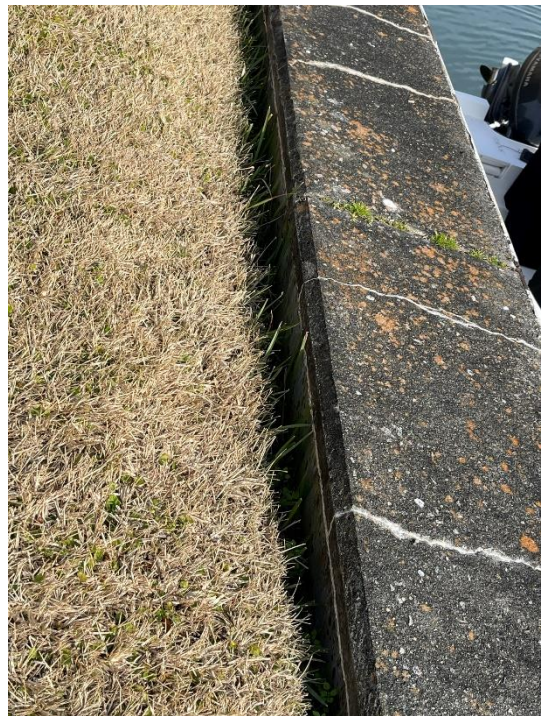
Station Number	Description
15+20	Multiple locations, 4+ inches deep, about 10' long
16+20/16+25	10+ inches deep, about 15' long
17+20	6+ inch deep, about 10' long
22+25	Multiple locations, 10+ inch deep, 10 to 15 feet long

024-backfill subsidence, WWI  
Station 16+25

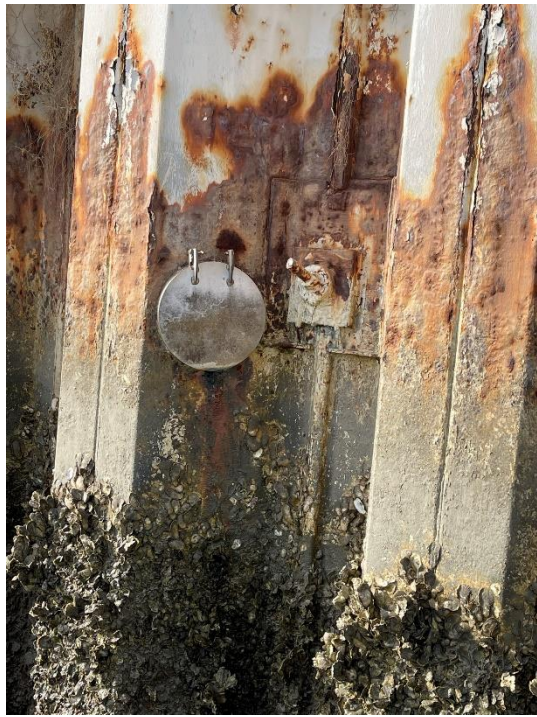
025-flapper valve (Typical). Note corrosion of bulkhead and bearing plate  
Station 15+25

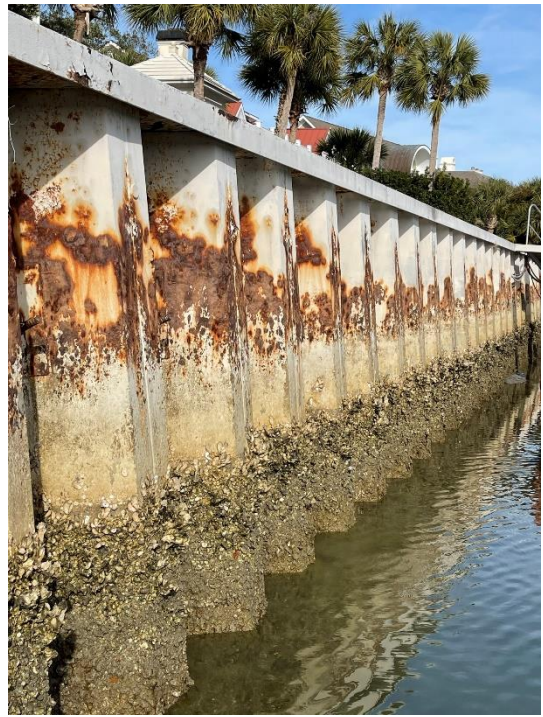
026-corrosion and marine growth, WWI (typical)  
Station 15+25

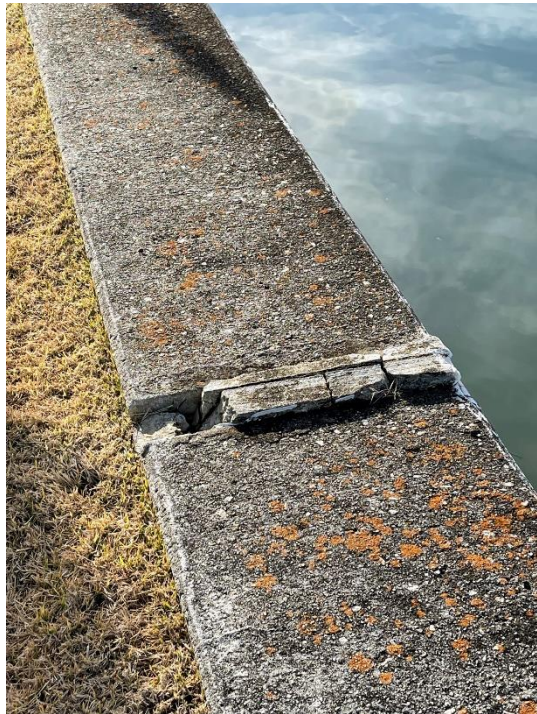
027-cap joint deterioration (typ)  
Station 44+00

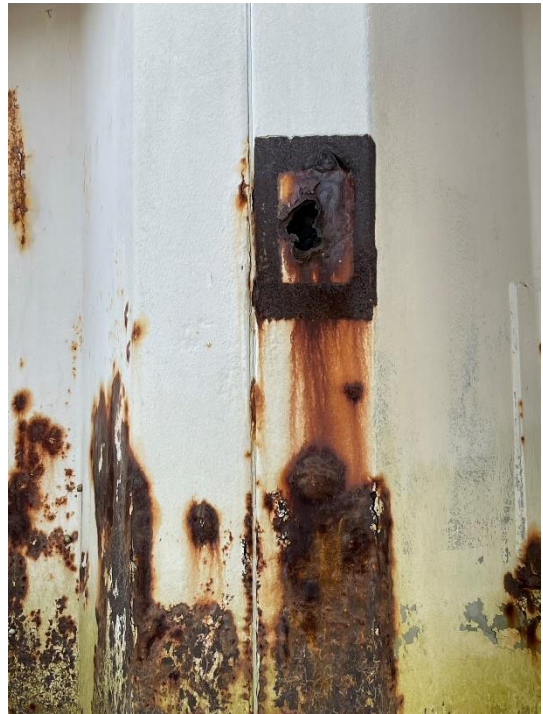
028-hole in the patch plate  
Station 49+50
