Bulkhead Monitoring Report

Morgan Creek Harbor
Isle of Palms, South Carolina

June 6, 2014

Terracon Project No. 73055027

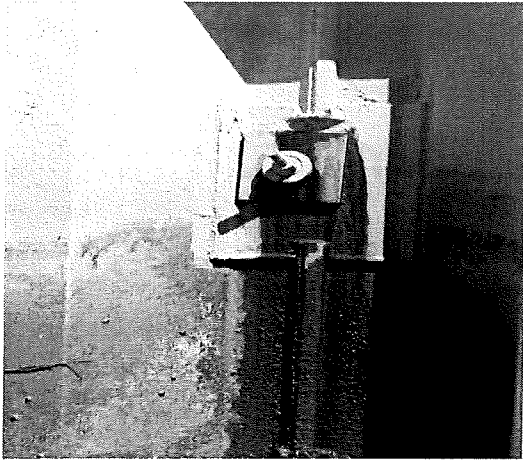
The tie back at 47 Water Way Island (WWI) was repaired in late December 2013 by TIC (The Industrial Company). During our current observation, we noted water leaks between the backer plates and also around the anchor rod nut/washer. In addition, there is some subsidence of backfill in this area. We recommend that TIC inspect the leak and backfill, and make the necessary repairs. Further, the disturbed area should be vegetated to prevent erosional losses.

4. The tie back at 47 Water Way Island (Station 6+30) was repaired by TIC in December, 2013. It appears to be performing well. The measurements of reference plates up and down station from it do not show any wall movement. Further, the wall section appeared to be in alignment with adjacent sections with no noticeable bulging or other forms of distress. However, we noticed water leaks between the backer plates and also around the nut/washer. In addition, there is some subsidence of backfill in this area. We recommend that TIC inspect the leak and backfill and repair it as necessary. Further, the disturbed area behind the wall should be vegetated as soon as practical to prevent erosional losses (Photos 1 and 2).

Photo 1. Tieback at 47 Water Way Island. Note the leak between plates/nut and washer. Some rust has developed.

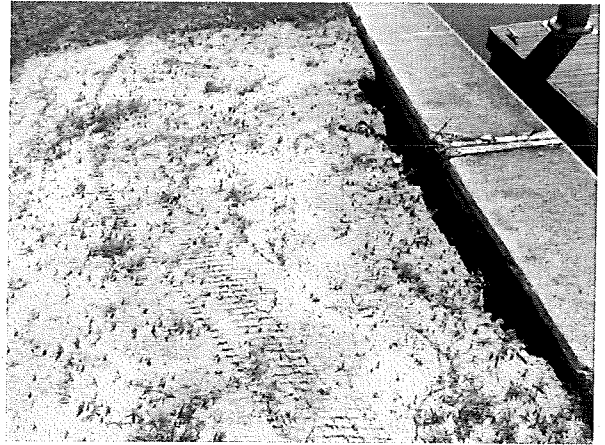
Photo 2. Subsidence of backfill at 47 Water Way Island tieback. No vegetation has been established in the excavated area.

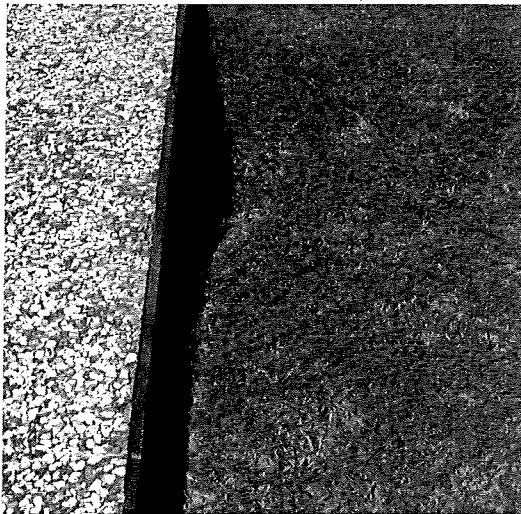
5. The anchor rod at 40 Water Way Island (Station 14+00) was repaired by TIC in February 2014 and appears to be performing well.
6. Several other areas of minor backfill subsidence were noted during our inspections. The subsidences are minor in nature and appear to be due to the irrigation lines and/or yard inlets present in the area. Also at several locations landscape shrubs are very close to the edge of wall. These areas should be periodically inspected and filled as necessary. Consideration should also be given to locating future irrigation heads away from the bulkhead (Photo 3 and 4).

Photo 3. Typical minor subsidence of backfill next to wall cap. The subsidences are typically about 2 to 3 inches and 12 to 24 inches long.

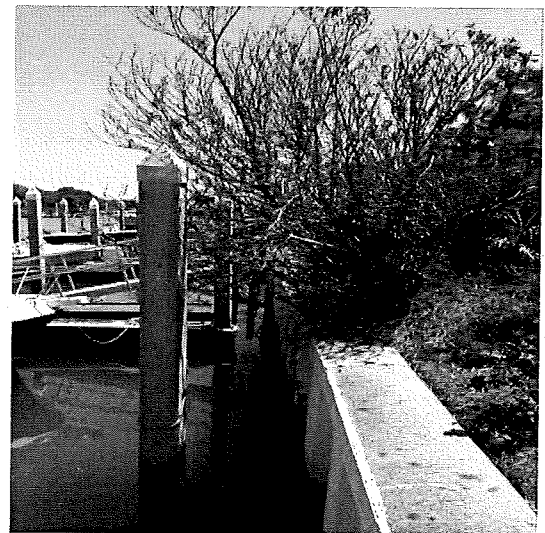
Photo 4. Trees and shrubs have been planted very near to back side of the wall. The wall cap has completely been covered by overgrown shrubs and trees.

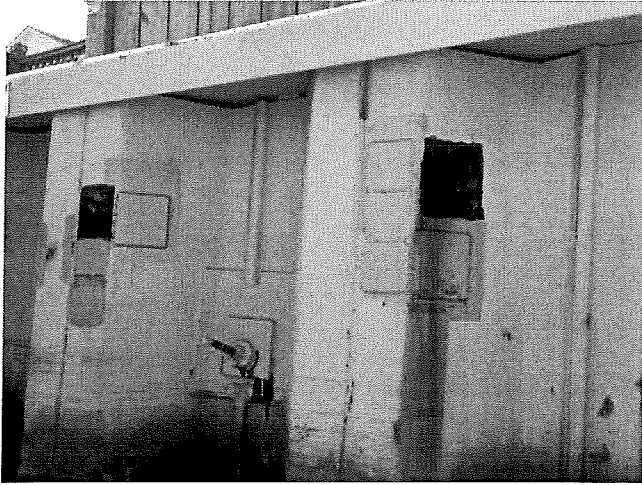
8. It has been almost two years since completion wall coating. Phillips Industrial Company began a maintenance program in the form of pinhole repairs and touch ups soon after coating completion, but the work was halted due to dredging activities and other factors. New pinholes, either next to existing patch plates or in other parts of the wall have developed. Also there are many pinholes locations which were prepared to receive a patch plate, but were not completed due to work stoppage. It is important that pinholes are repaired in a timely manner to minimize its impact on the wall performance. Patch plates (6"x6" and 8"x8" sheet metal plates) have been used to seal pin-holes in the past and should continue be used to repair any additional pinholes identified during maintenance program. Continual maintenance is necessary to minimize the corrosion of the bulkhead (Photos 5, 6, 7 and 8)

Photo 5. Pinhole prepared to receive a patch plate, but work not completed. Note rust in the exposed metal.

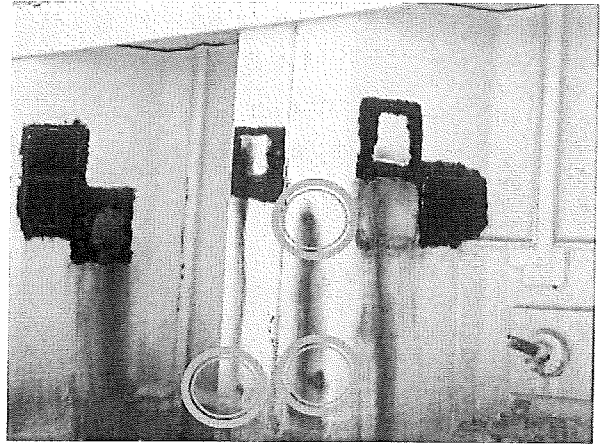
Photo 6. Same as Photo 5. Note additional pinholes being developed near previous locations. Corrosion is getting worst in these areas.

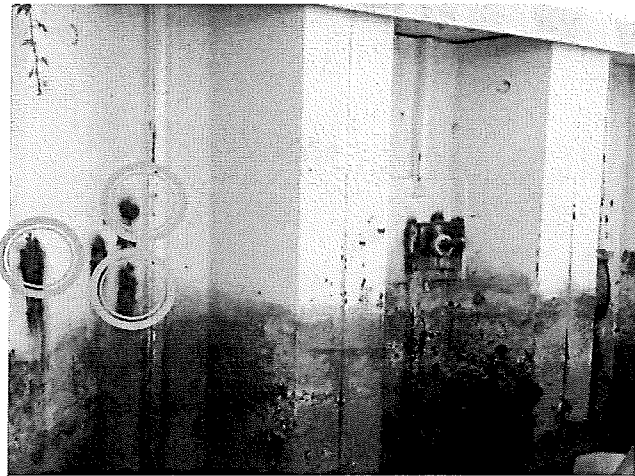
Photo 7. Pinholes in the wall. Also rust in the tieback has developed.

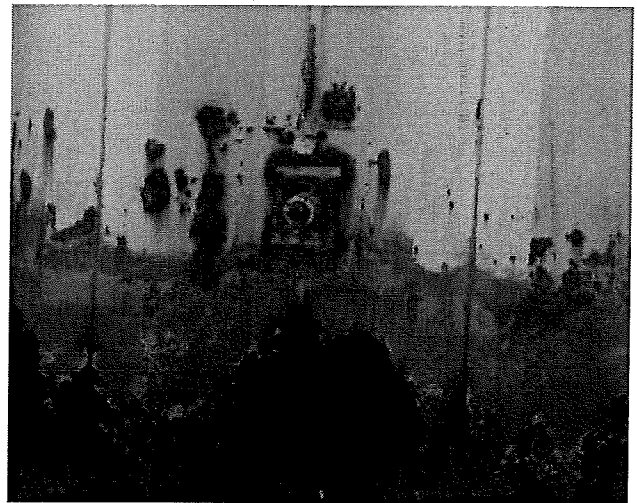
Photo 8. Widespread corrosion and pinholes.

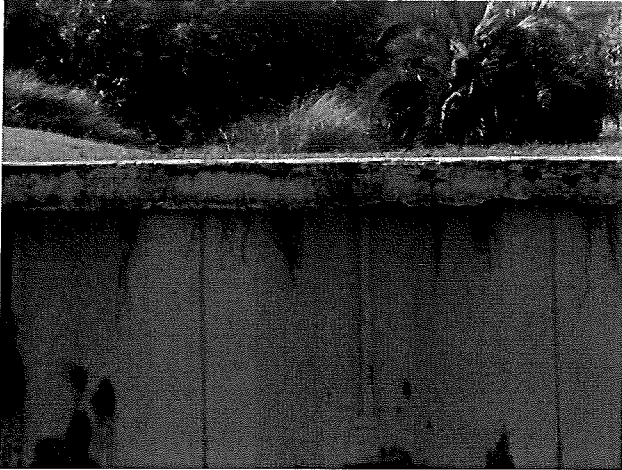
9. Rust has developed on exposed flanges of cap beam beginning at Station 28+00 and ending near the end of bulkhead. The rust appears to be related to fertilization leachate of the golf course lawn. The flange should be washed/cleaned and coated to prevent further rust and/or damage. Further, all joints in the concrete cap beams should be sealed to minimize moisture penetration into beam web/flange (Photo 9).

Photo 9. Rust on exposed flanges of cap beam
Station 28+00 to near end of wall.

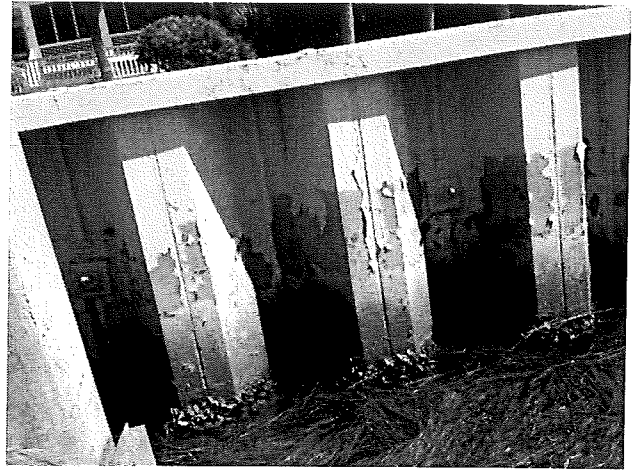
10. The coating on a 50±-foot section of wall on the Morgan Creek side of the wall shows signs of peeling. Mike Pilley indicated he was aware of it and would be re-coating the area (Photo 10).

Photo 10. Peeling of the coating on a section of wall
on the Morgan Creek. The area is about
50 feet long and 3 feet wide.
