**RE: Executive Summary
Morgan Creek Harbor Association Bulkhead Study**

Morgan Creek Bulkhead Study

**Wild Dunes Resort
Isle of Palms, South Carolina**

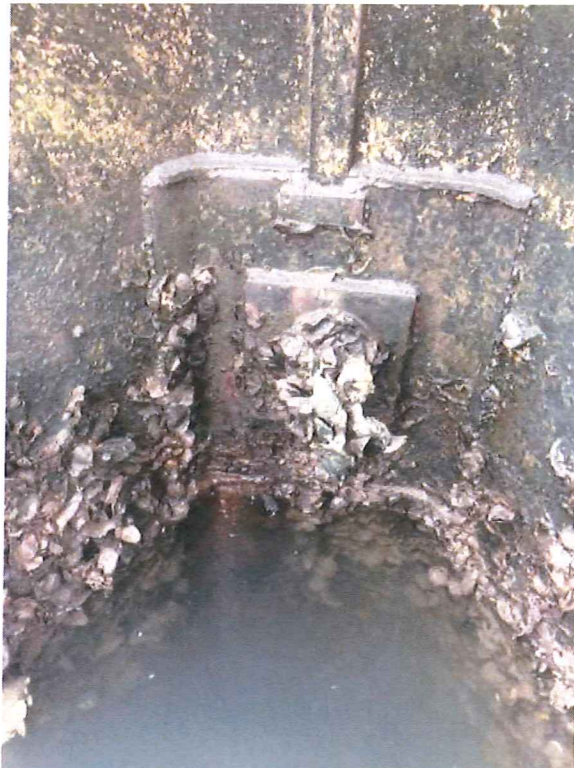
Photo 1

Removing the groundwater on the land-side of the bulkhead would reduce the rate of corrosion on the land-side of the unprotected steel sheets. This groundwater is comprised of both stormwater runoff and saltwater from the tidal movement. There is a French Drain system along the back of the bulkhead. Based on the location of the outlets, it appears the system removes groundwater from only the top 3-4 feet of the bulkhead. The groundwater below this French Drain applies additional hydrostatic pressure on the bulkhead during low tide cycles. This groundwater is not released from behind the bulkhead, which applied added force on the bulkhead and also allows the groundwater to remain against the un-coated steel sheet piling. There are areas where there are holes in the bulkhead and where small amounts of the groundwater is released, but not at a rate significant enough to have a positive effect. (**Photo 1** shows groundwater leaking out from a tie-back.)

It was noted during the inspection that several of the French Drain discharge pipes appear to be clogged and not releasing the groundwater as needed.

The French Drain system outlets should be cleaned to allow free drainage from behind the bulkhead. The installation of weep holes along or just above the low water line would relieve the hydrostatic or groundwater pressure from the bulkhead. The weep holes would allow the groundwater to drain freely at all tide levels and also at the lowest point possible behind the bulkhead. The releasing of this hydrostatic pressure on

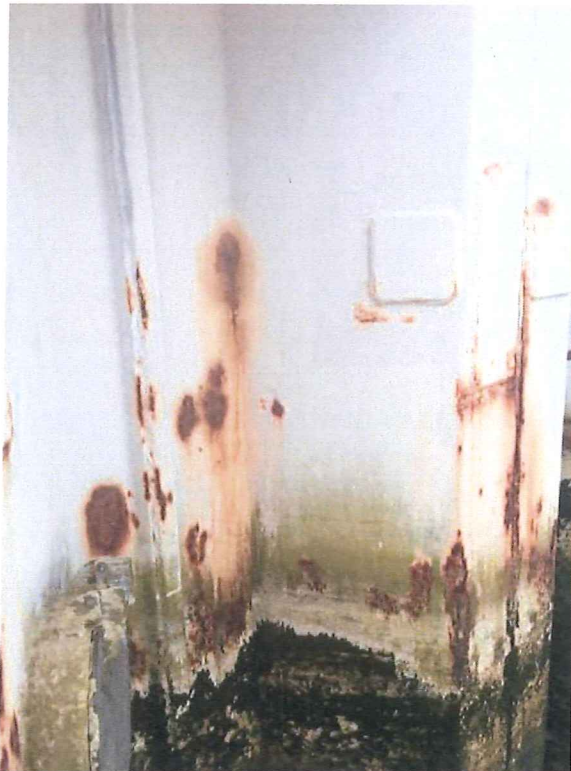
Photo 2

The corrosion spots that are coming through the coating could possibly be from a couple of sources. The first is corrosion coming through from the land-side of the steel sheets. This is evident in some areas where holes have formed. The second issue is the failure of the coating. This failure could be caused by improper surface prep and/or chlorides still being on the sub-surface prior to coating. Over time, the chlorides (salts) would cause the coating to fail and then expose the steel to corrosion. (**Photo 2** and **Photo 3** are of areas where the coating has failed.) At this time, it is unknown if this corrosion is from the land-side or from the coat failure. (**Photos 4-7** are of repaired areas and where holes have formed. In **Photo 6** and **Photo 7** the primer can be seen over repaired areas.)

Areas where the bulkhead sheets have been repaired by welding a steel plate to cover holes, or where the existing coating has been stripped to be re-coated should be properly primed and recoated. This included stripe coating the edges of the repaired area to ensure proper coverage of the edge. In the harsh saltwater environment, proper surface and repair preparation is very important to long term performance. (In **Photo 6** and **Photo 7**, the primer coat over the repaired area is beginning to fail as corrosion is beginning to appear.)
