May 27, 2021

**Re: Morgan Creek Harbor Corrosion Assessment Report  
Isle of Palms, South Carolina**

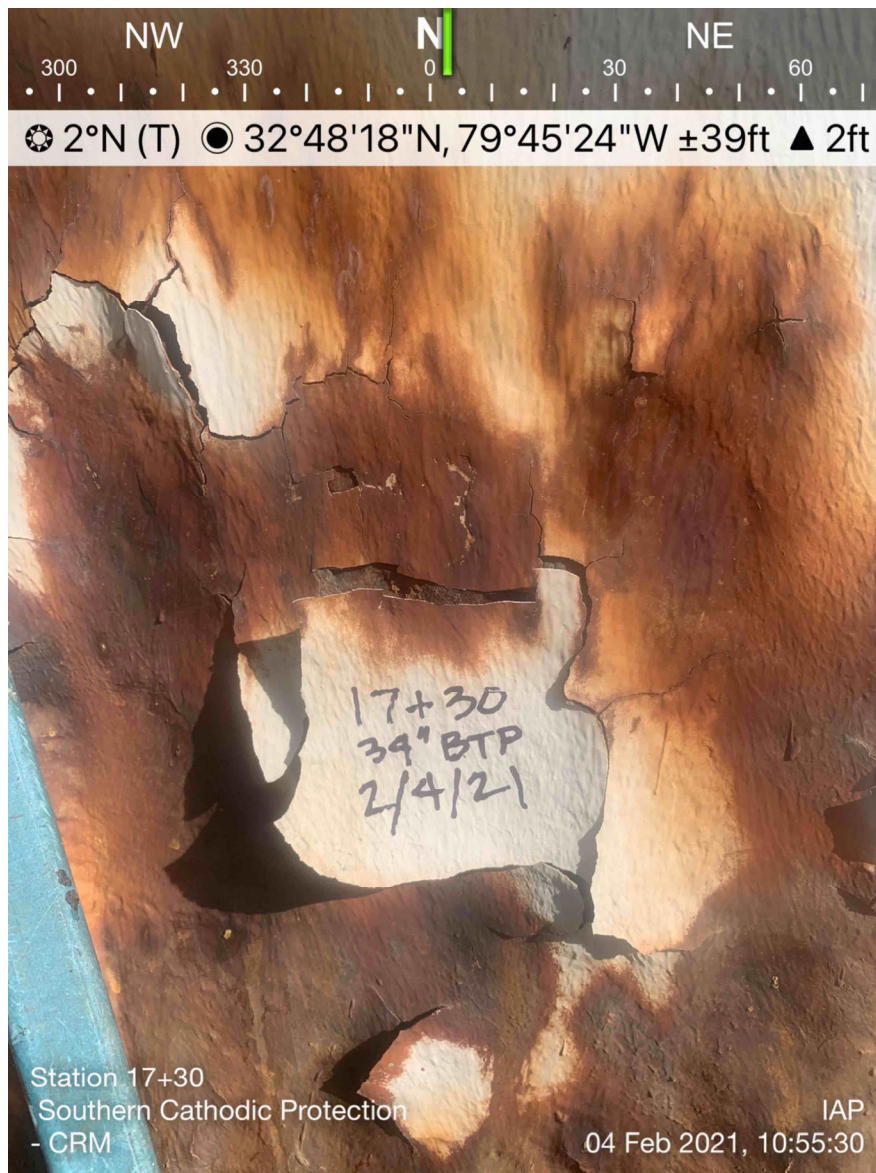
- Visual inspection of the structures found a significantly deteriorated coating system in the tidal and splash zones, particularly along the north wall segment. Large corrosion product scaling was observed with widespread inter-layer disbondment of the corroded metal. No through-wall penetrations were found; although, the wall was found leaking behind a jacking plate at Station 58+80 and a missing tie rod end was observed at Station 35+80. Figure 03 below illustrates typical coating and corrosion conditions observed.

**Figure 03:** Coating system failure with significant corrosion product scaling in the splash and tidal zones. Location was found on the north wall at Station 17+30.

- Following a detailed structural condition analysis confirming sufficient remaining strength of the wall, the coating system must be restored and a cathodic protection system designed and installed promptly. Should a structural investigation find the wall strength inadequate, the new wall should be installed with a complete coating system on both water and soil sides; and a robust cathodic protection system designed, installed and properly maintained for the wall life.

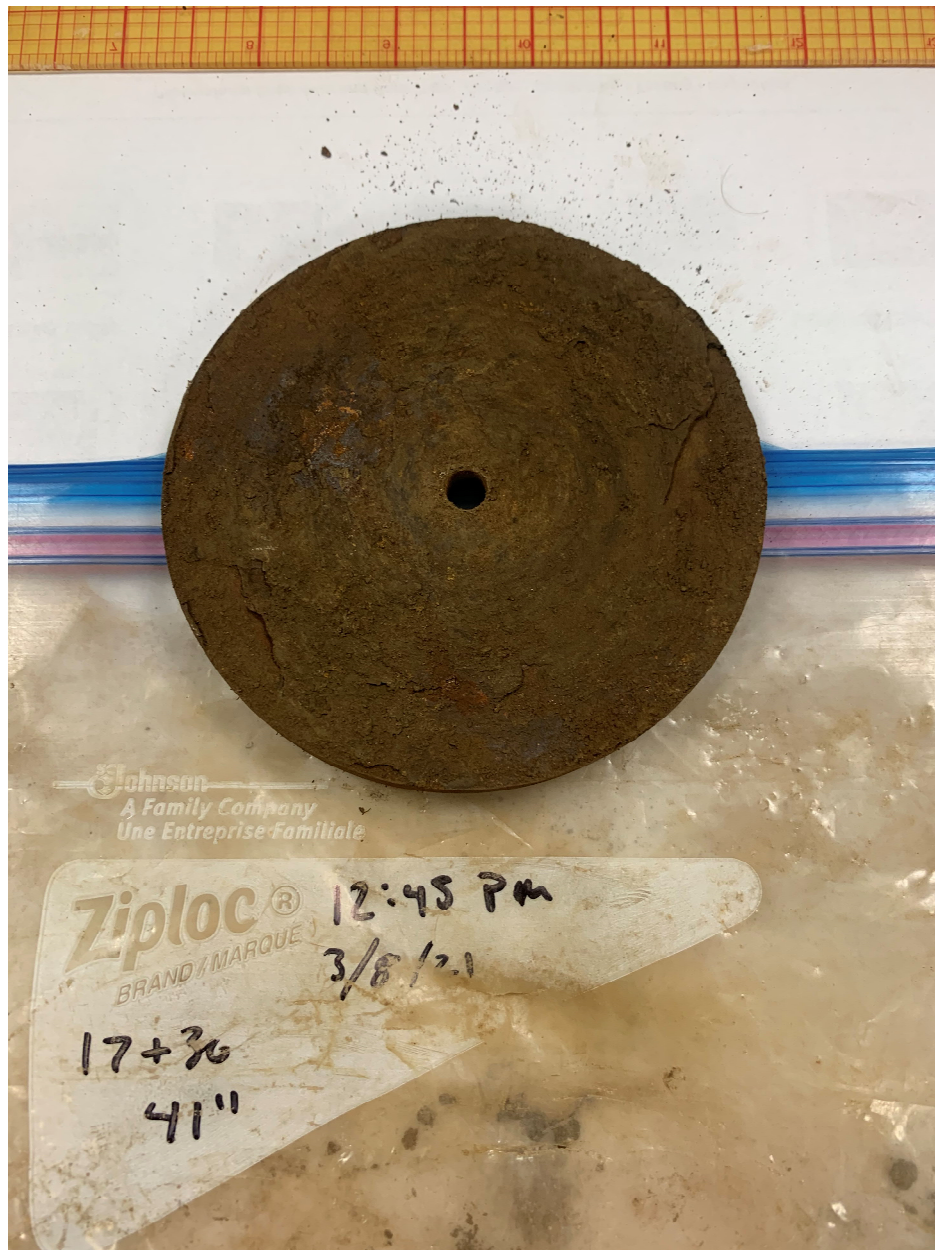
- The sheet pile metal samples were collected from sites where electrochemical testing indicated corrosion activity and wall loss were likely. Key findings include approximately 69% wall loss at Station 17+30 and a yield strength measurement below the steel grade specification for the indicated product utilized in the original installation. A wall structural analysis utilizing these data is scheduled to be performed by others. Figure 04 shows at the coupon collected at Station 17+30. The third-party examination results are included in Exhibit 1 below.

**Figure 04:** One of six coupons taken from the pile walls. Note the heavy corrosion product scale. The soil side of the coupon is shown. The water-side appearance was very similar.

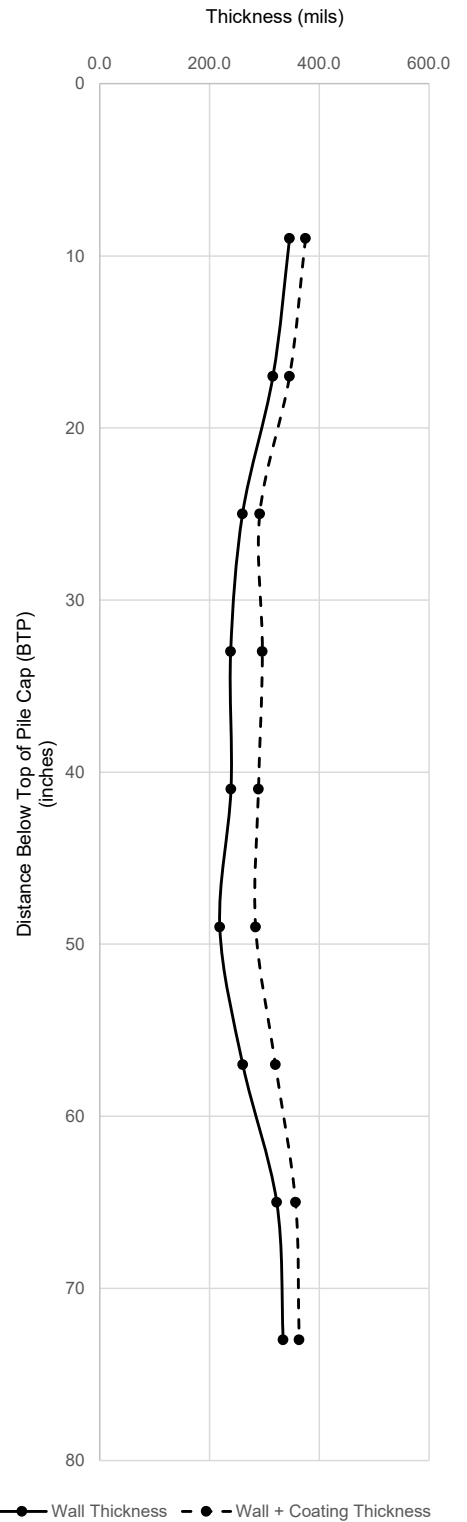
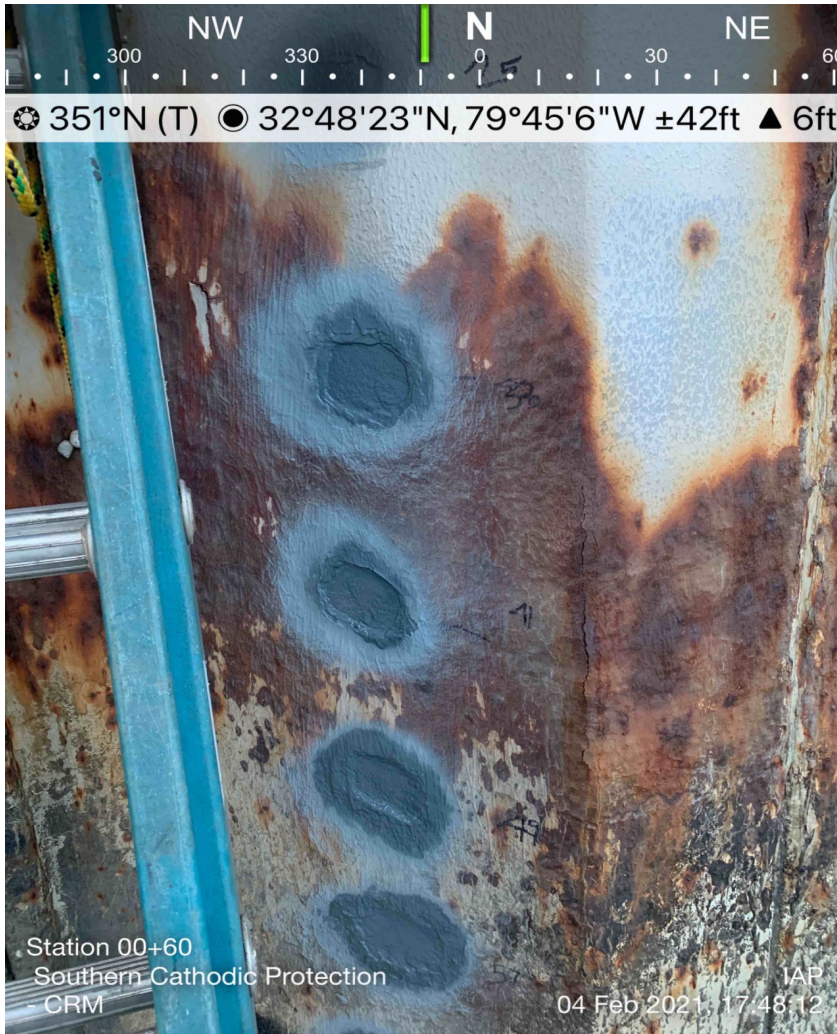
STA 00+60 Wall and Coating Thickness

Metal Thickness						Coating Thickness			
BTP	#	Mean	St. Dev.	Min.	Max.	Mean	St. Dev.	Min.	Max.
9	1	346.0	2.4	349	342	28.96	2.21	32.7	25.5
17	2	315.7	1.9	318	313	30.11	2.94	36.7	26.7
25	3	260.2	7.7	268	250	31.51	2.48	35.0	27.9
33	4	238.4	0.8	240	237	58.03	5.01	67.8	50.0
41	5	239.2	2.9	245	236	49.94	4.38	55.1	42.5
49	6	218.7	2.9	221	214	65.41	3.09	68.9	61.0
57	7	260.8	2.0	264	257	59.27	2.33	63.5	56.5
65	8	322.6	1.0	324	321	34.06	2.54	38.2	28.8
73	9	334.4	1.6	338	333	29.07	3.00	33.6	26.2

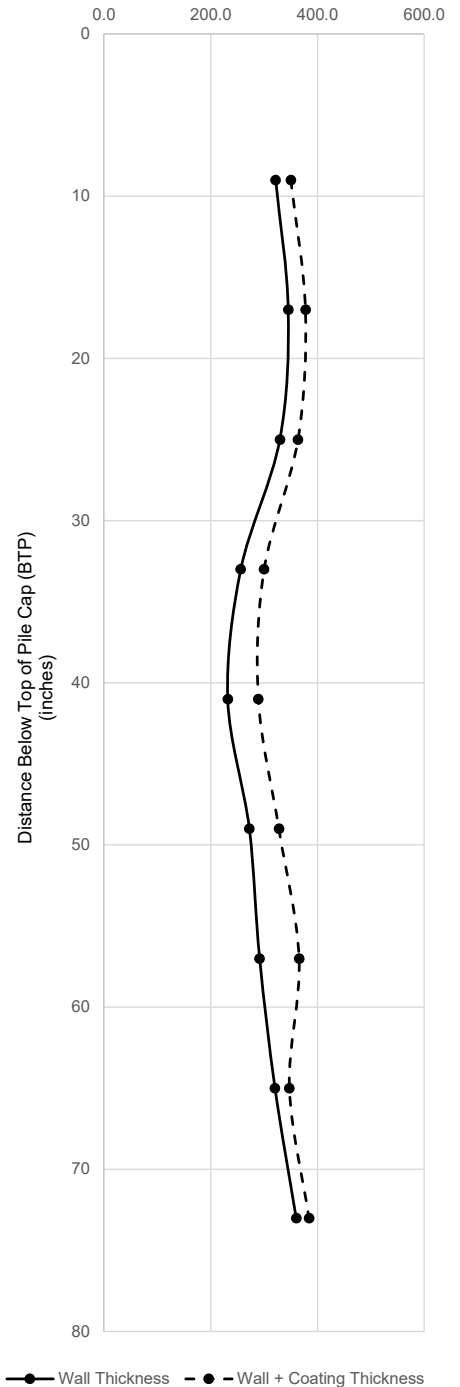
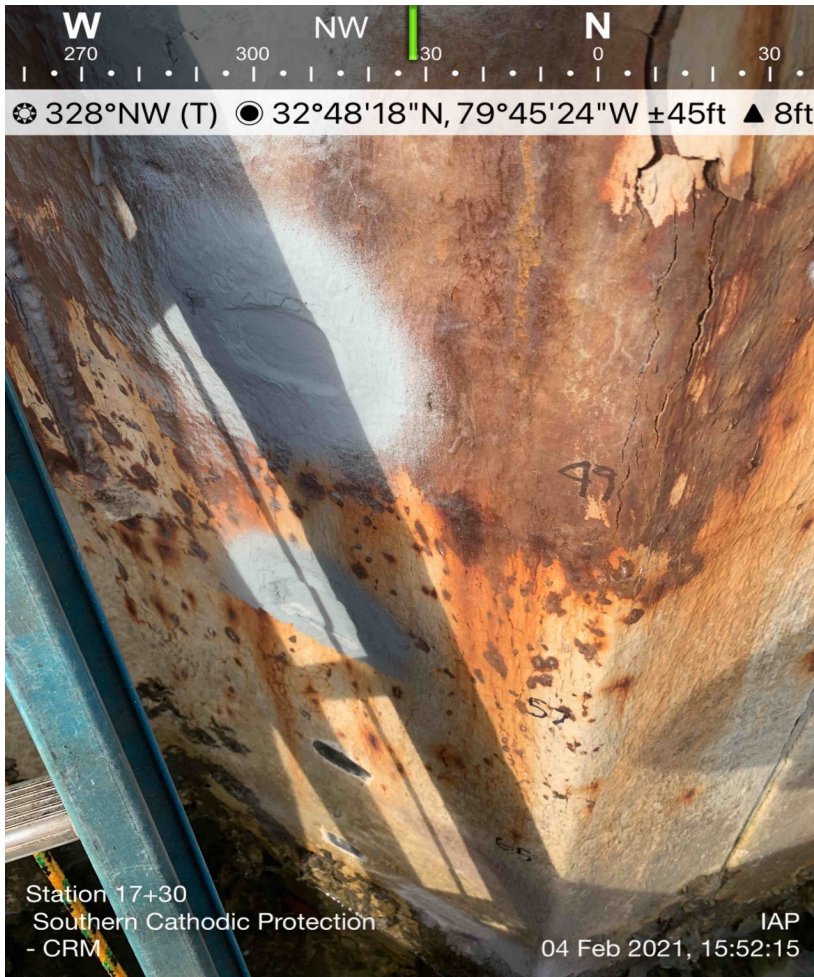
STA 17+30 Wall and Coating Thickness  
Thickness (mils)

BTP	#	Metal Thickness				Coating Thickness			
		Mean	St. Dev.	Min.	Max.	Mean	St. Dev.	Min.	Max.
9	1	321.5	1.1	323	319	28.67	1.19	30.2	26.9
17	2	345.4	3.7	349	337	32.21	1.87	35.0	30.0
25	3	329.7	1.1	331	328	33.95	2.61	36.5	27.6
33	4	256.3	1.5	260	255	43.75	2.56	47.1	39.6
41	5	232.0	4.5	240	225	57.23	3.39	64.1	50.8
49	6	272.5	0.7	273	271	55.30	2.79	59.0	50.8
57	7	291.6	6.9	303	283	74.10	1.29	76.3	72.2
65	8	320.4	2.1	324	317	27.02	2.13	30.0	24.6
73	9	360.1	3.5	365	353	24.04	2.13	27.8	20.8

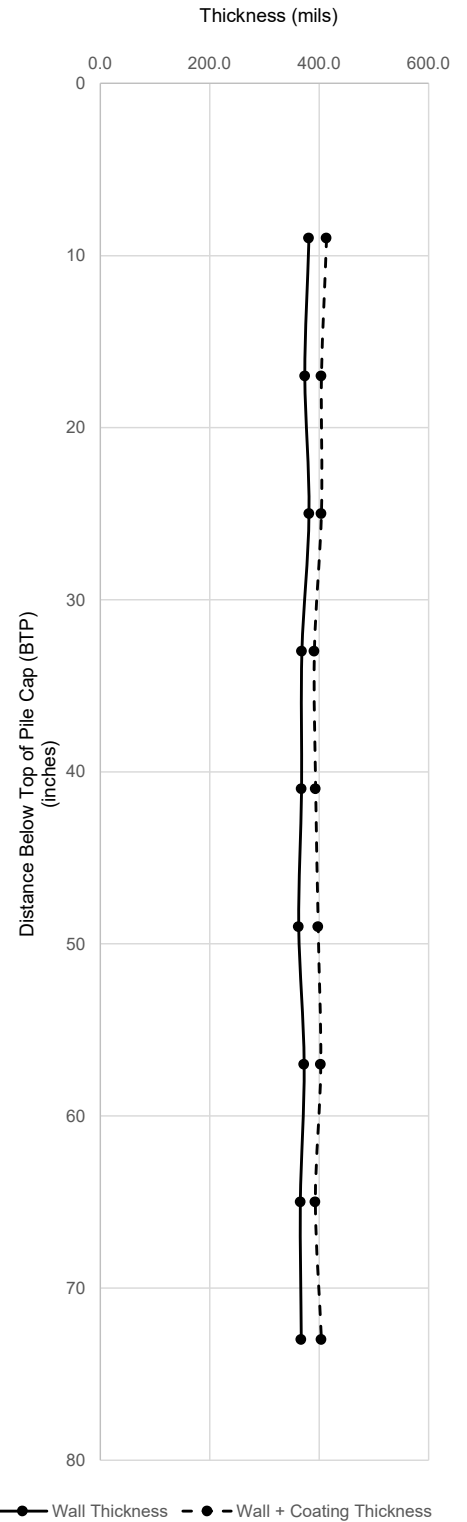
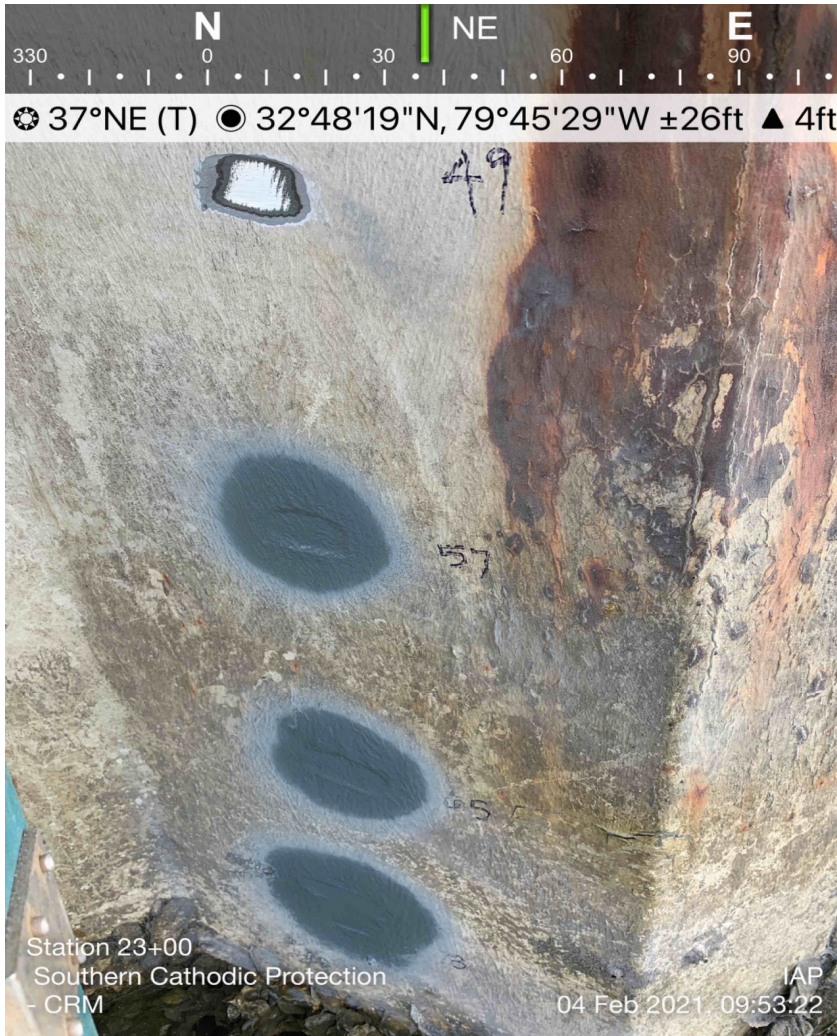
STA 23+00 Wall and Coating Thickness

Metal Thickness						Coating Thickness			
BTP	#	Mean	St. Dev.	Min.	Max.	Mean	St. Dev.	Min.	Max.
9	1	381.3	2.9	386	376	32.31	2.05	35.8	29.2
17	2	373.9	1.5	377	372	30.29	1.23	32.2	28.7
25	3	381.5	1.0	383	380	22.62	1.01	24.3	20.5
33	4	368.2	1.8	370	366	22.88	2.03	28.0	21.4
41	5	367.5	0.7	368	366	25.97	1.29	27.7	23.1
49	6	362.7	1.1	364	360	35.34	1.74	37.6	33.3
57	7	372.4	1.4	374	370	30.43	1.04	31.9	28.7
65	8	365.7	1.2	367	363	27.36	1.99	31.3	25.3
73	9	367.2	1.1	369	366	37.07	3.35	41.9	31.7

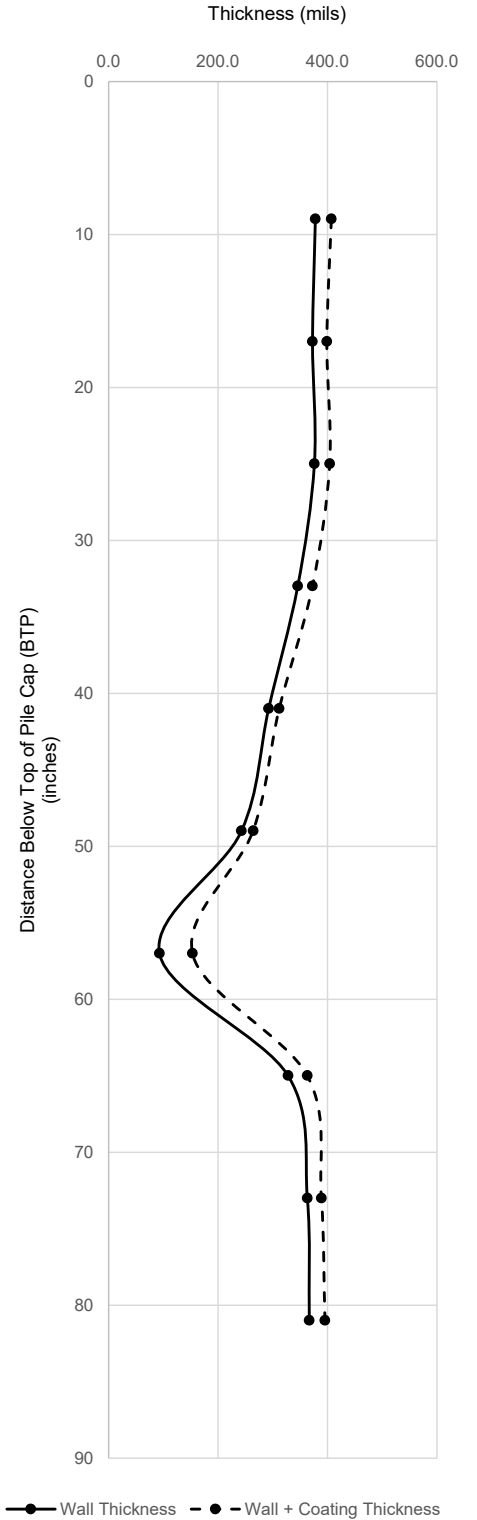
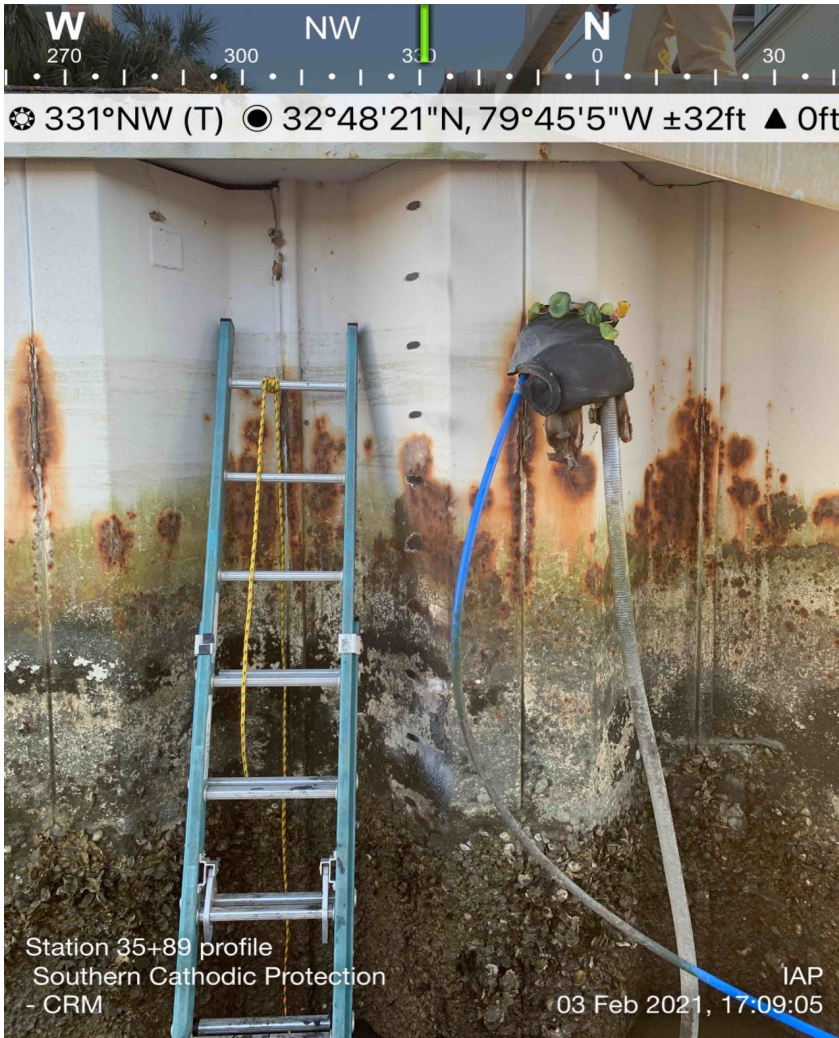
STA 35+89 Wall and Coating Thickness

<sup>3</sup> Using 11.7 mils lost per year as found at Station 35+89 Elevation 57" BTP and at nominal original wall thickness of 374 mils (9.5mm), through wall penetration will occur in 374mils/11.7mpy = 32 Years

BTP	#	Metal Thickness				Coating Thickness			
		Mean	St. Dev.	Min.	Max.	Mean	St. Dev.	Min.	Max.
9	1	377.7	2.3	381	373	29.37	3.35	34.6	27.0
17	2	372.7	3.9	377	364	25.96	2.05	30.0	22.8
25	3	375.9	1.5	379	374	27.84	1.92	29.8	23.9
33	4	345.7	2.6	351	342	26.82	1.08	28.0	25.1
41	5	292.4	1.1	295	291	19.12	3.42	25.7	14.2
49	6	242.8	8.2	250	233	21.12	1.49	23.5	18.7
57	7	93.1	2.8	97	89	60.06	6.55	73.1	50.6
65	8	327.9	1.7	330	324	34.98	10.19	54.7	19.0
73	9	363.0	1.1	364	361	25.57	3.04	30.6	21.2
81	10	366.7	2.4	371	363	28.59	1.55	31.1	26.0

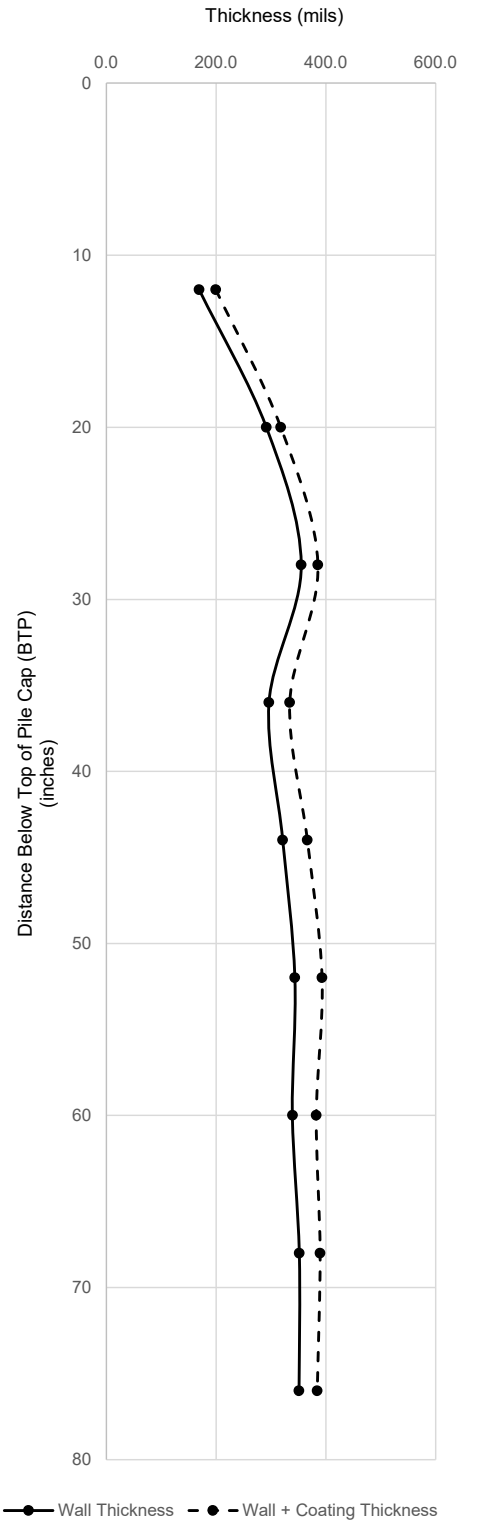
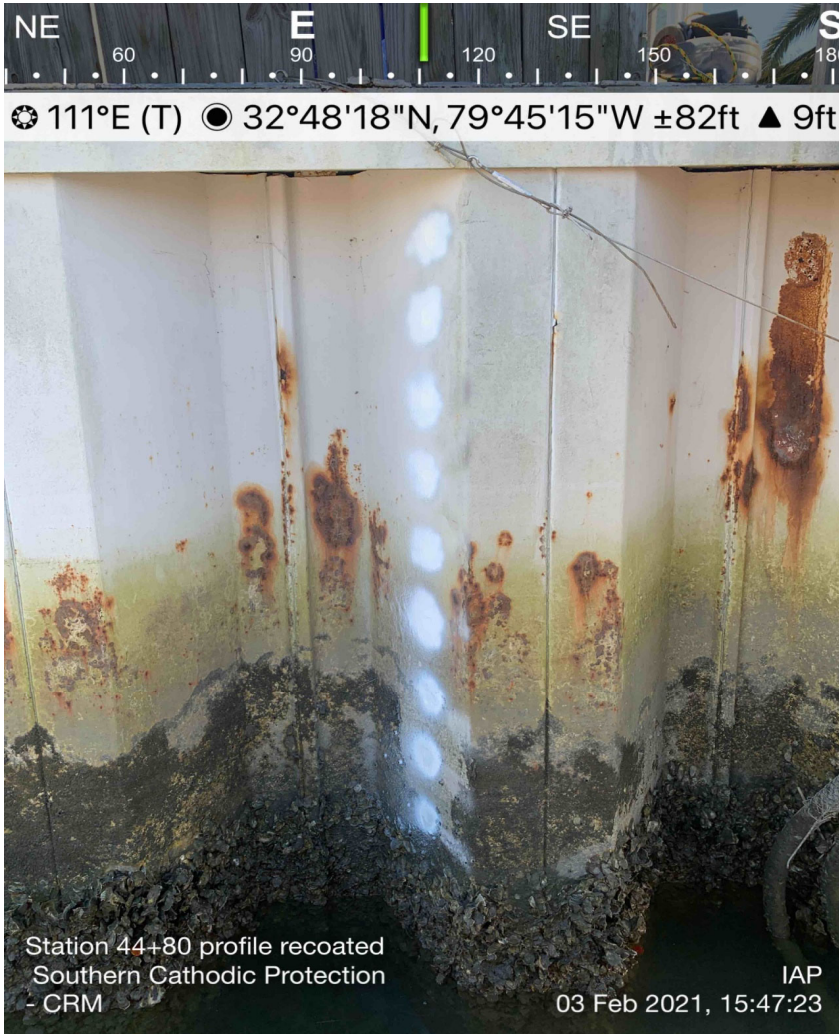
STA 44+80 Wall and Coating Thickness

Metal Thickness						Coating Thickness			
BTP	#	Mean	St. Dev.	Min.	Max.	Mean	St. Dev.	Min.	Max.
12	1	168.9	1.4	167	171	30.58	1.04	29.1	32.3
20	2	291.3	2.2	286	293	26.64	1.07	24.8	28.8
28	3	354.9	1.7	351	357	30.64	3.10	26.5	37.3
36	4	296.4	2.0	294	300	37.91	2.93	33.8	42.2
44	5	321.4	1.0	319	322	44.68	1.93	41.2	57.4
52	6	343.7	0.5	343	344	49.34	2.84	44.8	55.0
60	7	339.1	1.3	337	341	43.18	2.67	38.2	46.5
68	8	351.5	1.0	350	353	37.86	3.01	32.0	42.4
76	9	351.3	0.7	351	353	33.14	1.77	30.6	35.9

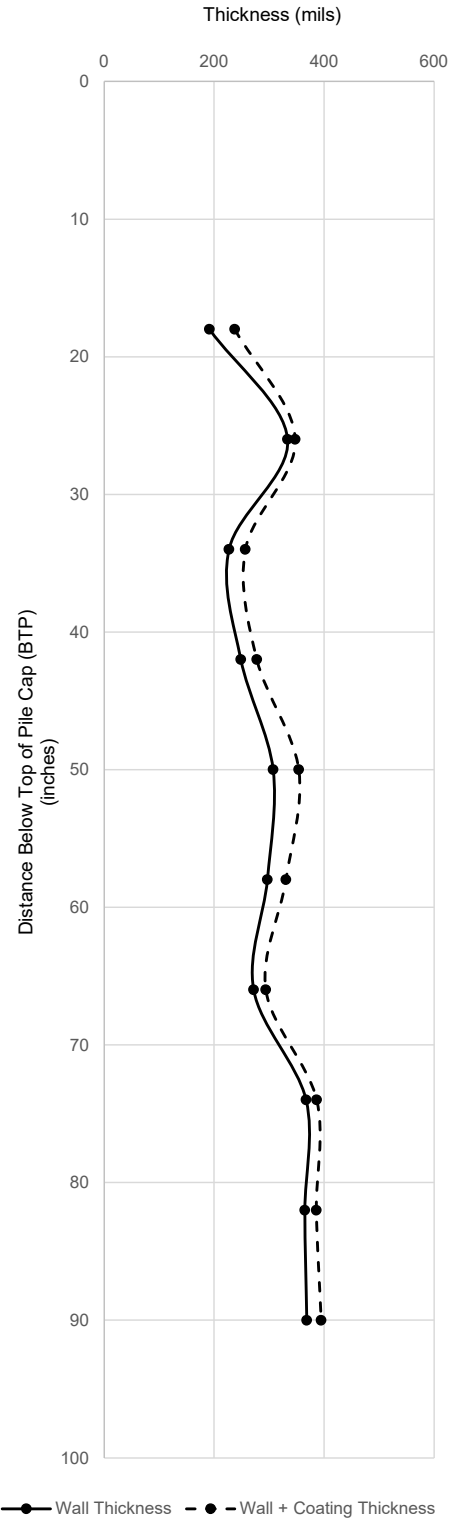
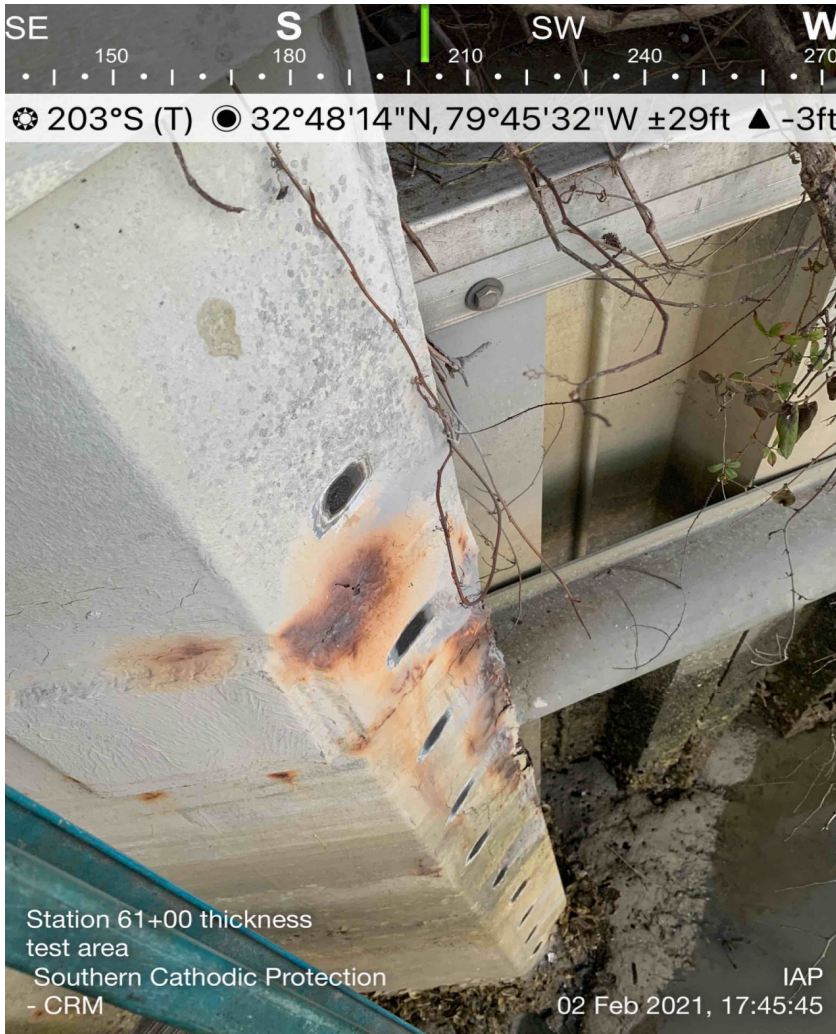
STA 61+00 Wall and Coating Thickness

Metal Thickness						Coating Thickness			
BTP	#	Mean	St. Dev.	Min.	Max.	Mean	St. Dev.	Min.	Max.
18	1	191.4	1.1	189	192	46.05	1.76	43.2	48.7
26	2	333.8	3.3	328	340	14.04	2.56	11.4	20.1
34	3	227.0	9.5	209	236	29.82	1.67	47.9	52.8
42	4	248.8	1.0	247	250	29.05	2.68	25.8	32.6
50	5	307.3	1.4	304	309	46.79	1.82	43.5	48.8
58	6	296.7	1.3	295	299	33.79	4.81	27.2	40.4
66	7	271.9	5.3	264	281	22.35	2.14	19.4	25.9
74	8	367.2	1.4	364	369	19.45	2.36	14.6	22.0
82	9	365.1	0.6	364	366	20.81	2.48	17.0	23.7
90	10	368.4	1.8	366	371	26.38	4.67	19.6	32.5

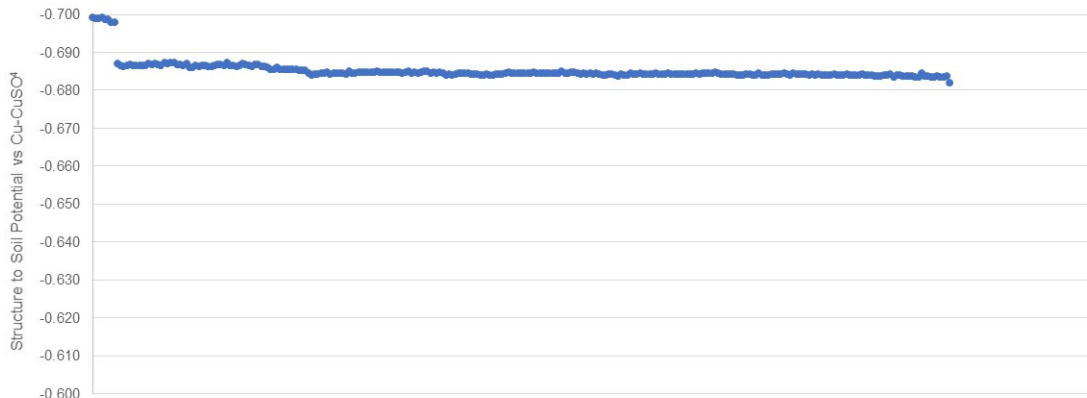
**STRAY CURRENT ASSESSMENT - TIME SERIES**  
Station 61+00

- Stray current testing found both structures free of stray or dynamic DC or AC voltages at the time of evaluation. All AC potentials were zero and all DC potentials were stable. The time series data recorded along each wall were largely flat. Minor fluctuation was observed in the range of a few millivolts, likely due to changing tide conditions. The data and time series plots are attached in Exhibit 3.
