## **Wild Dunes Yacht Harbor Dock Study**

*Location:*  
**Wild Dunes Resort  
Isle of Palms, South Carolina**

*Dated:*  
**December 14, 2014**

**Civil, Waterfront and Marine Planners & Engineers**

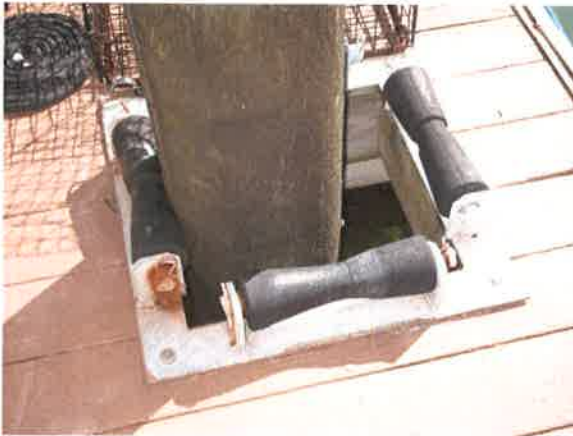
The main issues found with Dock A are some rotten wood, missing or broken rub rails and damaged or broken rollers on the pile guides. Several of the pile guides have been replaced on the dock, in some cases with new aluminum pile guides. The new pile guides have upper and lower rollers with the lower rollers being below the deck surface. All of these pile guides are located at the ends of the finger docks and have rollers on all four (4) sides of the pile. The piles along the main dock use the hoop and single roller style of pile guide. **Photos 2, 3** and **4** show the three different styles of pile guides on Dock A. **Photo 2** and **Photo 4** are the original pile guides which are constructed of galvanized steel. **Photo 3** is the new pile guide style which is constructed of aluminum.

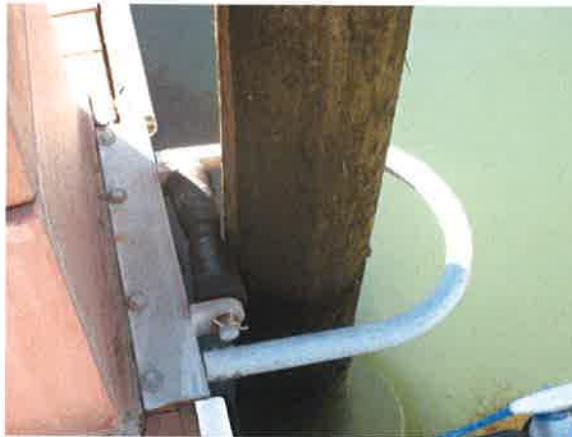
**Photo 4**

On several of the newer style aluminum pile guides, the lower rollers have been damaged from the movement of the dock. These pile guide rollers should be replaced and inspected on a frequent basis. **Photo 5** shows where there is a bolt missing from the pile guide

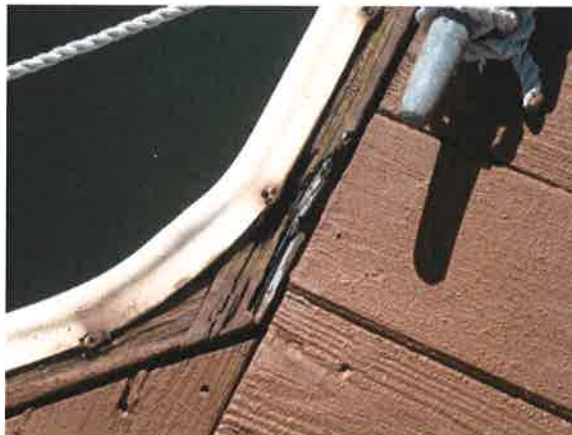
**Photo 6**

**Photo 3** also shows areas of the timber decking that are rotten. Rotten wood can also be seen in **Photo 6**. There are several areas of rotten wood along the header board as well.

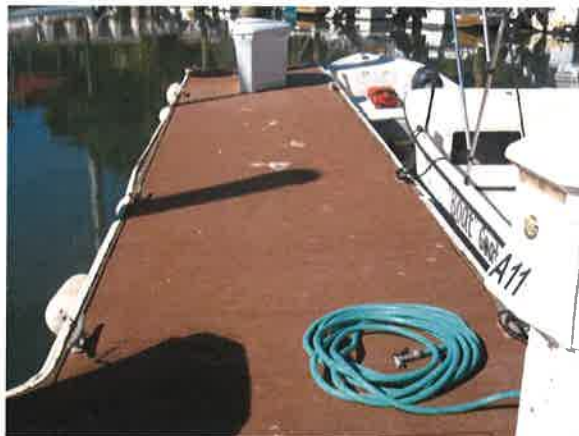
**Photo 7**

**Photos 7, 8, 9** and **10** show where the rub rail is broken or has come loose from the timber header board of the dock. Some areas the rub rail has failed and in other areas the timber has failed from rot.

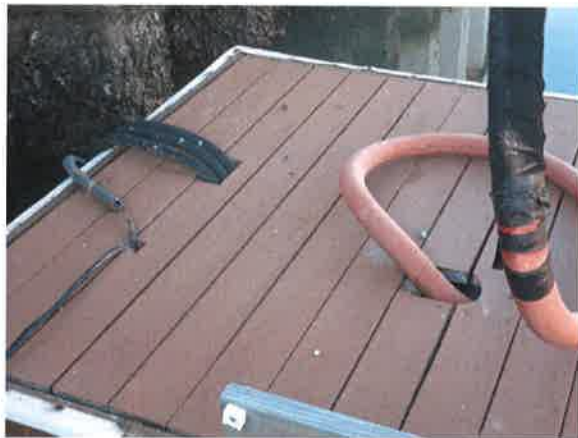
**Photos 11 and 12** show where the utilities have been damaged. **Photo 11** shows where the conduit has been broken and exposed wires are visible. **Photo 12** shows a broken hose bib handle.

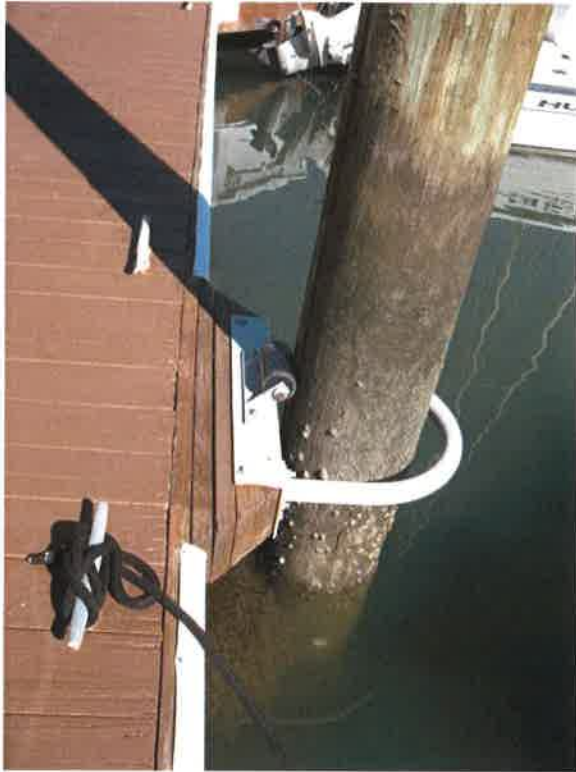
**Photo 20**

Much like Dock A, some of the pile guides have been replaced with newer pile guides. The main dock pile guides are hoop style with a single roller on the inboard portion of the pile guide. These guides appear to be in good condition and are functioning properly. The issue that is seen with many these main dock pile guides is the attachment to the dock. Several of the main dock pile guides are not mounted/bolted directly to the dock structure but instead they have been blocked outward to have proper alignment to the piles. It does not appear that the blocking has been thru-bolted to the dock structure as several are loose or move under little force. The pile guides are bolted to the blocking but the blocking does not appear to be securely fastened to the main dock structure. **Photo 20-22** show several of these pile guides that have been blocked outward. In

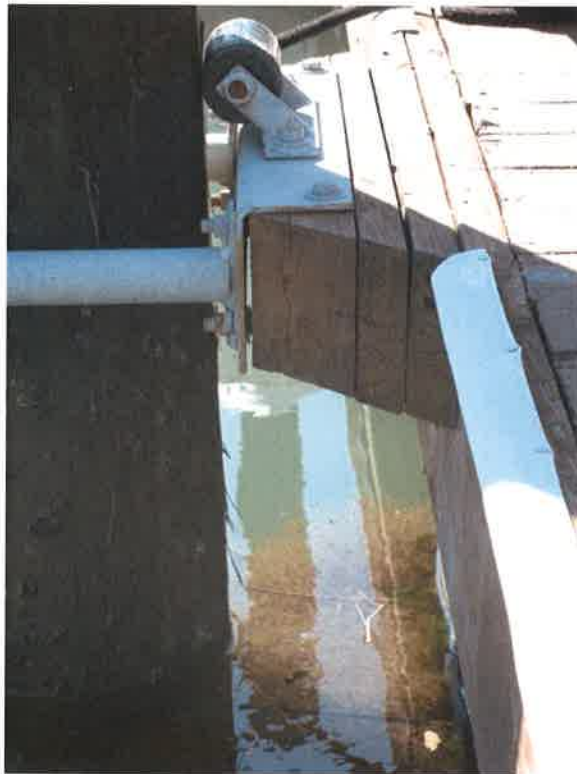
**Photo 22** gaps can be seen between the pile guide and the blocking along with in between the blocking itself.

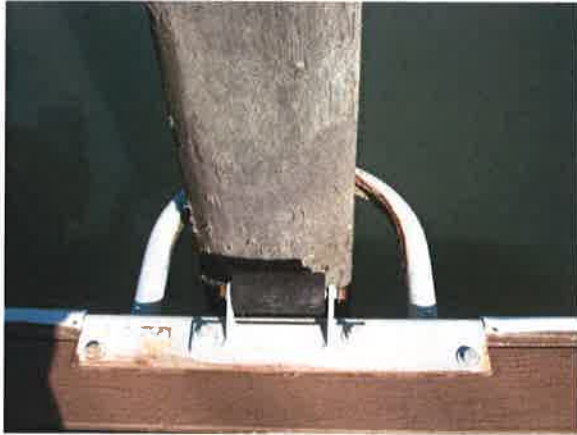
**Photo 23**

Several of the other hoop/single roller pile guides have been mounted properly to the main dock structure but several of these have experienced significant corrosion. Examples of these can be seen in **Photos 23** and **24**.

In both of these photos, severe corrosion of the hoop portion of the pile guide is evident. This is occurring from the movement of the pile against the galvanized metal hoop. The galvanizing treatment has been worn off exposing the unprotected metal.

Though the external single roller hoop style pile guides are experiencing corrosion of the galvanized metal, they are still functioning property. They should be monitored for further deterioration. The external pile guides along the main dock of Dock B should be re-fastened more securely as mentions in the Dock B section of this report. JGT recommends the external pile guides should be inspected annually or after a significant storm (or wave) event in order to monitor their condition and the corrosion.

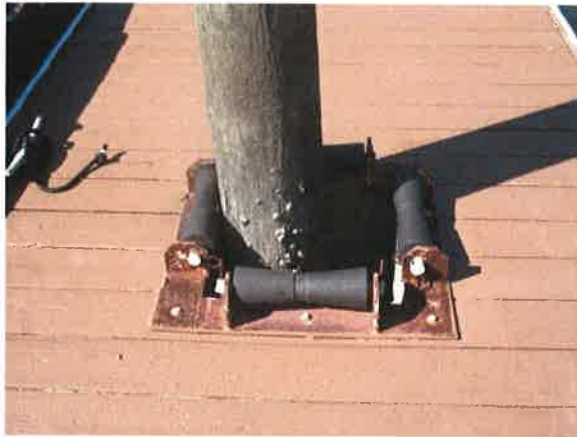
**Photo 27**

**Photo 27-29** shows the rusted, galvanized steel pile guides. The rusted pile guides are more common near the end of Dock B. The rusted or oxidized pile guides are structurally sound but should be monitored. Worn rollers can also be seen in **Photo 28** and **Photo 29**. These photos also show that the pile is not centered in the pile guide. This misalignment that has caused the rapid wear to the pile guide rollers.

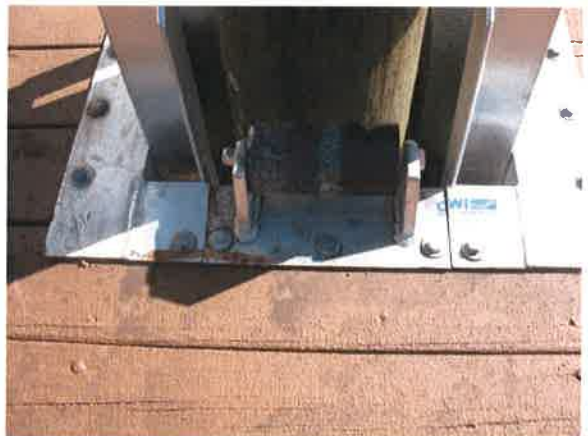
**Photo 30** shows the new aluminum pile guide. These pile guides had been cut to be installed. This can be seen in **Photo 30** where the lower pile guide roller is. A small section was cut out and then once installed the cutout section was bolted to the dock separately. This does not appear to be causing an issue but it does mean the pile guide assembly is not one unit.

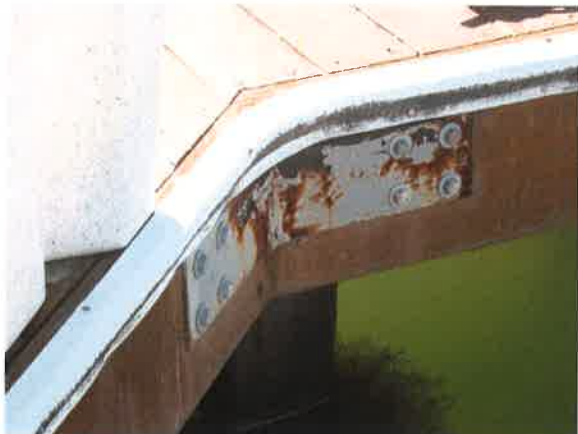
**Photo 31**

On Dock B, the gusset plates at the chamfer between the main dock and the finger docks are beginning to show signs of corrosion and the bolts holding the joints are corroded to a point where several need to be replaced. **Photo 31-33** show examples of where this corrosion is taking place and **Photo 32** shows where the bolts are in very bad shape.

The galvanized gusset plates are in average to fair condition along all of the docks inspected. Most of the corrosion is surface rust except for a few plates. Many of the bolts holding the gusset plates are corroded to the point where they will not be able to be removed. JGT recommends that the gusset plates should be inspected on an annual basis or after a significant storm (or wave) event in order to monitor the corrosion and their condition.

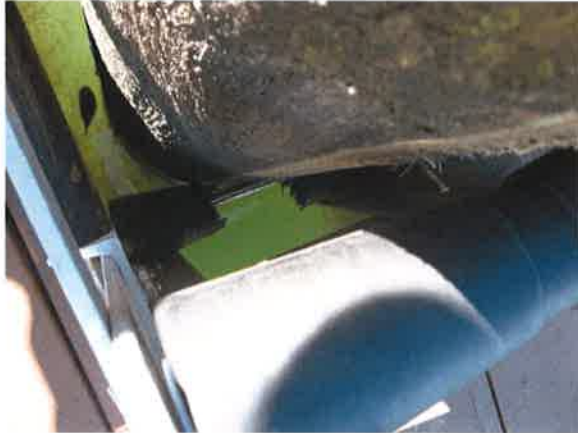
**Photo 49**

Another concern with the aluminum internal piles guides is the lower roller system. Many of the lower rollers are broken, very badly worn or even completely missing. **Photo 49-51** show these lower rollers that have been damaged. These rollers are damaged because of the manner in which the docks rotate during wave action. The lower pile guide rollers restrict the movement and rotation of the dock. The location or depth of the rollers in the dock means these rollers are subjected to significant impacts and forces.

There are some rollers on the pile guides that are worn and some that are broken. Many of the broken pile guide rollers are the lower rollers within the dock on the aluminum pile guides. Many of these lower rollers are broken because the lower rollers have restricted the rolling movement of the docks. This has caused the lower rollers to experience higher loads thus breaking many of them. There could be an argument made whether to replace the lower rollers, leave the pile guides and broken rollers as is or remove the lower rollers and allow the dock to rotate and move without the rollers. The original galvanized rollers did not have lower rollers.

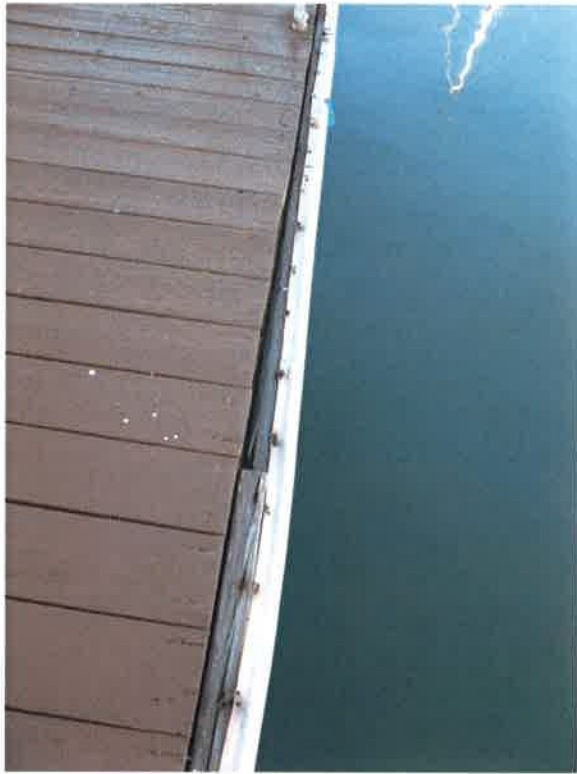
Along Dock C there are several areas where the timber is rotten or has come loose from the dock structure. **Photos 52-54** show a couple of these areas where the header boards are rotten or the fasteners have corroded away and the boards have come loose. These are representative of a condition that exists in several areas.

The reason for the “bowing” of this finger dock is not known and could not be seen. The loose stringer boards from **Photo 52** and **53** give an indication that the bowing of the dock could be from the timber structure members warping. The finger dock does not appear to have been impacted or sustained any type of damage that would cause this bowing. The finger dock appears to be floating level and is stable.

Many of the timber header boards along the main docks and finger docks can be re-fastened using new galvanized or stainless steel fasteners. None of the timber members on the dock are rotten to the point of requiring replacement but most need to be re-fastened or secured to the dock.

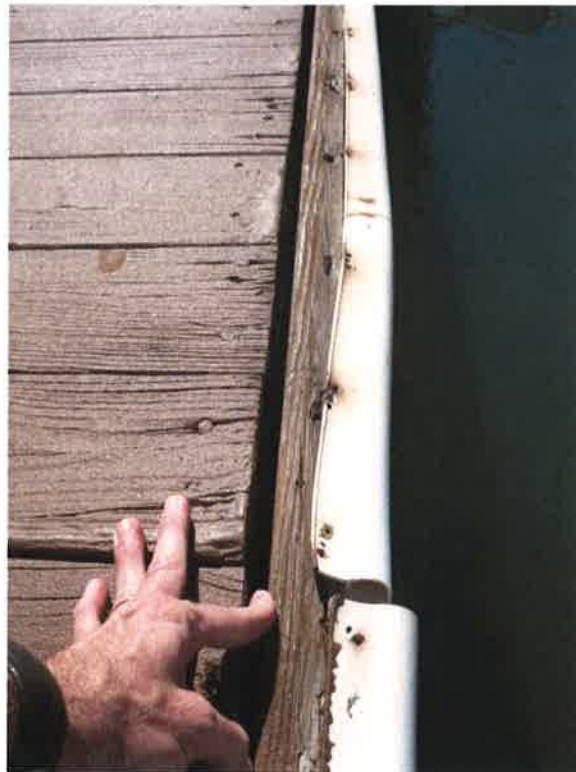
**Photo 53** and **Photo 54** show that the rub rail molding is beginning to fail. **Photo 55** shows another area where the rub rail molding is loose and needs to be replaced. **Photo 55** and **Photo 56** show a sampling of the gusset plates along Dock C. They appear to be in good condition with little corrosion taking place.

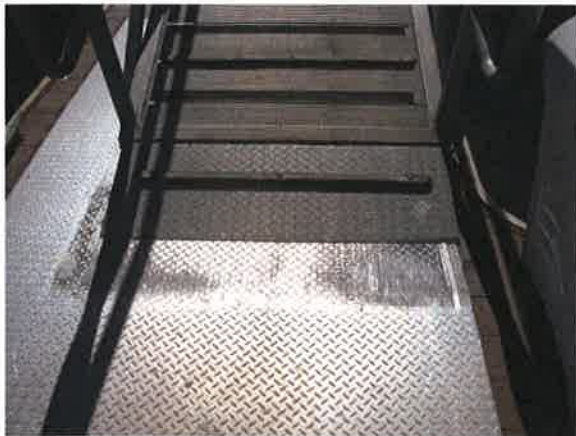
**Photo 59** and **Photo 60** shows the gangway and its position on the tread plate. It appears that the dock has shifted approximately 6-8 inches to the right in **Photo 59**. In **Photo 60**, the gangway has shifted over to where it is beginning to impact the cleat on the side on the main dock. **Appendix A** includes a report dated *September 5, 2014*, Titled "*Morgan Creek Marina-Dock D Inspection*". This report outlines the inspection and finding of why the gangway has moved to the right. This report finds that the main dock has a slight "bow" or bend in it. This has caused the portion of the main dock nearest to the gangway to shift. This September 5th report was conducted prior to the underwater inspection by Salmons Dredging Corp. of Dock D.

Following the Underwater inspection by Salmons Dredging Corp., it is believed that the movement dock and the bend is a result of an impact to the main dock. From the underwater inspection and looking at the gusset plates within the area of the bend, there appears there has been movement in some of the timber structural members beneath the decking. There was evidence that several of the bolts had pulled into the timber and the timber members had shifted. These items appear to have been caused by an impact to the main dock. The timber decking was not removed within this area to inspect the timber structure. It does not appear that the dock is broken or in danger of coming apart, only that a portion of the dock has shifted.

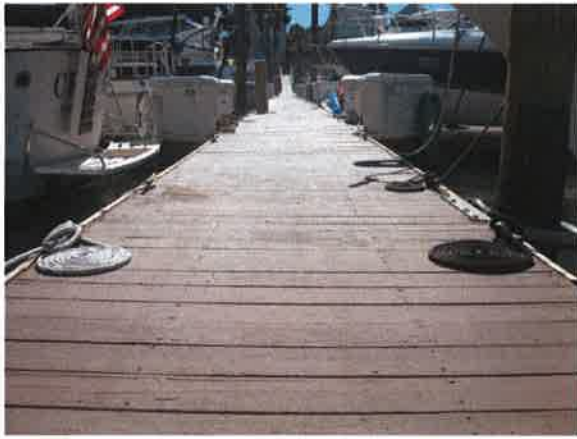
Photo 61

It is apparent that within this area where the main dock is "bowed", the main dock also dips (near the fire hose cabinet). **Photo 61, 62** and **63** shows this dip in the main dock as indicated by the leaning fire hose cabinet. It is unknown and could not be determined if the dip in the main dock and the bowing of the main dock are related. It could be caused by floatation issues or is simply a product of the "bowing" of the main dock.

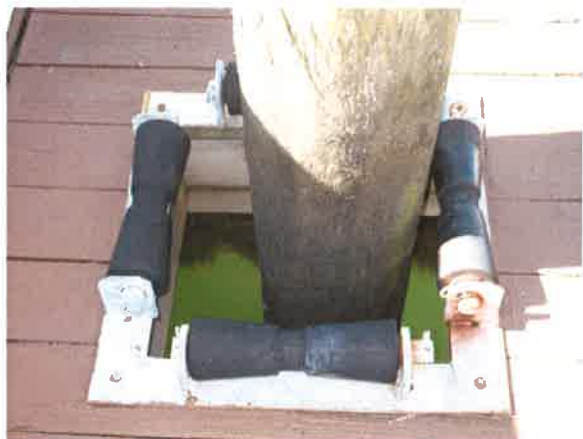
**Photo 66**

surface corrosion. **Photos 66** and **67** show the typical galvanized internal pile guide and their typical condition on Dock D. The rollers on the galvanized internal pile guides appear to be in good condition.

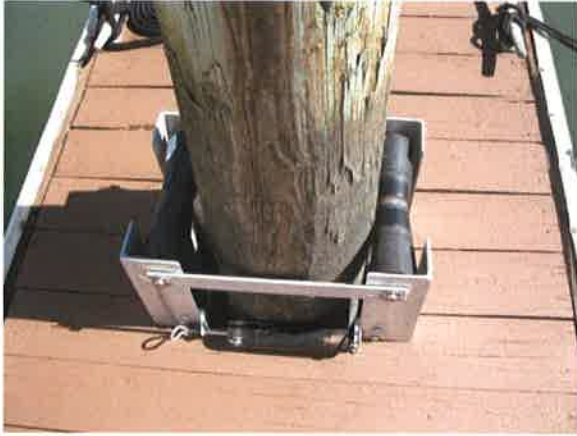
**Photo 72**

**Photos 72-77** show the second type of aluminum internal pile guide. These internal pile guides also have lower rollers on two sides, however; several of these rollers are broken as is seen in **Photo 75** and **76**. This internal pile guide also does not have rollers on the back side of the pile guide as seen in **Photo 77**. The damage to the timber pile can be seen from the dock rubbing against the pile.

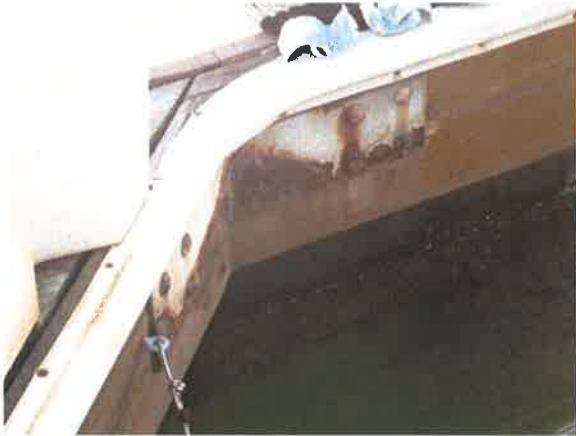
Photo 78

Much like the other docks, the galvanized metal gussets at the corners of the main dock and the finger docks, are showing signs of corrosion. **Photos 78-82** show these galvanized metal gussets

along Dock D. In all of these photos, there are signs that the lower bolts are severely corroded and are beginning to break apart.

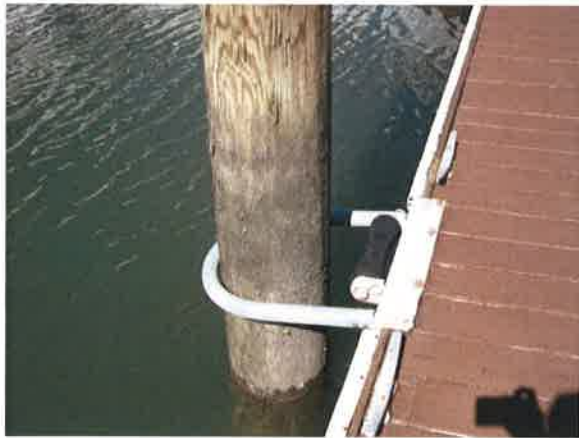
**Photo 83**

The main dock single roller hoop style external pile guides are in average to fair condition with signs of corrosion beginning. **Photos 83 and 84** show these external pile guides on Dock E.

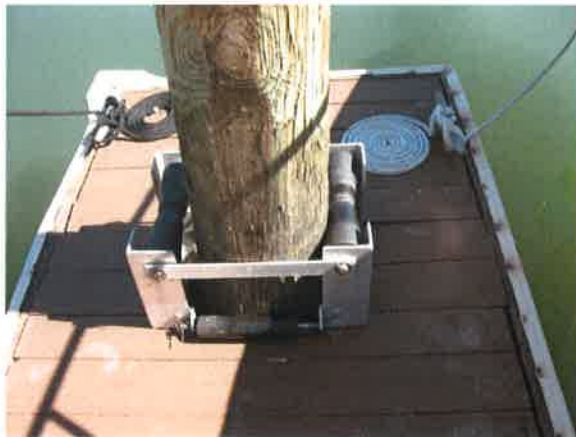
**Photo 90**

The second type of aluminum internal pile guide is the same style that is on the other docks along with Dock E. As with the other docks, this style of internal pile guide has several broken lower pile guide rollers. **Photos 90-92** show these pile guides and **Photo 92** shows where the lower pile guide roller is broken and missing.

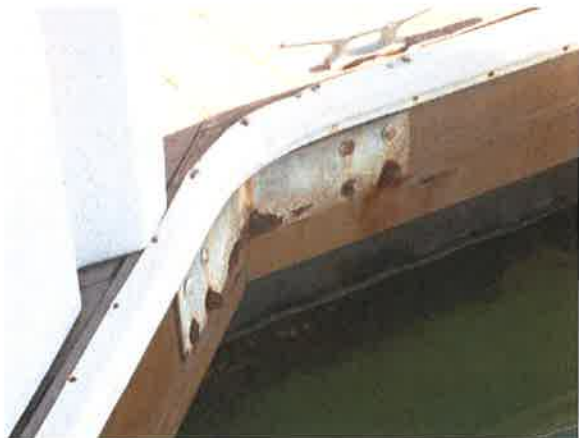
**Photo 93**

The galvanized gusset plates on Dock E at the intersections of the main dock and the finger docks are typical of the other docks inspected. **Photos 93-97** show these gusset plates along Dock E. In **Photo 94**, the corrosion is worse than the others photographed. The lower portion of the gusset plates and the lower bolts (closest to the waterline) are showing signs of significant corrosion.

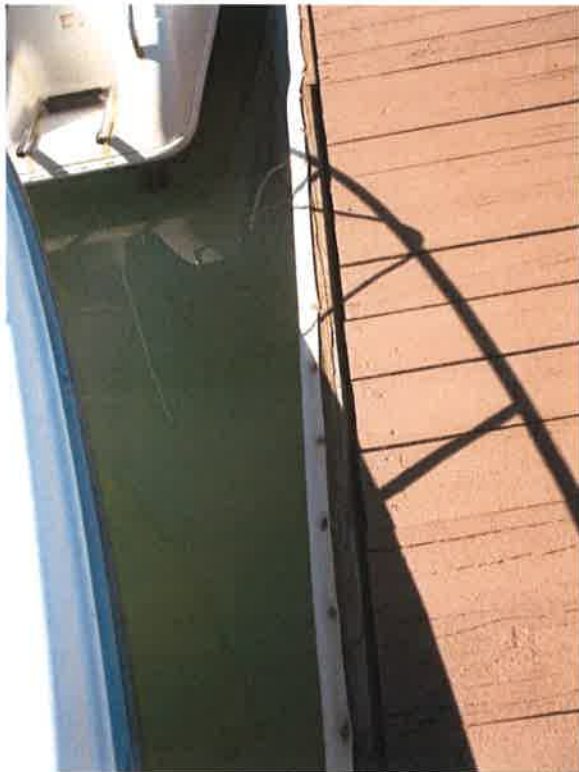
**Photo 98**

There are a couple of timber header boards along the finger docks that are loose. **Photos 98** and **99** show two such areas. A combination of rotten wood and corroded fasteners appear to be the reason for the looseness of the boards.

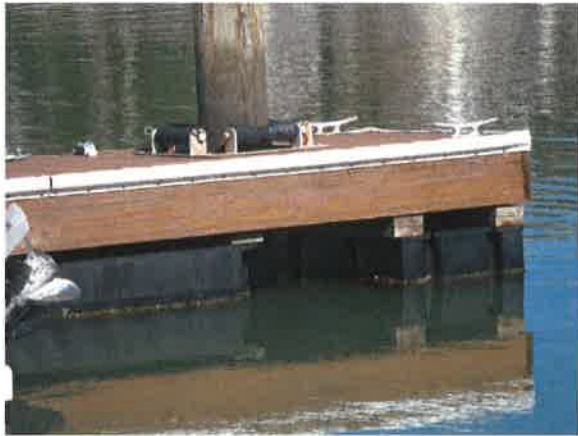
**Photo 101**

**Photos 101** and **102** show the timber 2x member that the float is attached to which is then attached to the bottom of the dock structure. **Photo 102** also shows where the timber 2x member is split. **Photo 103** is of a typical galvanized bolt that fastens the plastic float to the timber 2x member. Many of these bolts and nuts have corroded away to a point where they are basically a corroded stub holding the float. These will continue to get worse and the loss of movement of the plastic floats is possible during heavy wind or wave action. The plastic float appears to be in good condition with no signs of problems or damages.

The plastic floats supporting the timber dock structure are in good condition. The issue is the galvanized bolts that attach the plastic floats to the timber dock structure. These bolts are approximately 50% corroded away. Should a significant storm or wave event occur it is possible that these plastic floats may come loose, move or become unattached from underneath the docks. Given the estimated life expectancy of the entire dock system, JGT would recommend securing with stainless steel lag bolts. It is recommended that new stainless steel lag bolts be installed on the four (4) corners of each float on all of the floating docks. The new lag bolts would be installed adjacent to the existing bolts. It is estimated that for all five (5) docks, this would cost approximately \$60,000.00. This work must be done by a diver from underneath the structures. JGT recommends that plastic floats should be inspected annually or after a significant storm (or wave) event in order to monitor their condition and attachment to the dock structure.

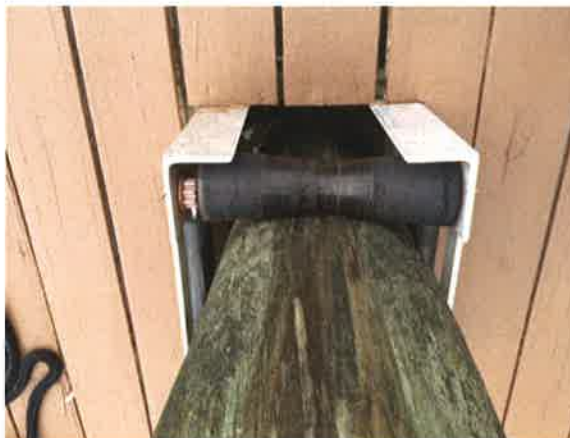
**Photo 5** shows a pile and pile guide roller under pressure at the end of a finger dock. This pressure does not correspond to the movement of the dock and the finger dock is straight.

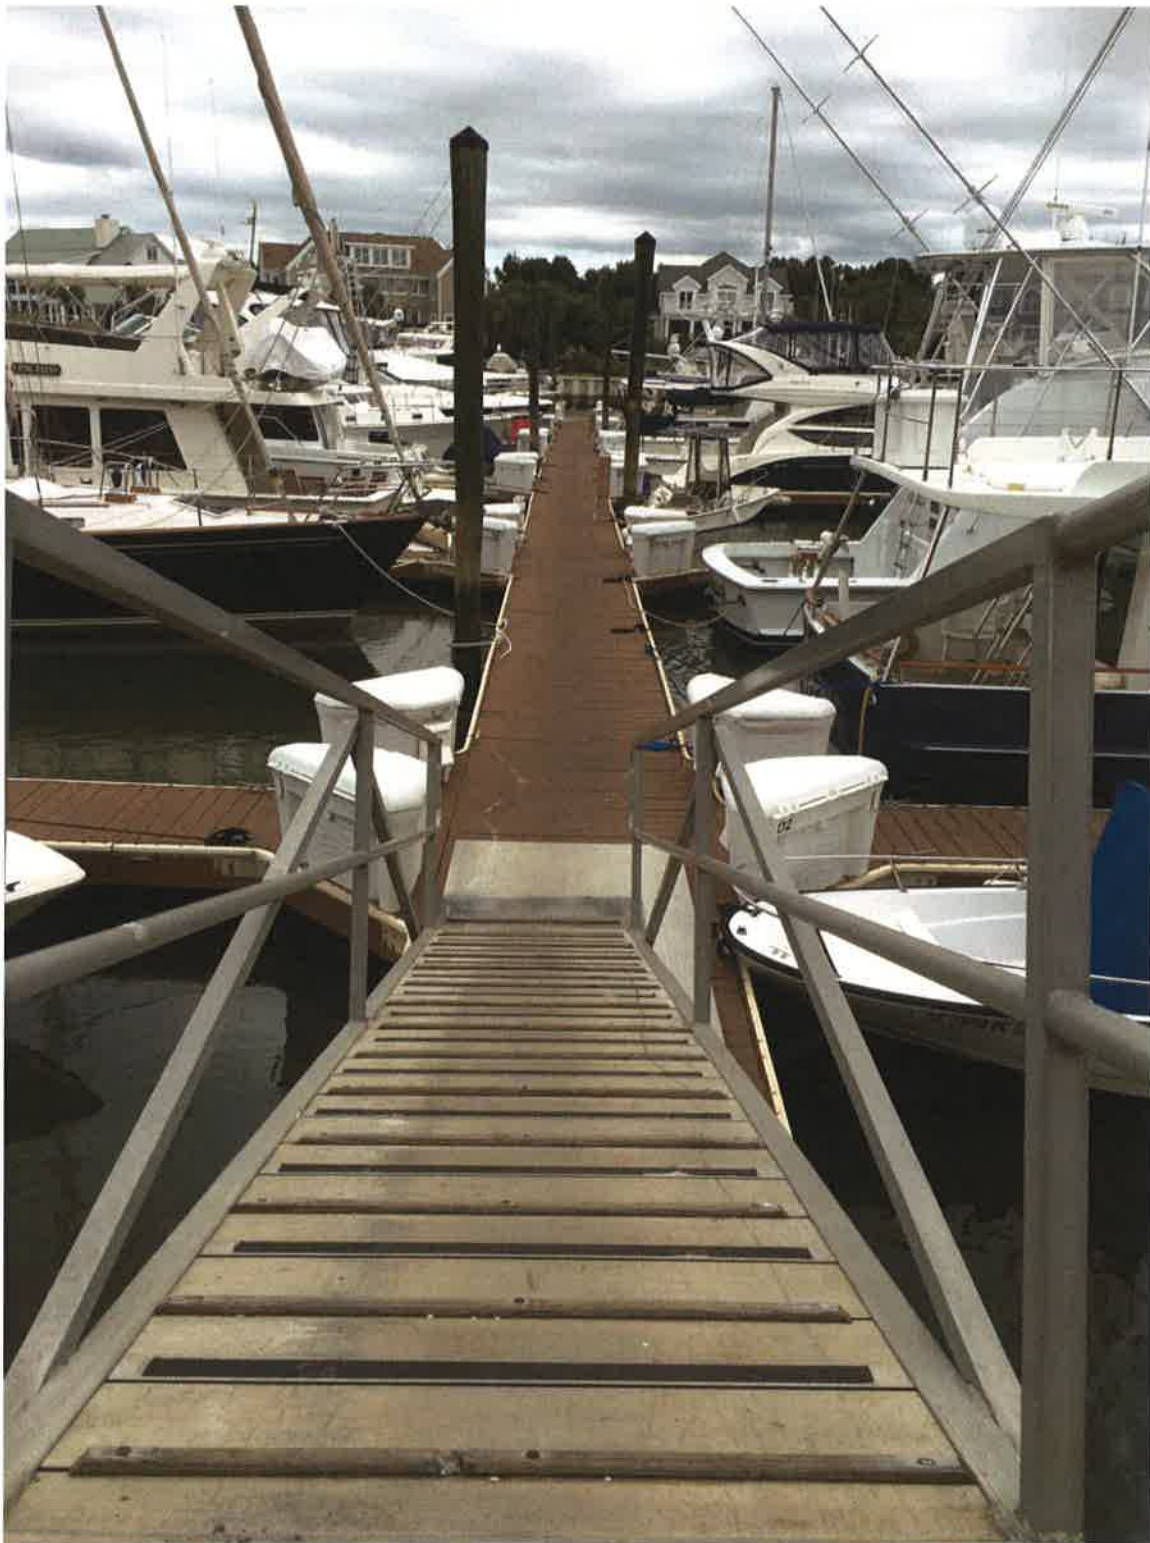
Based off the inspection of Dock D, JGT feels that the something has come loose or broken within the structure of the main dock. Through the inspection and pictures it can be seen where the break or bend occurs along the main dock. **Photo 6** shows the Dock D main dock.

JGT would recommend working with a contractor to further investigate the problem by removing dock boards so the internal substructure can be inspected.

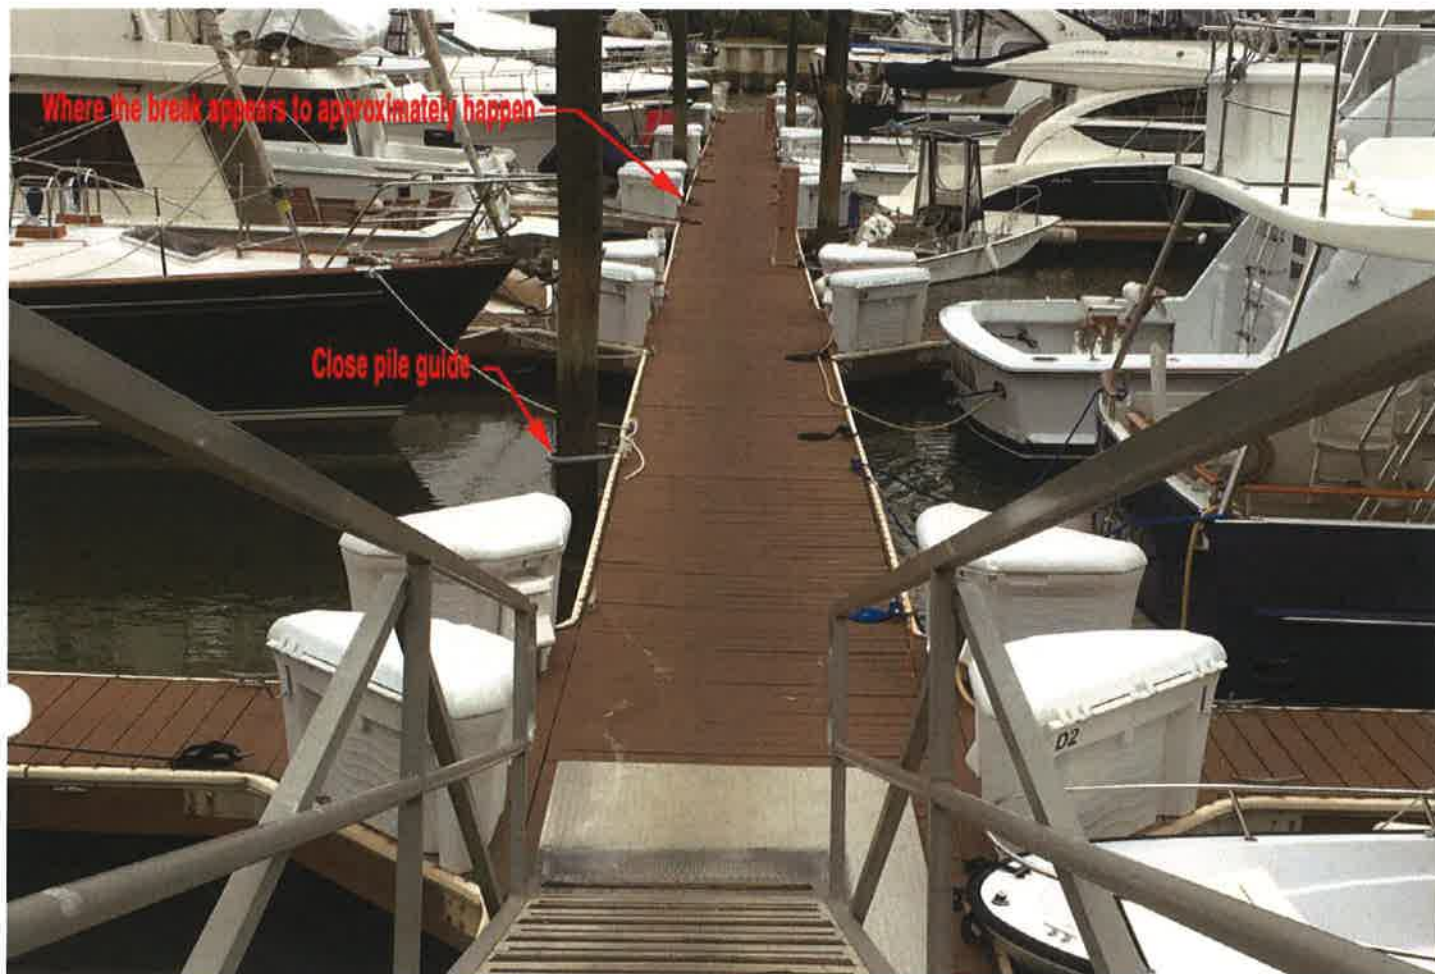
**Photo 7**

Photo 7 shows the Dock D main dock with the bending point labeled. The nearest main dock pile is labeled and it can be seen that the pile guide is not centered. Though not binding or under pressure it does indicate the dock has moved to the right of the picture.

As noted, JGT could not find the cause of the movement during the inspection but the findings point to an internal structural problem. Further investigation would be needed to find the exact cause. This would entail removing deck boards on the main dock to expose the timber substructure of the dock. There is no external evidence of breakage or damage; though in **Photo 7**, the label indicates the approximate location of the problem area. Given the age of the timber dock structure, an internal structural problem from soft or rotten un-maintained, unseen timbers is possible.

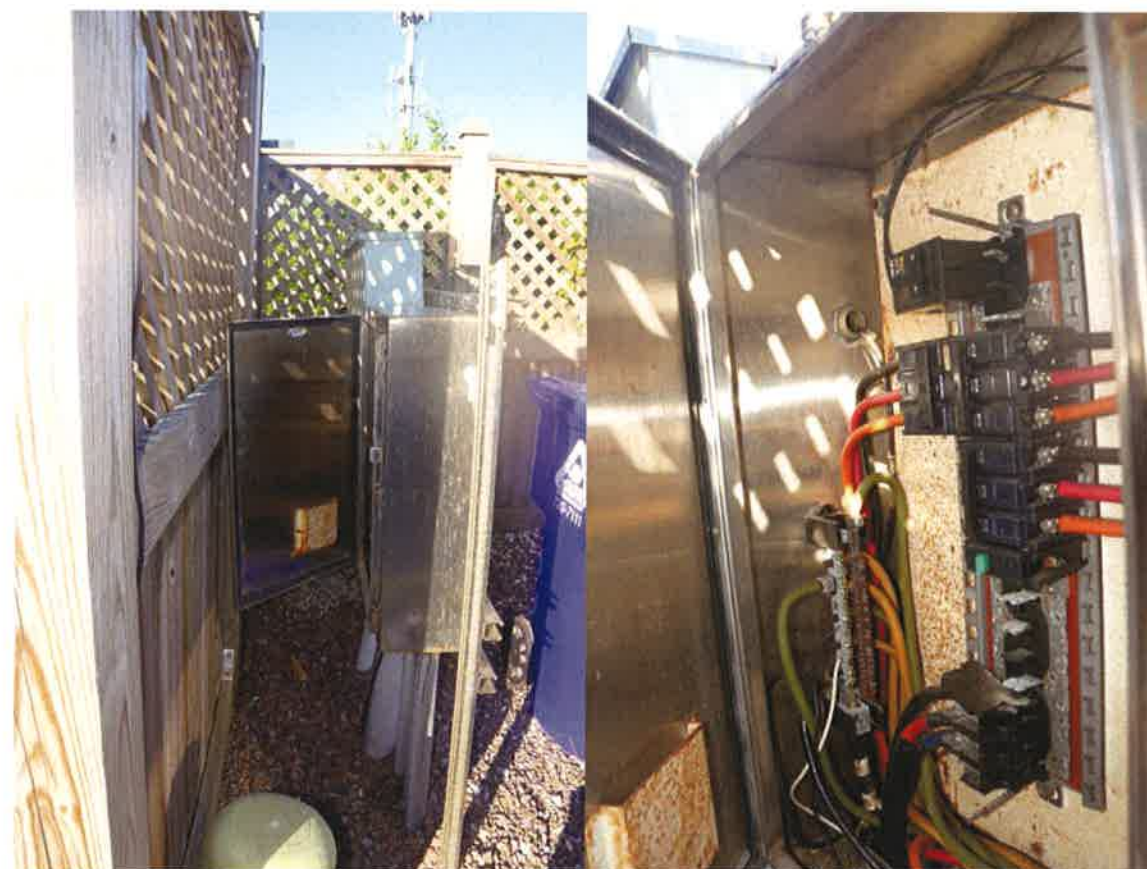
Dock A main panel is missing the inner cover allowing live parts exposed and the panel bus is badly corroded.

Dock A main panel

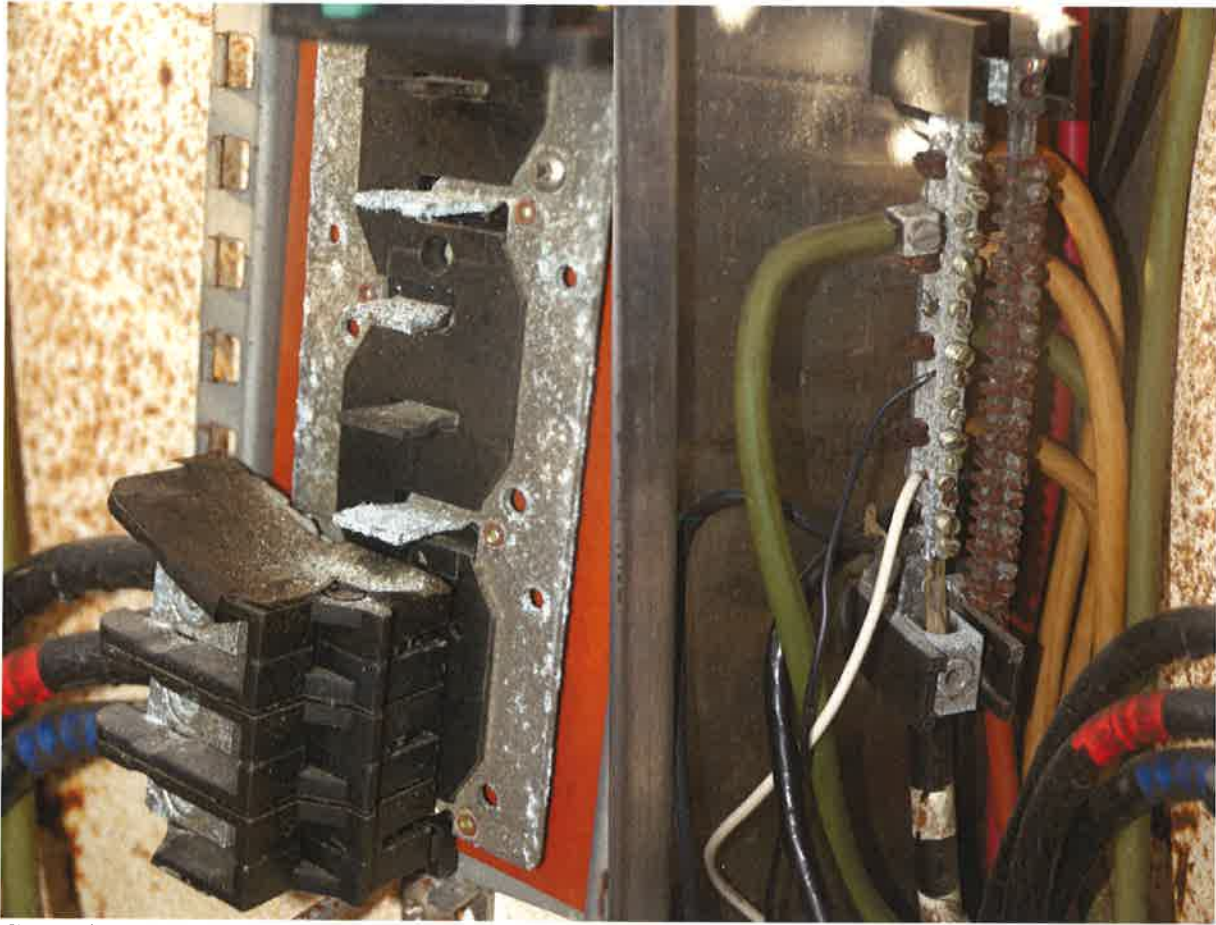
Corrosion at dock A main panel

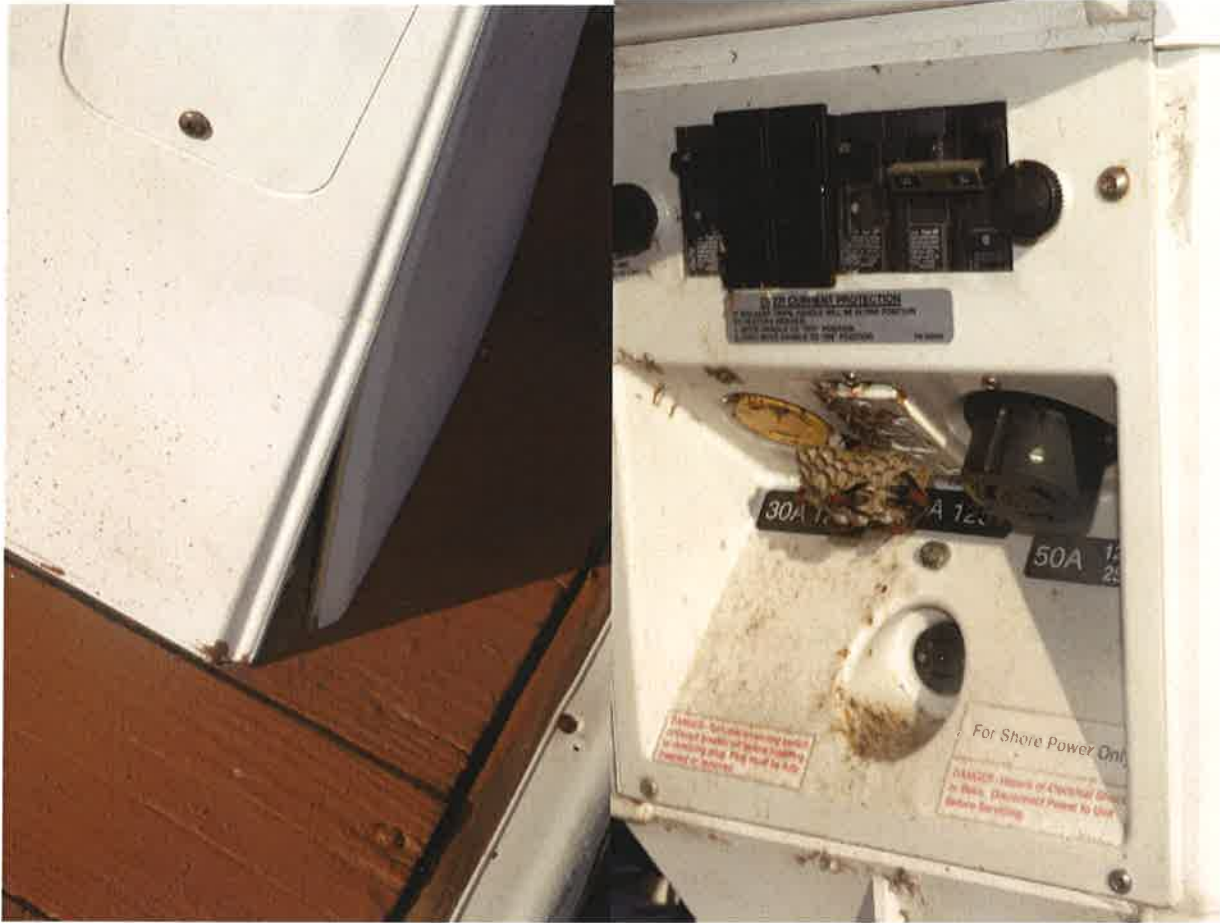
Broken pedestal base and wasps

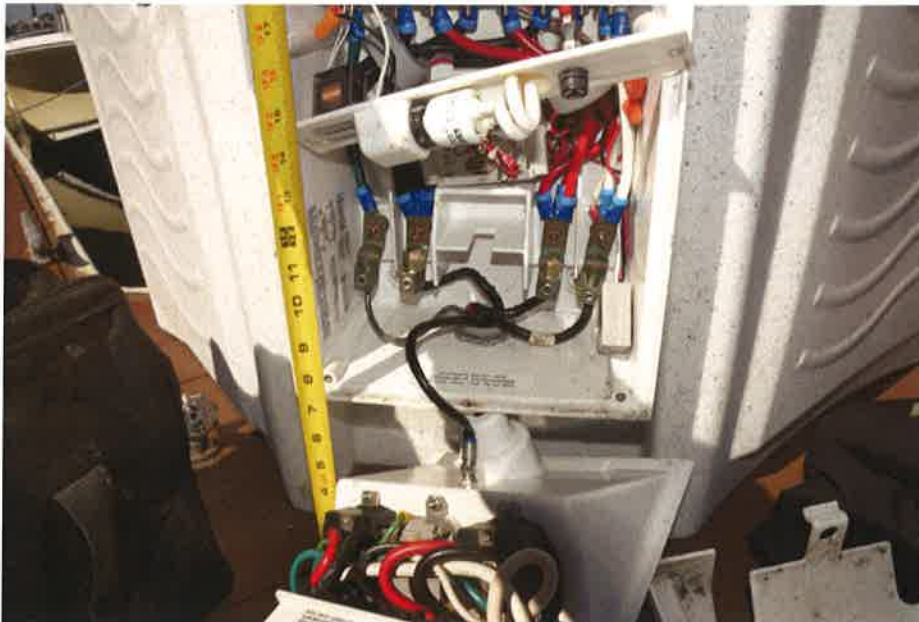
Dock box mounted pedestals

The pedestals mounted on the dock boxes are below the 12" minimum per NFPA 303 article 5.12.1.3.

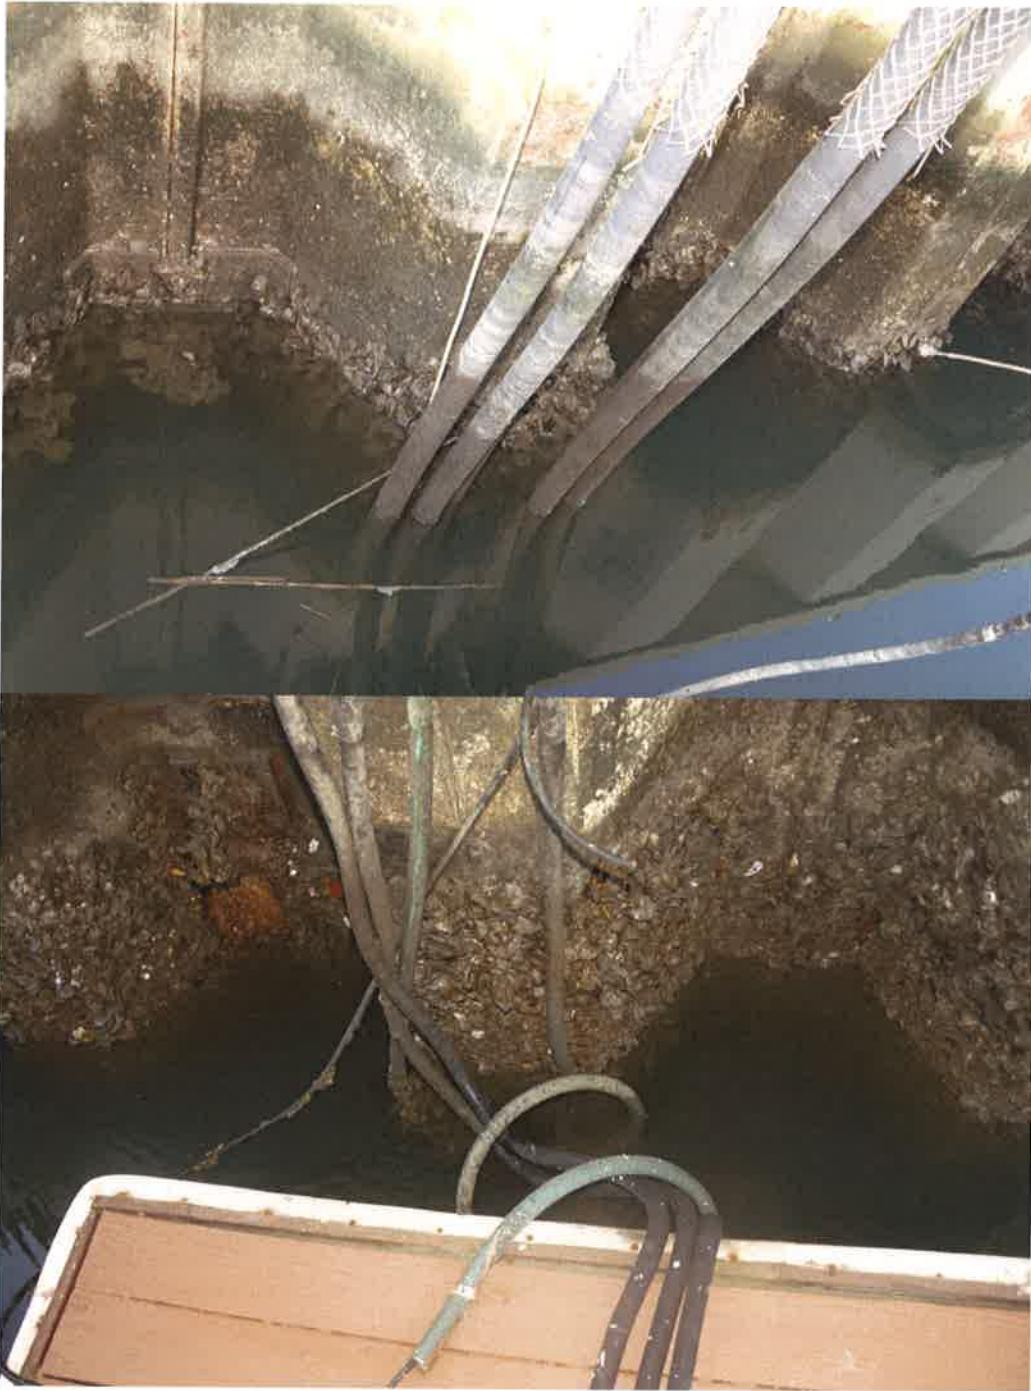
Main pedestal feeder cables

The main feeder cables appear to hang very close to the seawall and may be subject to damage from oyster shells. I recommend the cables be secured to the underside of the walkway to allow more distance from the seawall.

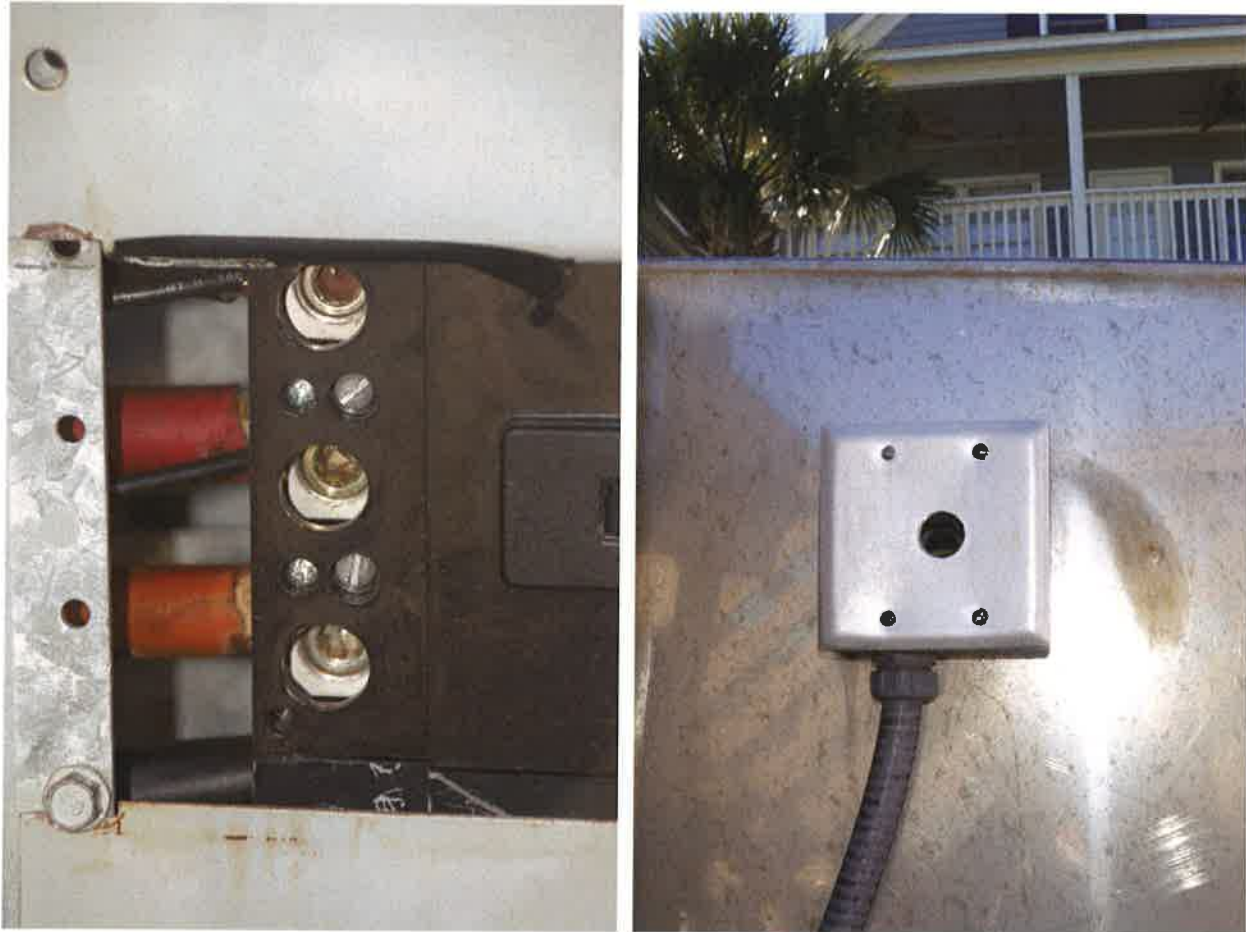
The lighting for the main seawall and dock ramp is connected to a 225 amp circuit breaker at each of the main electrical panels. This connection is allowed per NEC tap rule but is not a good practice as there is no protection of the 20 amp circuit from the 225 amp circuit breaker. The lighting circuit does not have its own protection as the panels are only allowed six circuit breakers without using a main circuit breaker. This lighting circuit originally had a junction box with a photoswitch. The photoswitches have been relocated and the junction box covers were left with an open hole.

Connect of lighting circuit to feeder circuit breaker and open junction box on side of panel.
