From: Heath Hansell, PE

Date: May 15, 2020

Re: **Morgan Creek Bulkhead Project Alternatives Review**

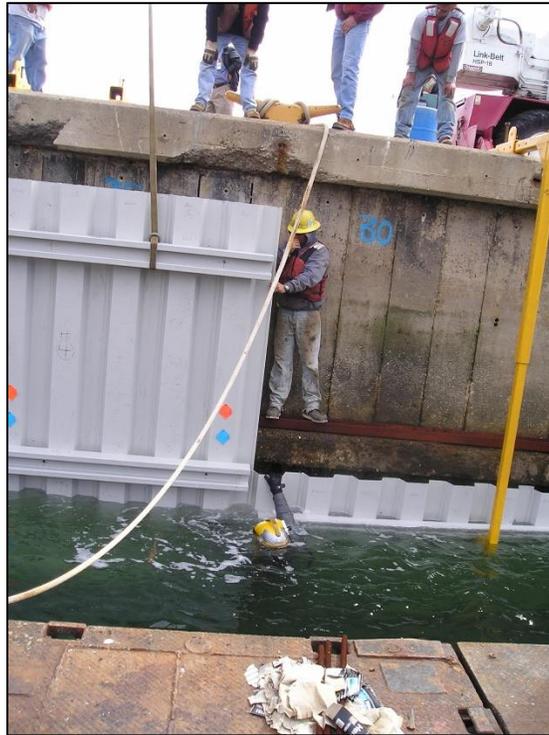
sections to speed construction as shown in the below photo below provided by Creative Pultrusion (another composite sheet pile and component manufacturer).

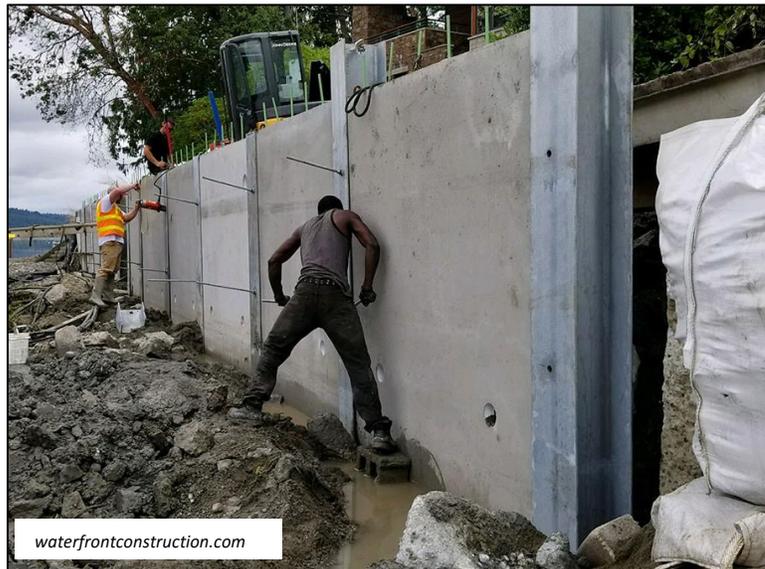
This alternative would construct a new concrete soldier pile and panel bulkhead just waterward of the existing structure. New concrete piles would be driven as close as possible to the existing wall. If required, new helical tiebacks would be installed at each soldier pile. Between the piles, pre-cast reinforced concrete panels would be installed to span the distances between each soldier pile. Utilities, drainage, and gangway attachments would require modification/extension through the new bulkhead. The void space between the new and old wall would be filled with gravel material. Work would be conducted primarily from heavy water-based barge/equipment and removal and reinstallation of floating docks and anchor piles would be required. Fill between the existing and new wall may be required to utilize land-based installation with associated impacts and restoration. Estimated service life for a properly designed new concrete soldier pile bulkhead is 50 years. A photo of a soldier pile bulkhead (with steel soldier piles instead of concrete) is shown below.

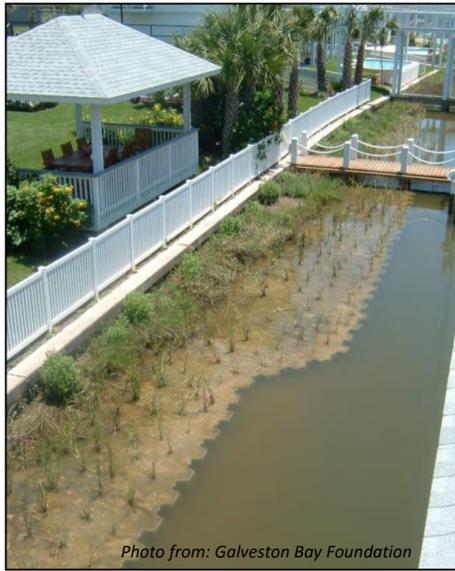
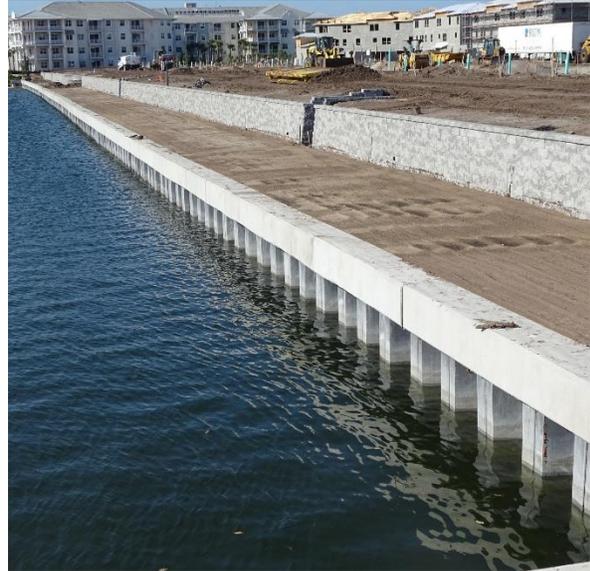
This option would require substantial upland excavation, demolition and debris removal. The sloped or terraced shoreline could be created using typical rip rap rock, modular block units, mechanically stabilized earth (MSE) methods, smaller terraced bulkheads/retaining walls, or similar methods. Structurally, the benefit of this terraced configuration is that it reduces the exposure heights of the individual bulkhead which requires less robust structures and gives more flexibility in design/materials. Assuming an idealized cutoff of the existing bulkhead at the mudline and typical installed revetment slope landward (1V:1.5H), this final configuration could encroach into the upland up to approximately 25ft landward of the existing bulkhead location. The photos below show examples of terraced shorelines. One shows where two levels of bulkheads were used to create a high tide living shoreline.
