## **Wild Dunes Yacht Harbor Dock Study**

*Location:*  
**Wild Dunes Resort  
Isle of Palms, South Carolina**

*Dated:*  
**December 14, 2014**

**Civil, Waterfront and Marine Planners & Engineers**

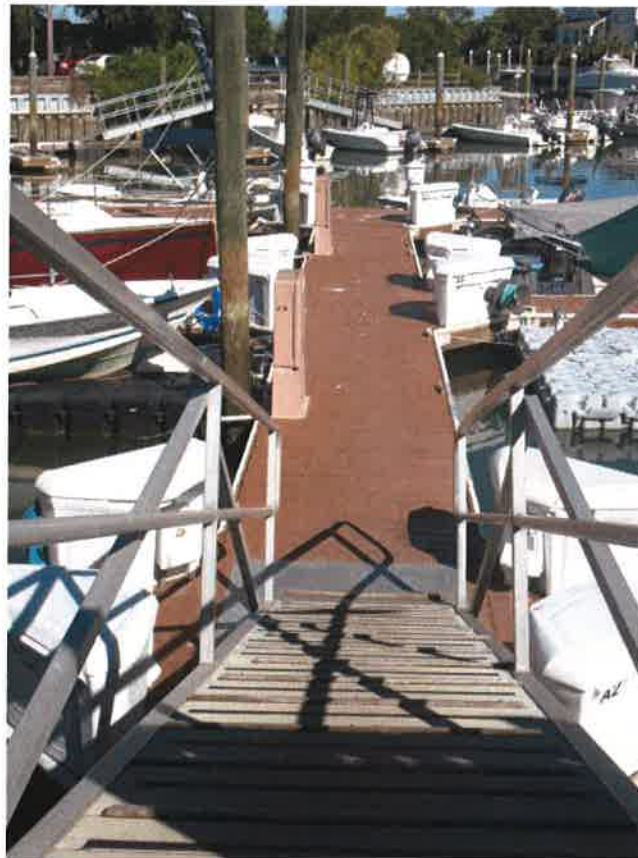
Dock A is the smallest and the most protected of the docks inspected. It is located at the western end of the Morgan Creek Marina basin near the Dewees Island Marina docks. **Photo 1** shows the dock from the gangway.

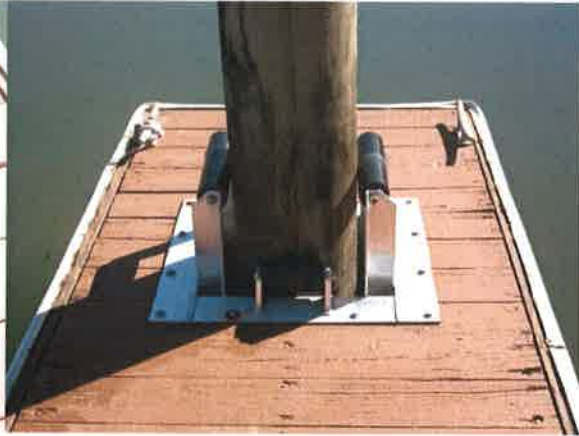
The main issues found with Dock A are some rotten wood, missing or broken rub rails and damaged or broken rollers on the pile guides. Several of the pile guides have been replaced on the dock, in some cases with new aluminum pile guides. The new pile guides have upper and lower rollers with the lower rollers being below the deck surface. All of these pile guides are located at the ends of the finger docks and have rollers on all four (4) sides of the pile. The piles along the main dock use the hoop and single roller style of pile guide. **Photos 2, 3** and **4** show the three different styles of pile guides on Dock A. **Photo 2** and **Photo 4** are the original pile guides which are constructed of galvanized steel. **Photo 3** is the new pile guide style which is constructed of aluminum.

**Photo 3** also shows areas of the timber decking that are rotten. Rotten wood can also be seen in **Photo 6**. There are several areas of rotten wood along the header board as well.

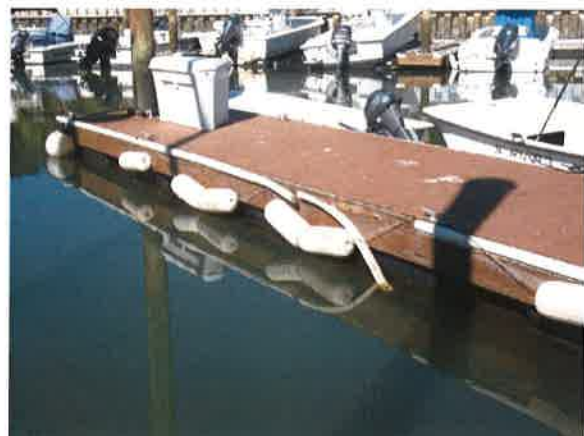
**Photo 8**

**Photos 7, 8, 9** and **10** show where the rub rail is broken or has come loose from the timber header board of the dock. Some areas the rub rail has failed and in other areas the timber has failed from rot.

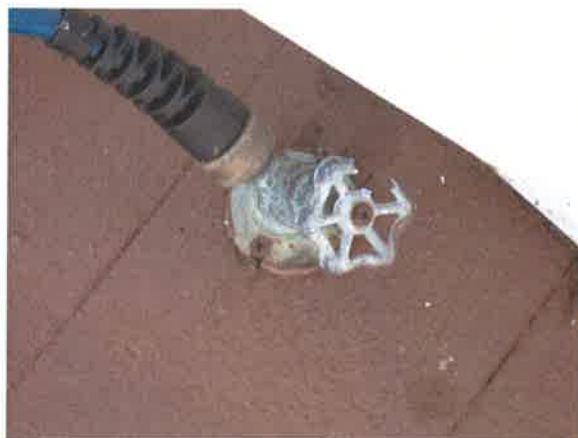
**Photos 11 and 12** show where the utilities have been damaged. **Photo 11** shows where the conduit has been broken and exposed wires are visible. **Photo 12** shows a broken hose bib handle.

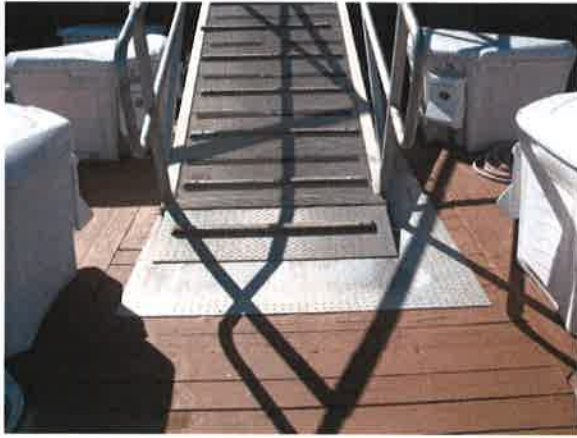
Photo 13

**Photo 13** shows how the gangway sits on the dock. Based on the marking, the gangway has not moved nor has the dock shifted. **Photo 14** shows the emergency ladder at the end of the dock. The ladders on all of the docks are mounted securely and are in good shape. **Photo 15** and **Photo 16** show the fire hose and fire extinguisher box that is located on the dock. These are common on all of the docks and appear to be in good shape.

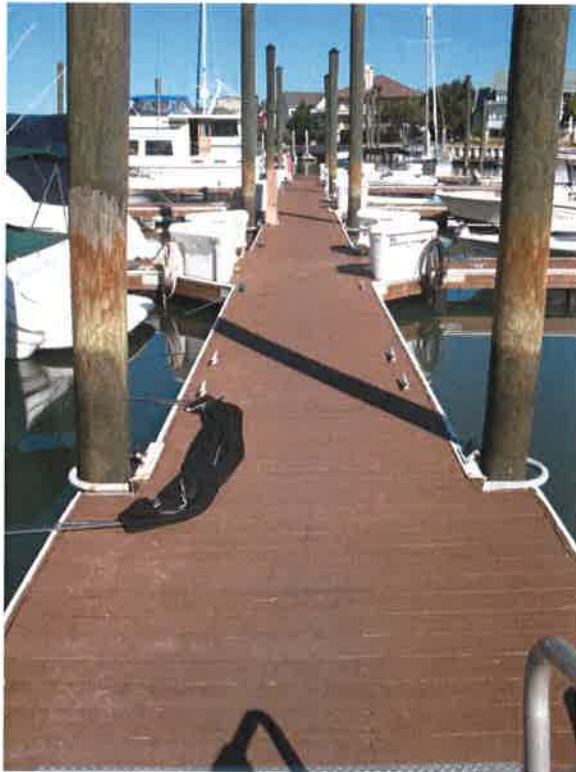
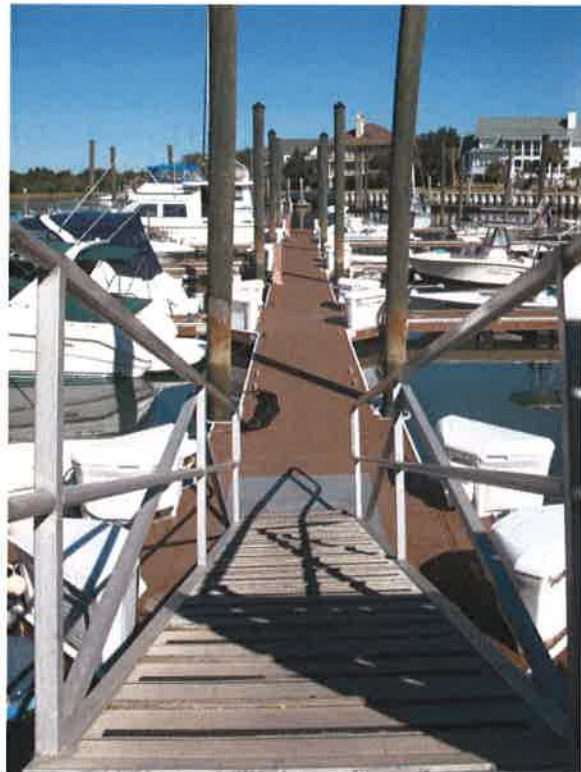
**Photo 17** and **Photo 18** show the main dock of Dock B. Unlike the other docks, Dock B has the piles along the main dock in pairs. On the other docks, the piles are staggered on either side along the

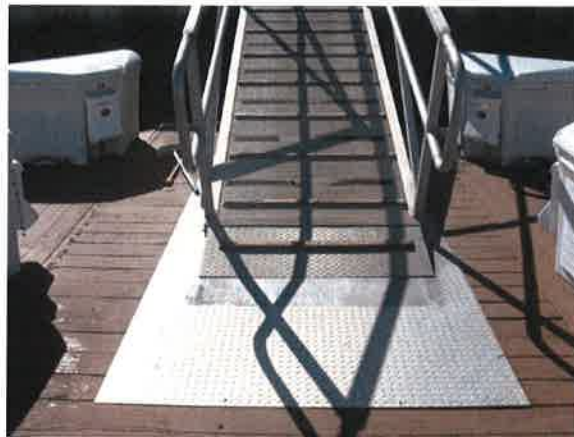
main dock. **Photo 19** shows the gangway which appears to be stable and properly positioned on the tread plate.

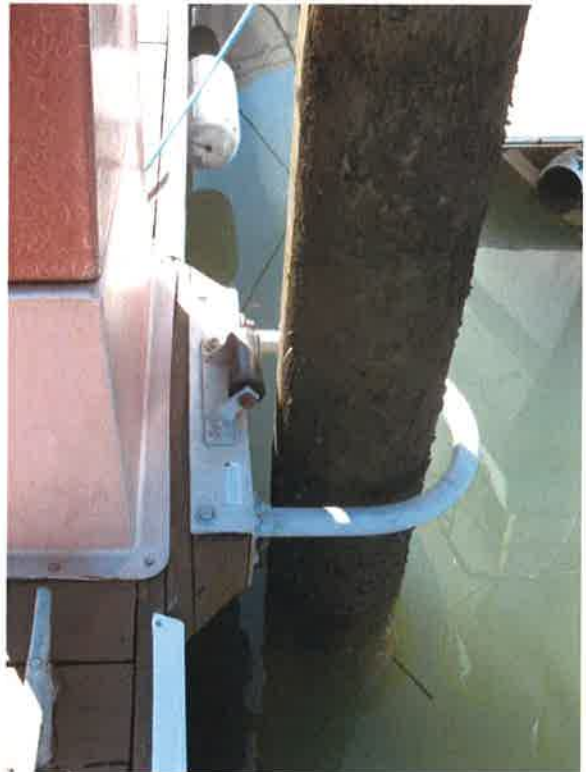
**Photo 21**

Much like Dock A, some of the pile guides have been replaced with newer pile guides. The main dock pile guides are hoop style with a single roller on the inboard portion of the pile guide. These guides appear to be in good condition and are functioning properly. The issue that is seen with many these main dock pile guides is the attachment to the dock. Several of the main dock pile guides are not mounted/bolted directly to the dock structure but instead they have been blocked outward to have proper alignment to the piles. It does not appear that the blocking has been thru-bolted to the dock structure as several are loose or move under little force. The pile guides are bolted to the blocking but the blocking does not appear to be securely fastened to the main dock structure. **Photo 20-22** show several of these pile guides that have been blocked outward. In

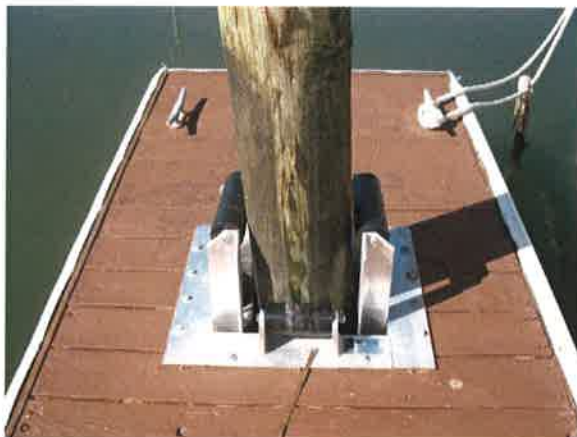
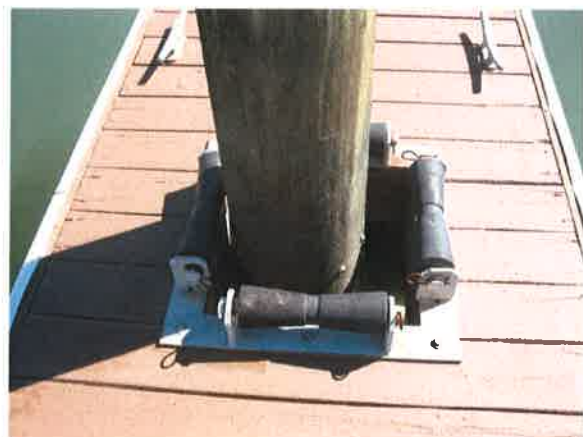
**Photo 25** and **Photo 26** show the two different types of finger dock pile guides on Dock B. **Photo 25** is the aluminum replacement guide and **Photo 26** is the original galvanized steel style of pile guide.

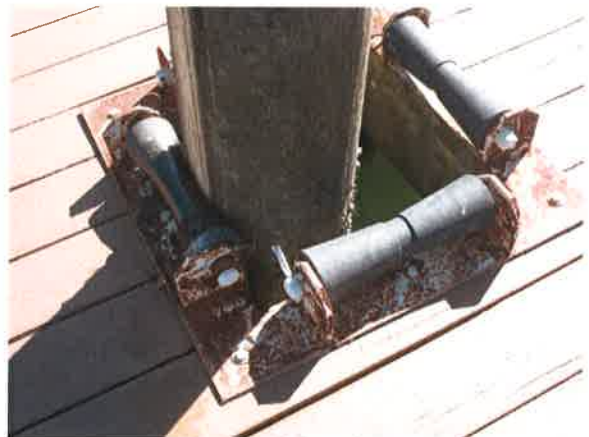
**Photo 27-29** shows the rusted, galvanized steel pile guides. The rusted pile guides are more common near the end of Dock B. The rusted or oxidized pile guides are structurally sound but should be monitored. Worn rollers can also be seen in **Photo 28** and **Photo 29**. These photos also show that the pile is not centered in the pile guide. This misalignment that has caused the rapid wear to the pile guide rollers.

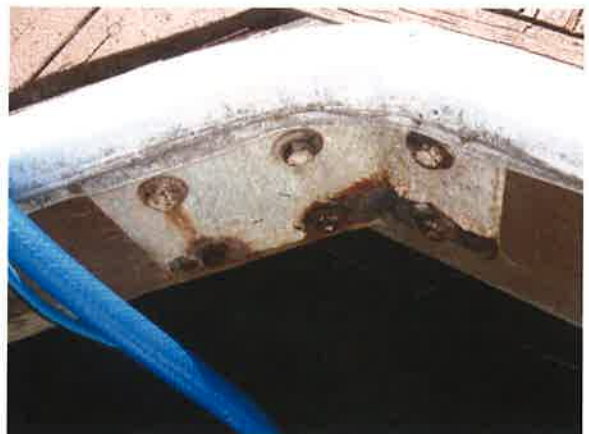
On Dock B, the gusset plates at the chamfer between the main dock and the finger docks are beginning to show signs of corrosion and the bolts holding the joints are corroded to a point where several need to be replaced. **Photo 31-33** show examples of where this corrosion is taking place and **Photo 32** shows where the bolts are in very bad shape.

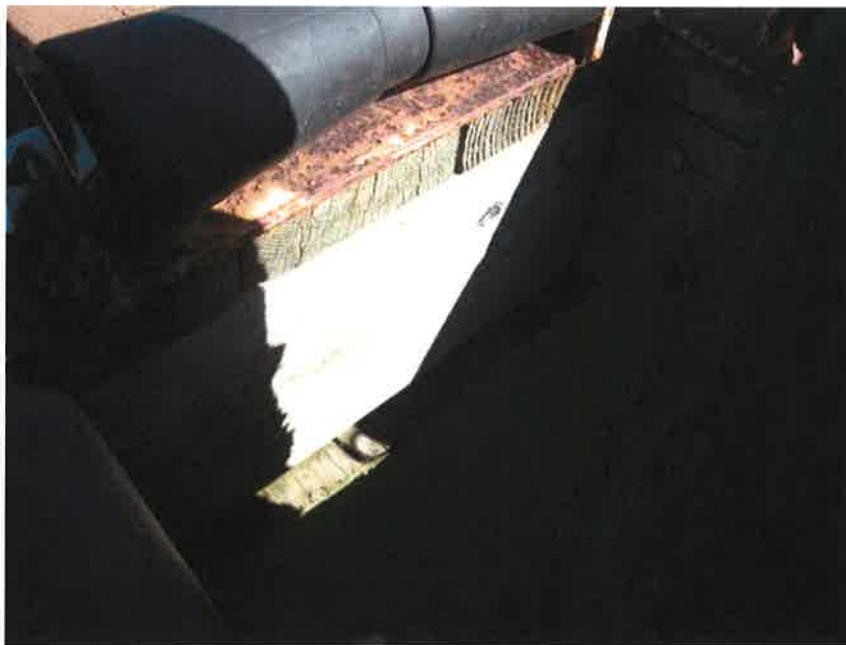
**Photo 34** is a view inside of one of the finger pile guide openings. It is apparent in this picture that the plywood layer under the dock structure has been pulled away or rotted away from the dock structure and is hanging down. This is exposing the inside of the dock structure to possible wave action.

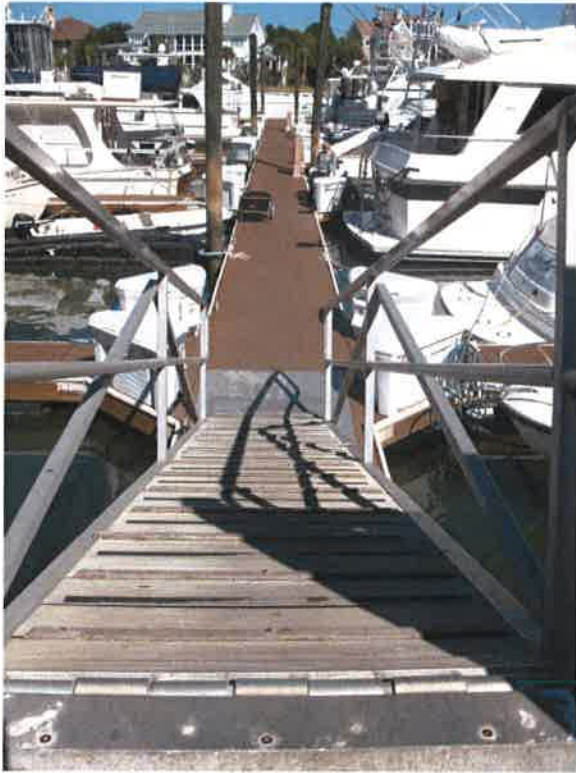
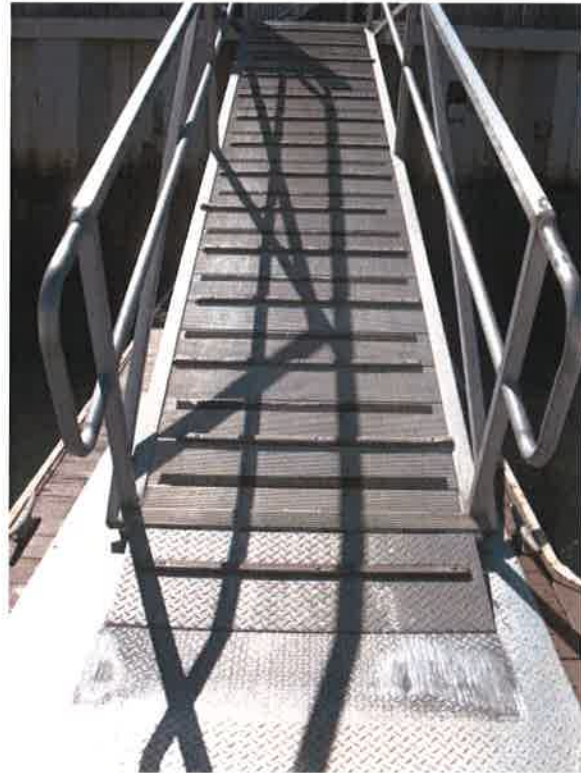
**Photo 35** and **Photo 36** show the main Dock C and the aluminum gangway. The gangway appears to be stable and properly positioned on the tread plate.

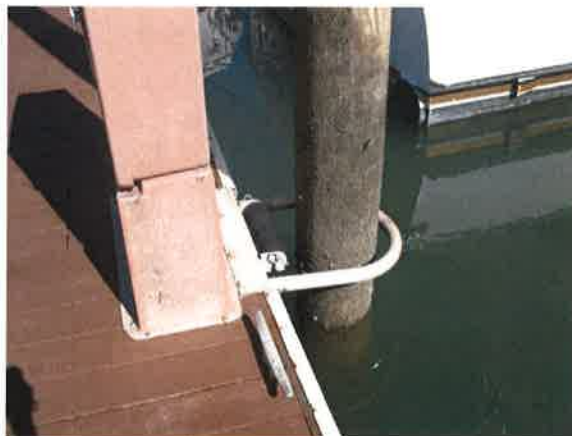
The pile guides along the main dock are galvanized steel, single roller hoop style. They appear to be in good condition with minor corrosion. The pile guides are mounted properly to the main dock structure with bolts and no blocking. **Photo 37** shows the main dock pile guides.

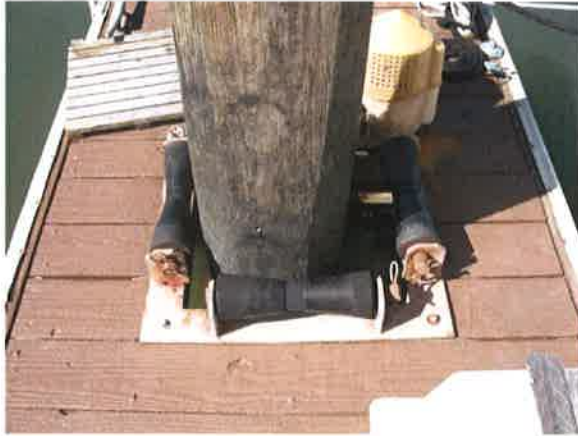
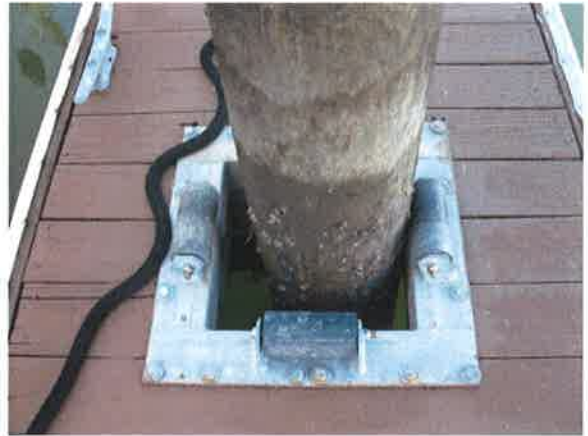
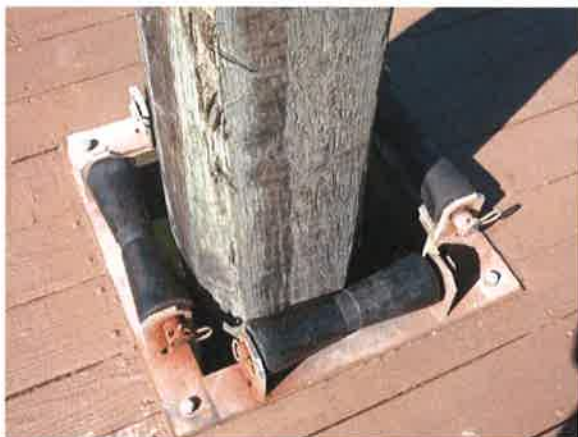
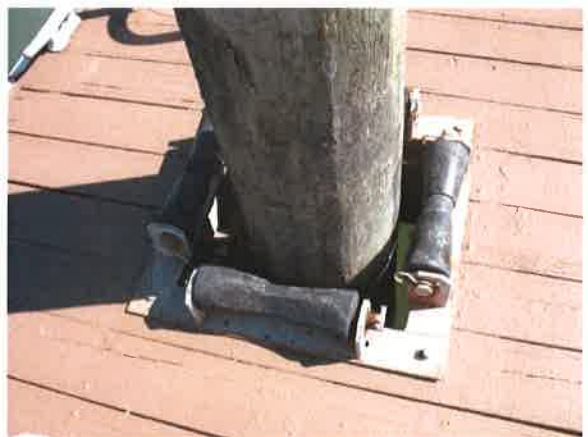
guides on Dock C are different than the other aluminum pile guides found on previously discussed Docks A and B. The galvanized steel internal pile guides are shown in **Photos 38-41**. All of these pile guides appear to be in good condition and functioning properly. In **Photo 39** it can be seen that this steel pile guide is slightly different than the other steel pile guides. The rollers on the pile guide in **Photo 39** are smaller. The pile guide functions properly.

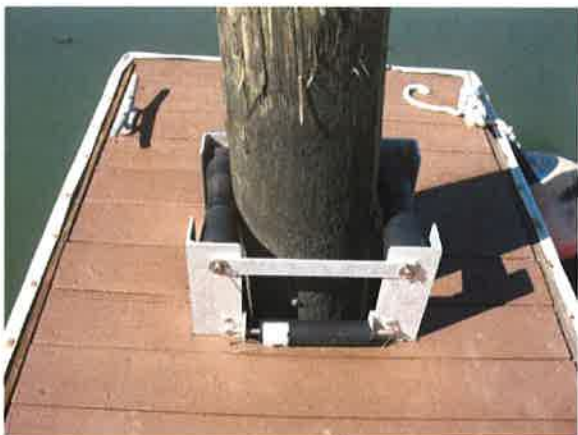
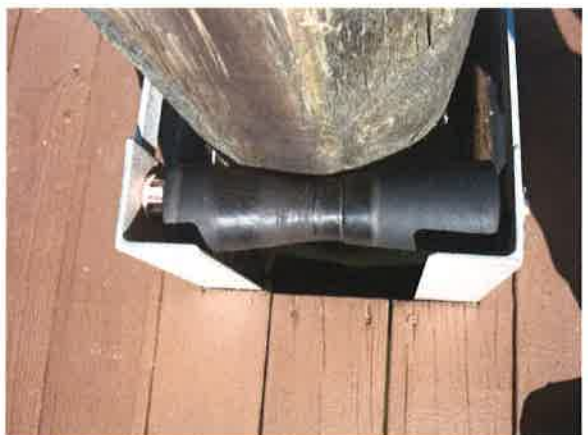
The aluminum style of internal pile guide found on Dock C has upper and lower rollers on two sides of the guide and one smaller pile guide roller on just one or both of the other sides.

**Photo 42** and **43** show this style of aluminum internal pile guide. **Photo 44-48** show the aluminum pile guides along with the roller assemblies. In **Photo 44**, the lower roller can be seen. In **Photo 45** and **Photo 46**, the other smaller rollers can be seen. It can also be seen that there are two different styles and mounting methods for these smaller rollers. **Photo 47** and **Photo 48** show that there are no smaller rollers on one side of the aluminum pile guides. This would allow the timber pile to impact or rub against the dock structure. It is unknown why these rollers were not installed at these internal pile guide locations.

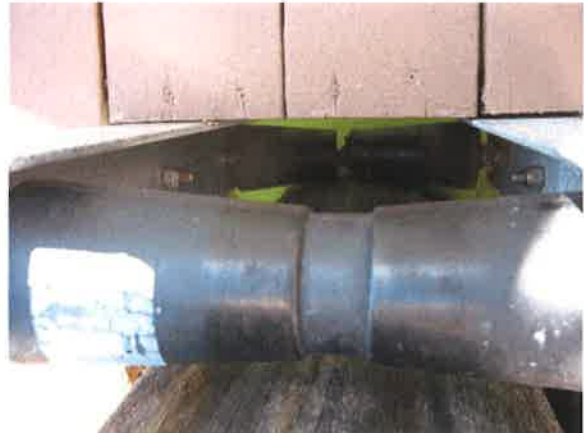
**Photo 50**

Another concern with the aluminum internal piles guides is the lower roller system. Many of the lower rollers are broken, very badly worn or even completely missing. **Photo 49-51** show these lower rollers that have been damaged. These rollers are damaged because of the manner in which the docks rotate during wave action. The lower pile guide rollers restrict the movement and rotation of the dock. The location or depth of the rollers in the dock means these rollers are subjected to significant impacts and forces.

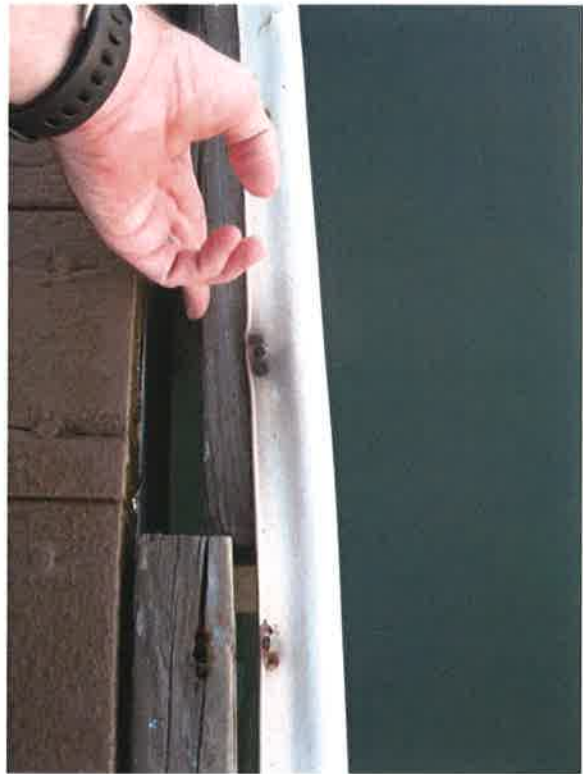
Along Dock C there are several areas where the timber is rotten or has come loose from the dock structure. **Photos 52-54** show a couple of these areas where the header boards are rotten or the fasteners have corroded away and the boards have come loose. These are representative of a condition that exists in several areas.

**Photo 53** and **Photo 54** show that the rub rail molding is beginning to fail. **Photo 55** shows another area where the rub rail molding is loose and needs to be replaced. **Photo 55** and **Photo 56** show a sampling of the gusset plates along Dock C. They appear to be in good condition with little corrosion taking place.

The reason for the “bowing” of this finger dock is not known and could not be seen. The loose stringer boards from **Photo 52** and **53** give an indication that the bowing of the dock could be from the timber structure members warping. The finger dock does not appear to have been impacted or sustained any type of damage that would cause this bowing. The finger dock appears to be floating level and is stable.

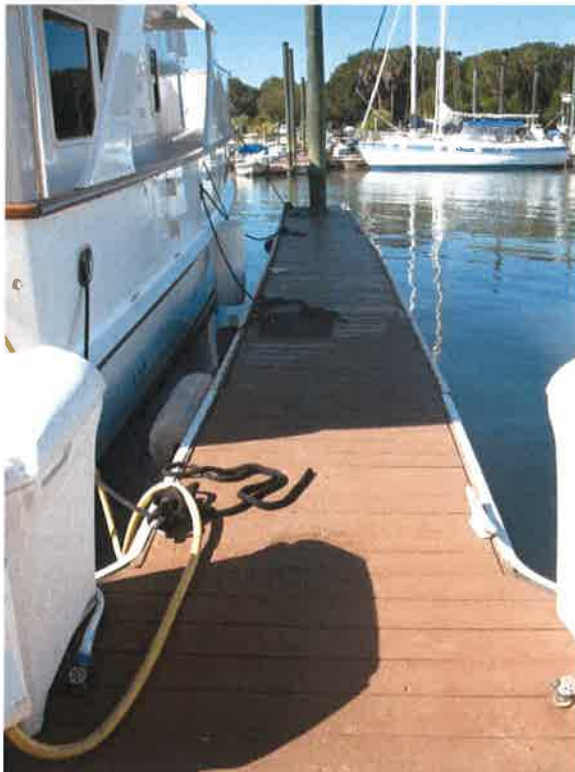
One item that was noticed on Dock C is the finger dock at C17/C19 has a noticeable “bow” in the dock. **Photos 57-58** show the bow in this finger dock. In **Photo 57** the “bow” extends out toward the right of the picture. **Photo 58** is from the opposite end of the finger dock and the “bow” extends toward the left of the picture. This finger dock is also where **Photos 52** and **53** were taken and the spot can be seen approximately ½ of the way down the finger on the left-hand side.

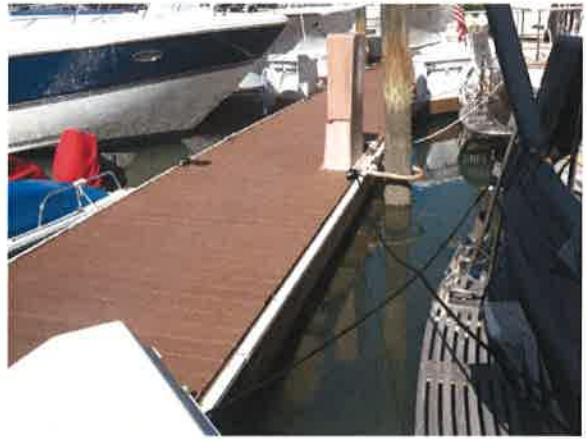
Photo 62

It is apparent that within this area where the main dock is "bowed", the main dock also dips (near the fire hose cabinet). **Photo 61, 62** and **63** shows this dip in the main dock as indicated by the leaning fire hose cabinet. It is unknown and could not be determined if the dip in the main dock and the bowing of the main dock are related. It could be caused by floatation issues or is simply a product of the "bowing" of the main dock.

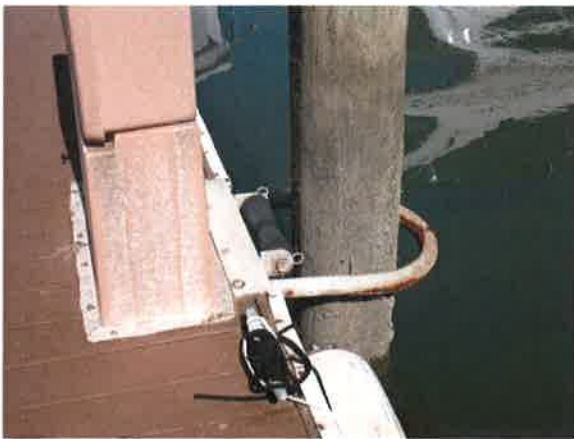
Photo 64

Much like the other docks, Dock D has several different types of pile guides. The external pile guides along the main dock are the same as the previous docks. The external pile guides along Dock D are experiencing significant corrosion of the galvanized metal. **Photos 64** and **65** show the single roller hoop style external pile guides and the corrosion that is occurring.

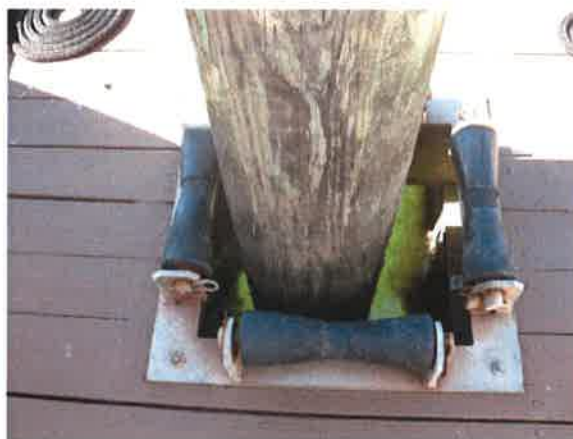
**Photo 67**

surface corrosion. **Photos 66** and **67** show the typical galvanized internal pile guide and their typical condition on Dock D. The rollers on the galvanized internal pile guides appear to be in good condition.

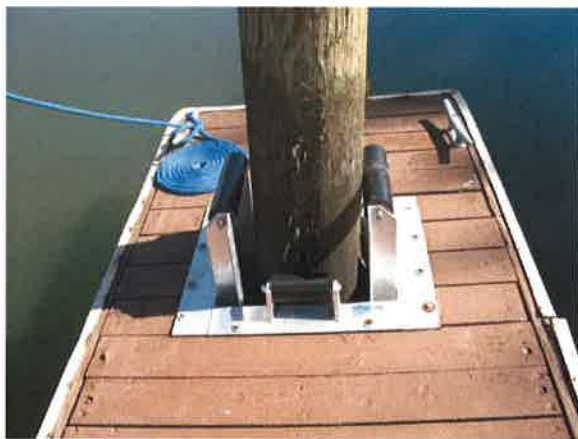
**Photo 68**

**Photos 68-71** are of one of the other types of aluminum internal pile guides. **Photos 70** and **71** show where the pile guides were cut for installation. Though this is not ideal, the pile guide functions properly. These pile guides have lower rollers and all appeared to be functioning properly.

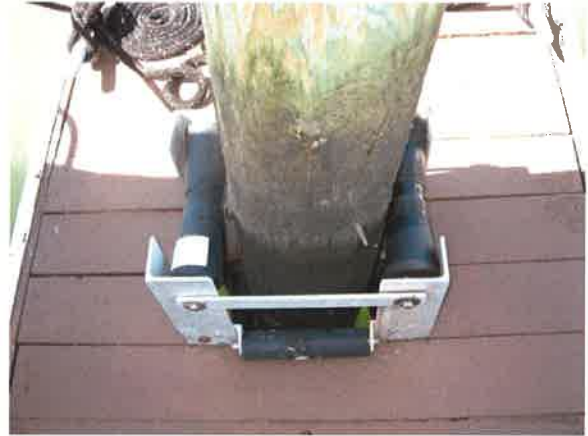
**Photo 73**

**Photos 72-77** show the second type of aluminum internal pile guide. These internal pile guides also have lower rollers on two sides, however; several of these rollers are broken as is seen in **Photo 75** and **76**. This internal pile guide also does not have rollers on the back side of the pile guide as seen in **Photo 77**. The damage to the timber pile can be seen from the dock rubbing against the pile.

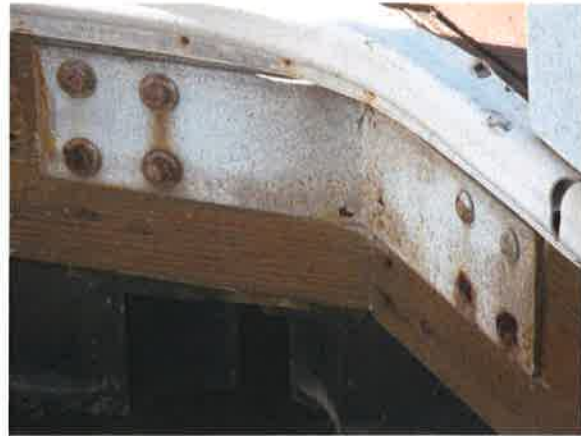
Photo 79

Much like the other docks, the galvanized metal gussets at the corners of the main dock and the finger docks, are showing signs of corrosion. **Photos 78-82** show these galvanized metal gussets

along Dock D. In all of these photos, there are signs that the lower bolts are severely corroded and are beginning to break apart.

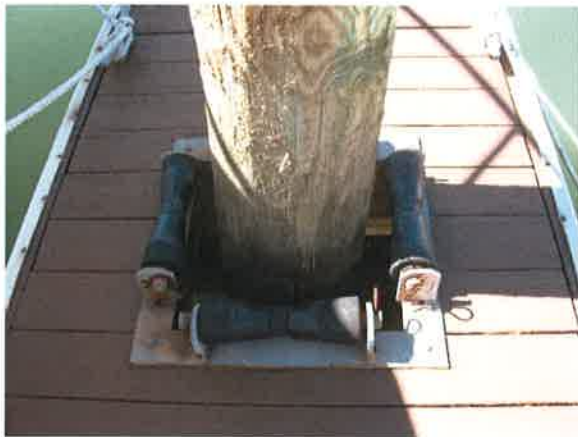
**Photo 85**

As with Dock C, Dock E has the same three (3) different types of internal pile guides on the finger docks. The galvanized steel internal pile guides are in average to fair condition with signs of minor corrosion. **Photos 85 and 86** show these pile guides and their typical condition on Dock E.

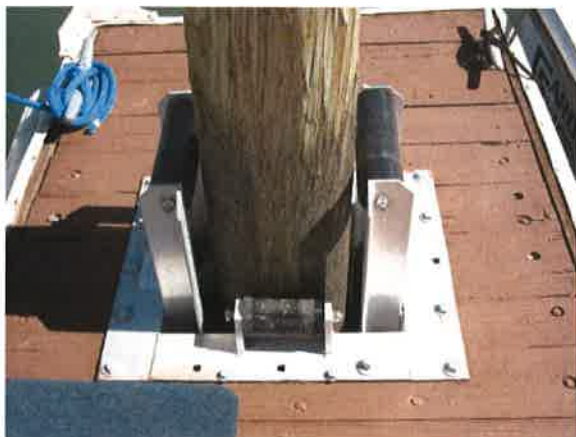
**Photo 87**

The two (2) different types of aluminum internal pile guides are the same styles as Dock C. **Photos 87-89** show one type of these internal pile guides.

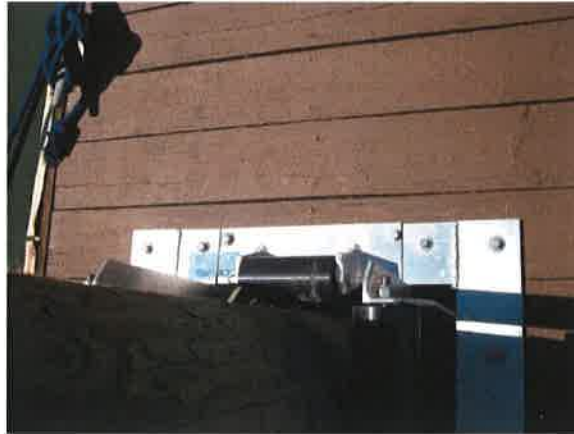
**Photo 89** shows where the pile guide bracket has been cut in order to fit around the piles. This installation method is typical for these internal aluminum pile guides on the other docks and Dock E.

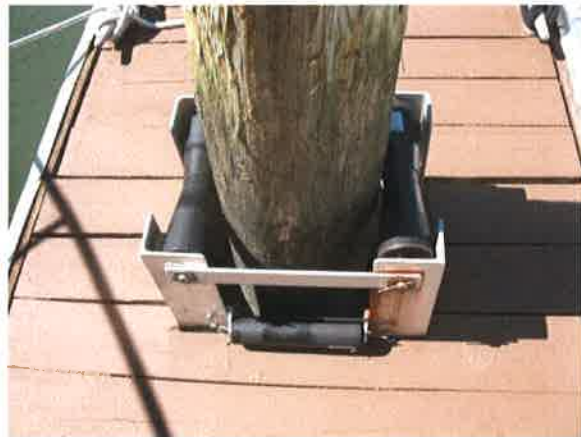
**Photo 91**

The second type of aluminum internal pile guide is the same style that is on the other docks along with Dock E. As with the other docks, this style of internal pile guide has several broken lower pile guide rollers. **Photos 90-92** show these pile guides and **Photo 92** shows where the lower pile guide roller is broken and missing.

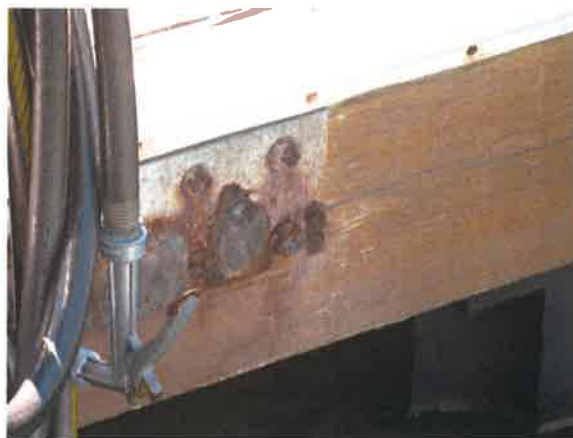
**Photo 94**

The galvanized gusset plates on Dock E at the intersections of the main dock and the finger docks are typical of the other docks inspected. **Photos 93-97** show these gusset plates along Dock E. In **Photo 94**, the corrosion is worse than the others photographed. The lower portion of the gusset plates and the lower bolts (closest to the waterline) are showing signs of significant corrosion.

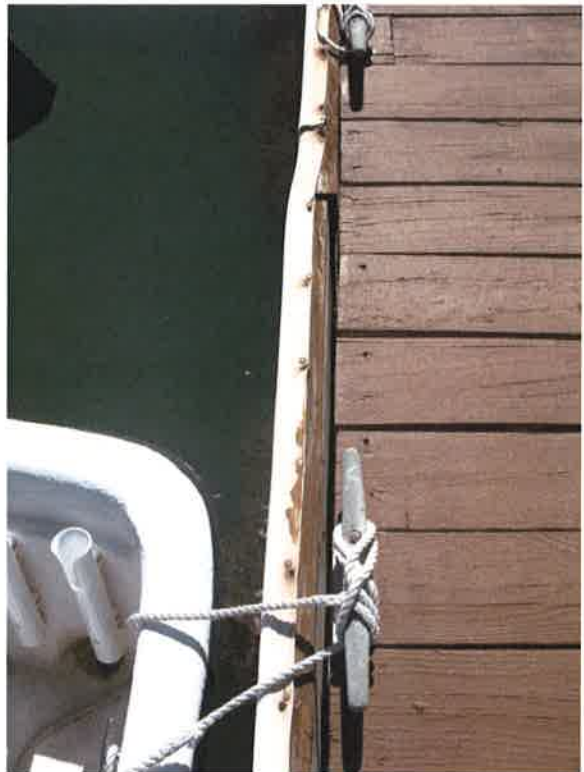
**Photo 99**

There are a couple of timber header boards along the finger docks that are loose. **Photos 98** and **99** show two such areas. A combination of rotten wood and corroded fasteners appear to be the reason for the looseness of the boards.

Many of the timber header boards along the main docks and finger docks can be re-fastened using new galvanized or stainless steel fasteners. None of the timber members on the dock are rotten to the point of requiring replacement but most need to be re-fastened or secured to the dock.

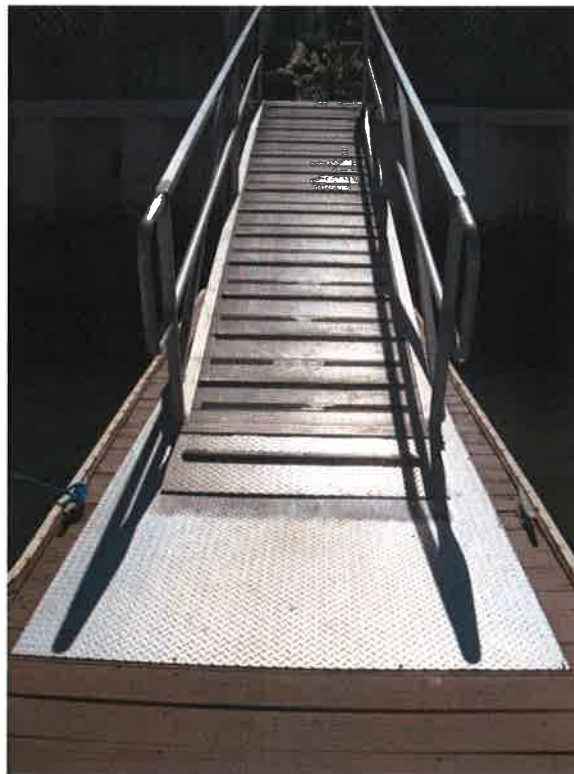
**Photo 100**

The gangway on Dock E appears to rest on the main dock straight and level without signs of lateral movement. The gangway is seen in **Photo 100**.

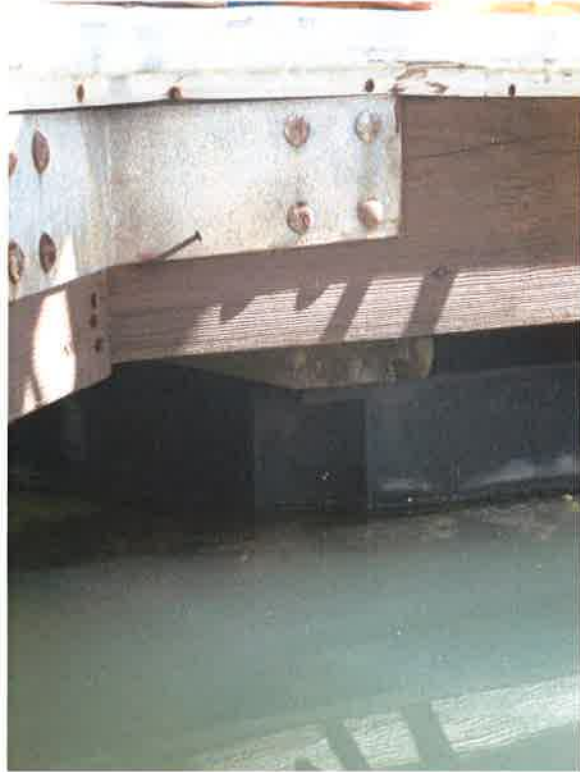
**Photos 101** and **102** show the timber 2x member that the float is attached to which is then attached to the bottom of the dock structure. **Photo 102** also shows where the timber 2x member is split. **Photo 103** is of a typical galvanized bolt that fastens the plastic float to the timber 2x member. Many of these bolts and nuts have corroded away to a point where they are basically a corroded stub holding the float. These will continue to get worse and the loss of movement of the plastic floats is possible during heavy wind or wave action. The plastic float appears to be in good condition with no signs of problems or damages.

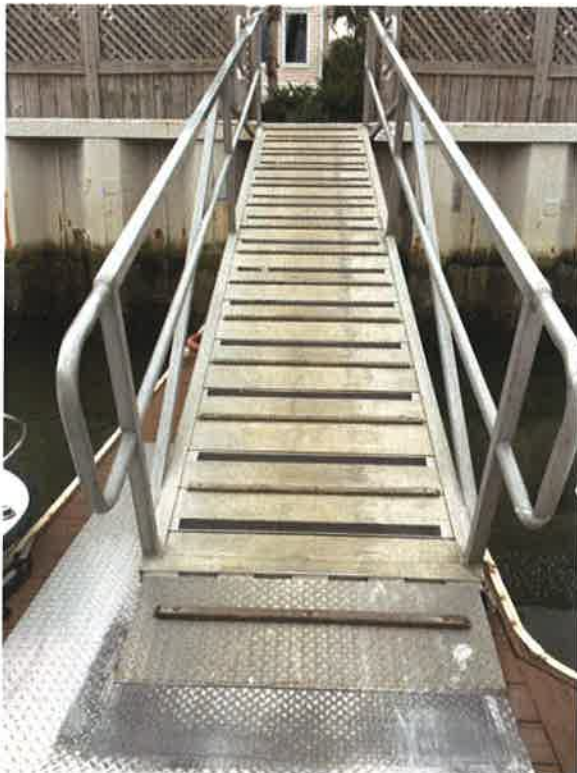
The purpose of the inspection of Dock D at the Morgan Creek HOA Marina was to determine the cause of the dock/gangway shift of the dock. Based on a site visit conducted on August 27<sup>th</sup>, 2014 during low tide, it appears that the timber dock has shifted approximately 6 inches laterally. This is gauged from the position of the gangway on the dock and the rub marks of the gangway on the tread plate. **Photo 1** shows where the gangway has rubbed in the past and its new location. **Photo 2** shows that the gangway has moved over enough to hit and damage the existing cleat.

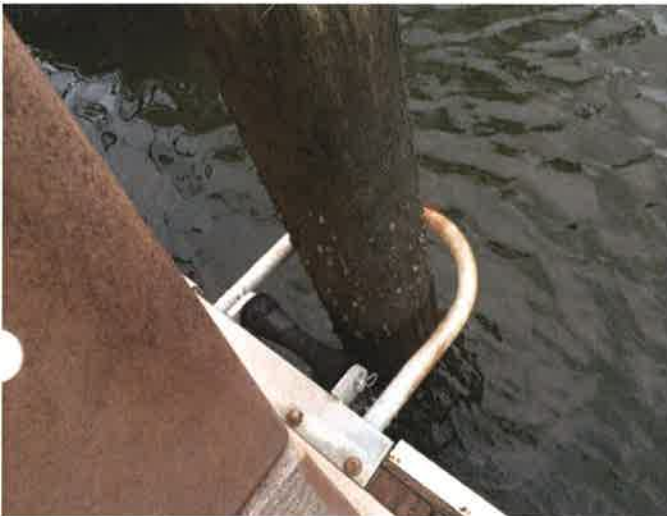
**Photo 3**

**Photos 3 and 4** show typical piles and pile guides.

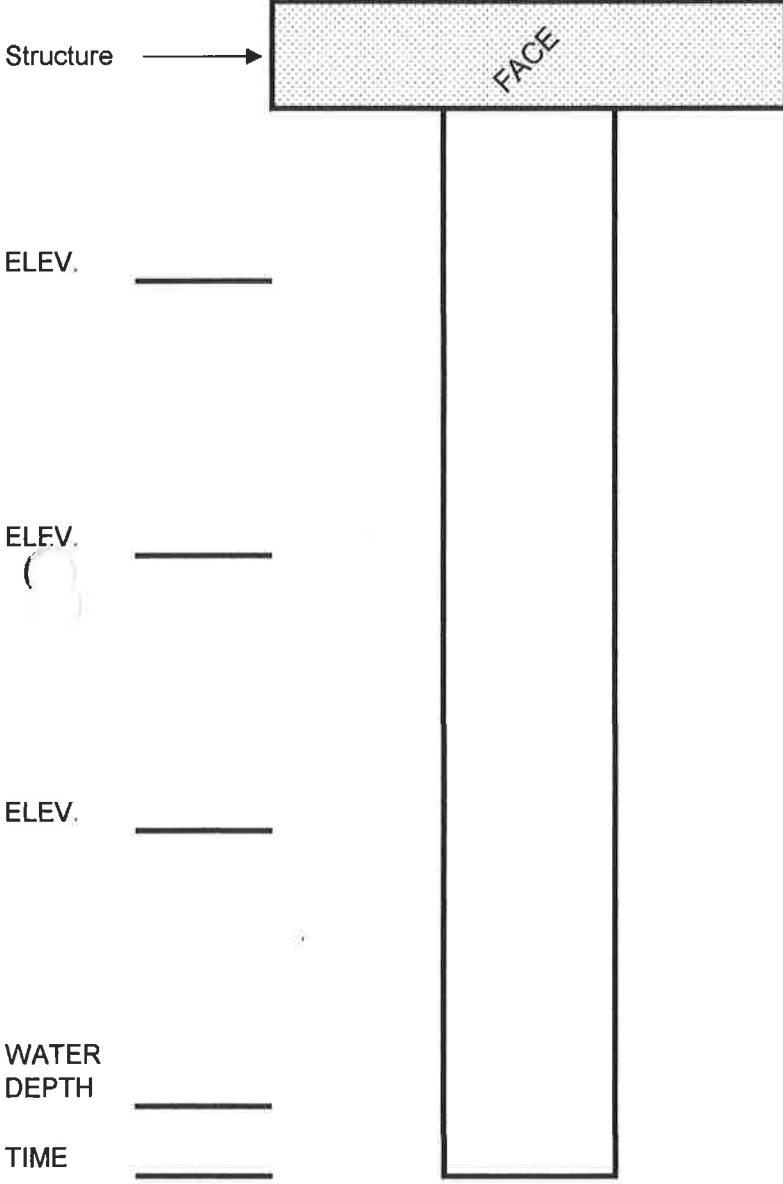
PILE # C1 Attitude: Plumb  
 JACKET: N/A LENGTH: N/A  
 TYPE: H. FORM N/A B. BAG N/A  
 GENERAL COND: Good EXP. STEEL: N/A

SOFT GROWTH: HARD GROWTH:  
 TZ: \_\_\_\_\_ % TZ: \_\_\_\_\_ %  
 BTZ: 100 % BTZ: 50 %

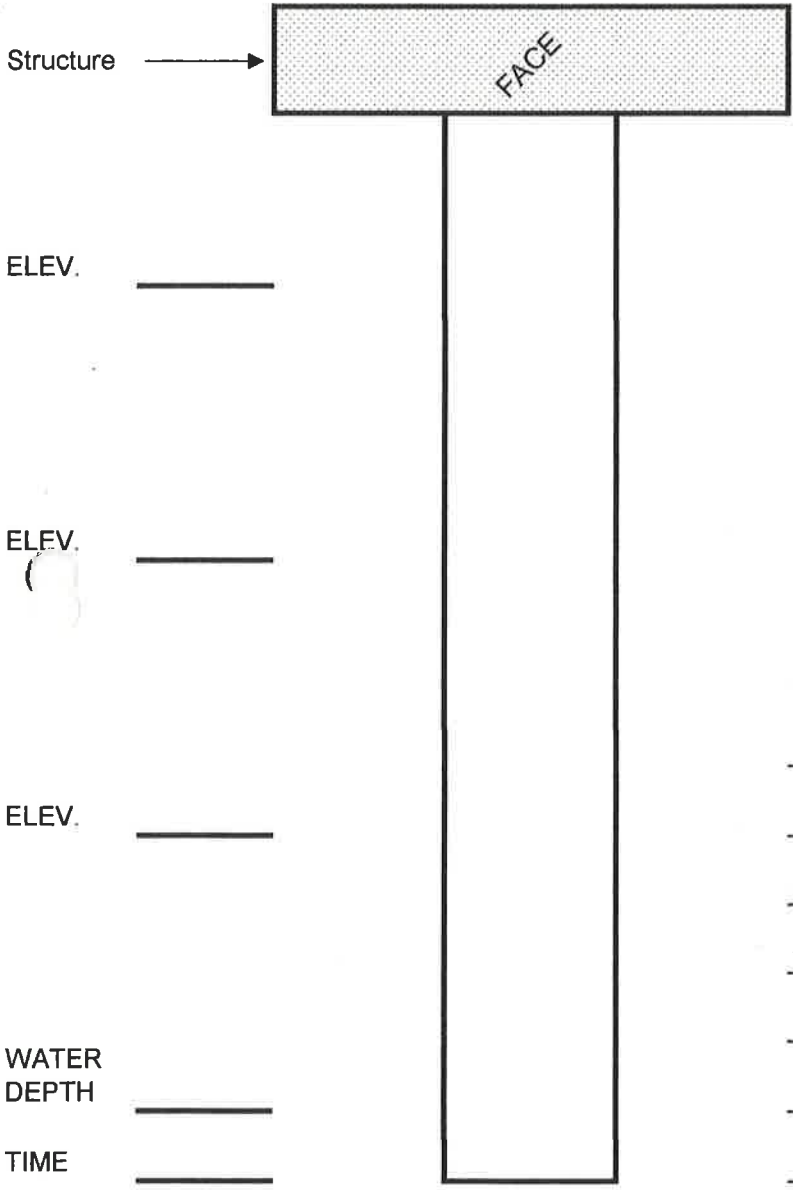
PILE # C3 Attitude: Plumb  
 JACKET: N/A LENGTH: N/A  
 TYPE: H. FORM N/A B. BAG N/A  
 GENERAL COND: Good EXP. STEEL: N/A

SOFT GROWTH: HARD GROWTH:  
 TZ: \_\_\_\_\_ % TZ: \_\_\_\_\_ %  
 BTZ: 75 % BTZ: 50 %

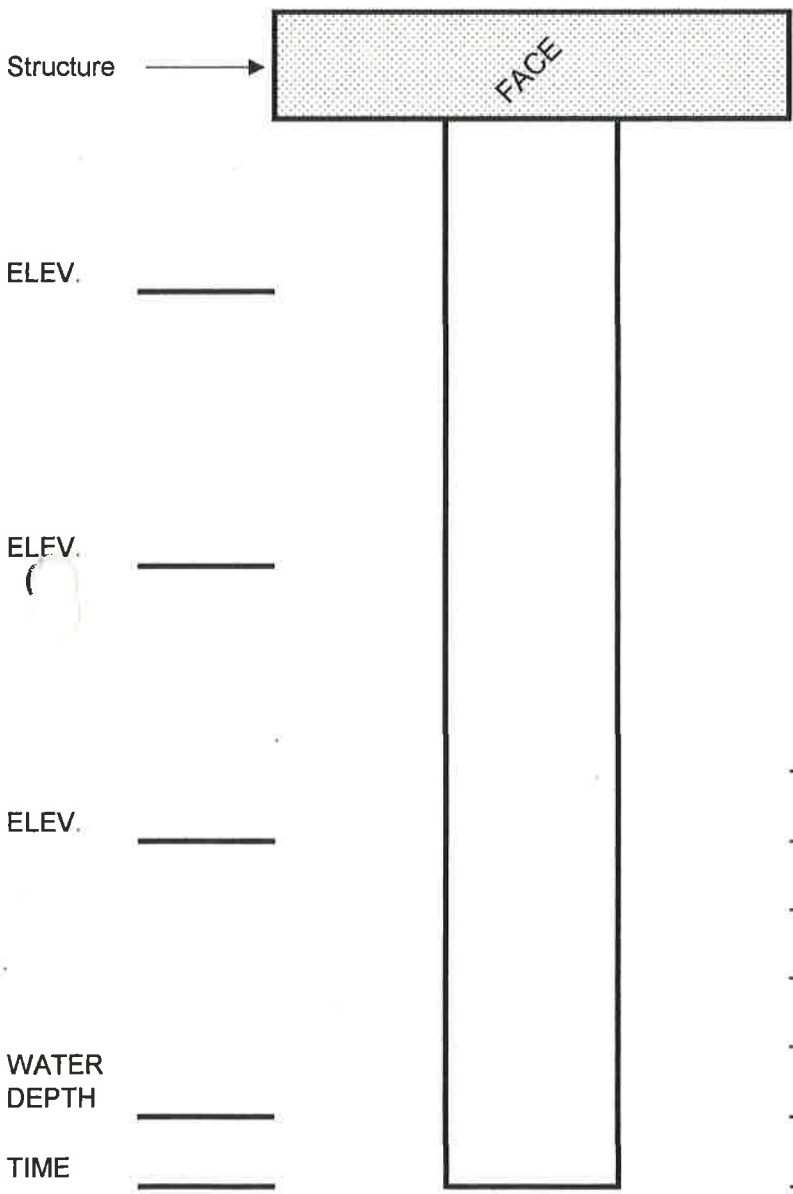
PILE # C5 Attitude: Plumb  
 JACKET: N/A LENGTH: N/A  
 TYPE: H. FORM N/A B. BAG N/A  
 GENERAL COND: Good EXP. STEEL: N/A

NOTES: Divers performed a Level I (swim-by)  
inspection on this pile. The piling was covered in both  
(soft) marine and (hard) shell growth as described above.  
Divers saw no evidence of marine boer activity and  
the piling was solid when sounded with a hammer.  
Divers saw other visible signs of defects, except as  
may be noted hereafter.

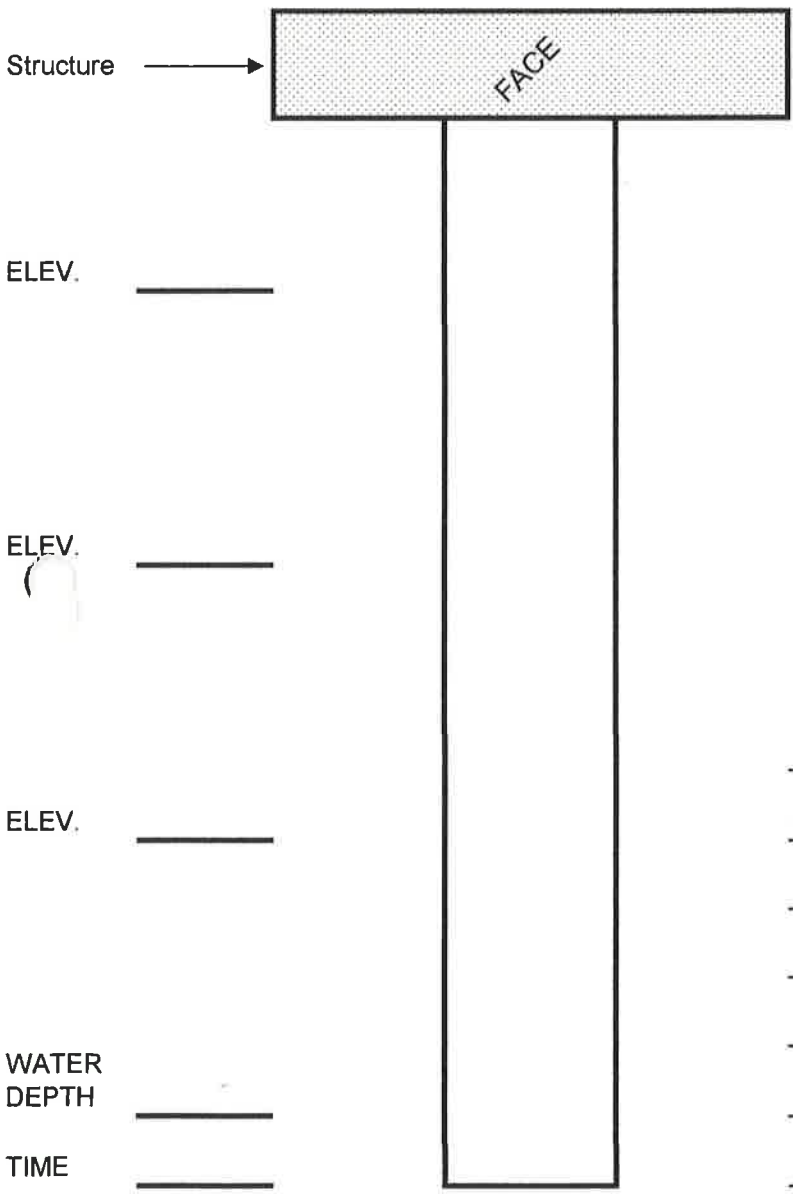
PILE # C6 Attitude: Plumb  
 JACKET: N/A LENGTH: N/A  
 TYPE: H. FORM N/A B. BAG N/A  
 GENERAL COND: Good EXP. STEEL: N/A

NOTES: Divers performed a Level I (swim-by)  
inspection on this pile. The piling was covered in both  
(soft) marine and (hard) shell growth as described above.  
Divers saw no evidence of marine boer activity and  
the piling was solid when sounded with a hammer.  
Divers saw other visible signs of defects, except as  
may be noted hereafter.

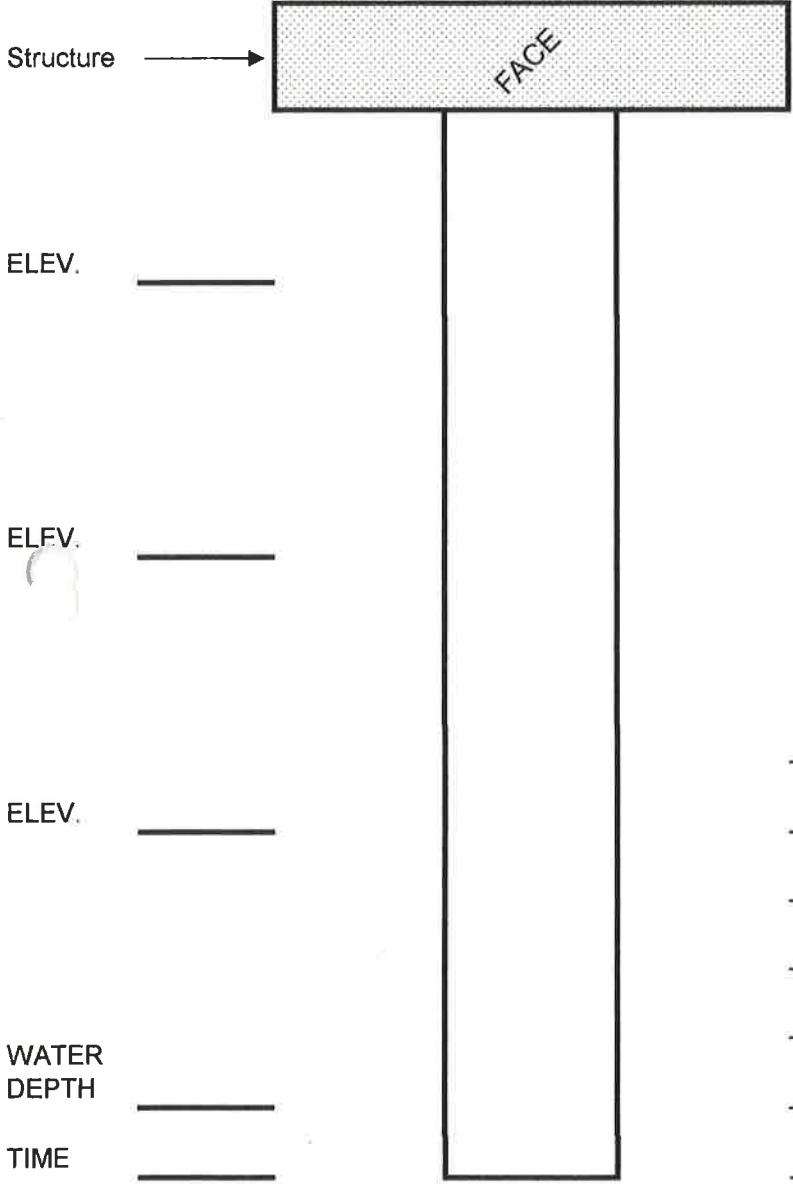
PILE # C7 Attitude: Plumb  
 JACKET: N/A LENGTH: N/A  
 TYPE: H. FORM N/A B. BAG N/A  
 GENERAL COND: Good EXP. STEEL: N/A  
 SOFT GROWTH: TZ: \_\_\_\_\_ % BTZ: 100 %  
 HARD GROWTH: TZ: \_\_\_\_\_ % BTZ: 50 %

Defects: Cracks Spalls Breaks Rust  
 NOTES: Divers performed a Level I (swim-by)  
inspection on this pile. The piling was covered in both  
(soft) marine and (hard) shell growth as described above.  
Divers saw no evidence of marine boer activity and  
the piling was solid when sounded with a hammer.  
Divers saw other visible signs of defects, except as  
may be noted hereafter.
