## **Wild Dunes Yacht Harbor Dock Study**

*Location:*  
**Wild Dunes Resort  
Isle of Palms, South Carolina**

*Dated:*  
**December 14, 2014**

**Civil, Waterfront and Marine Planners & Engineers**

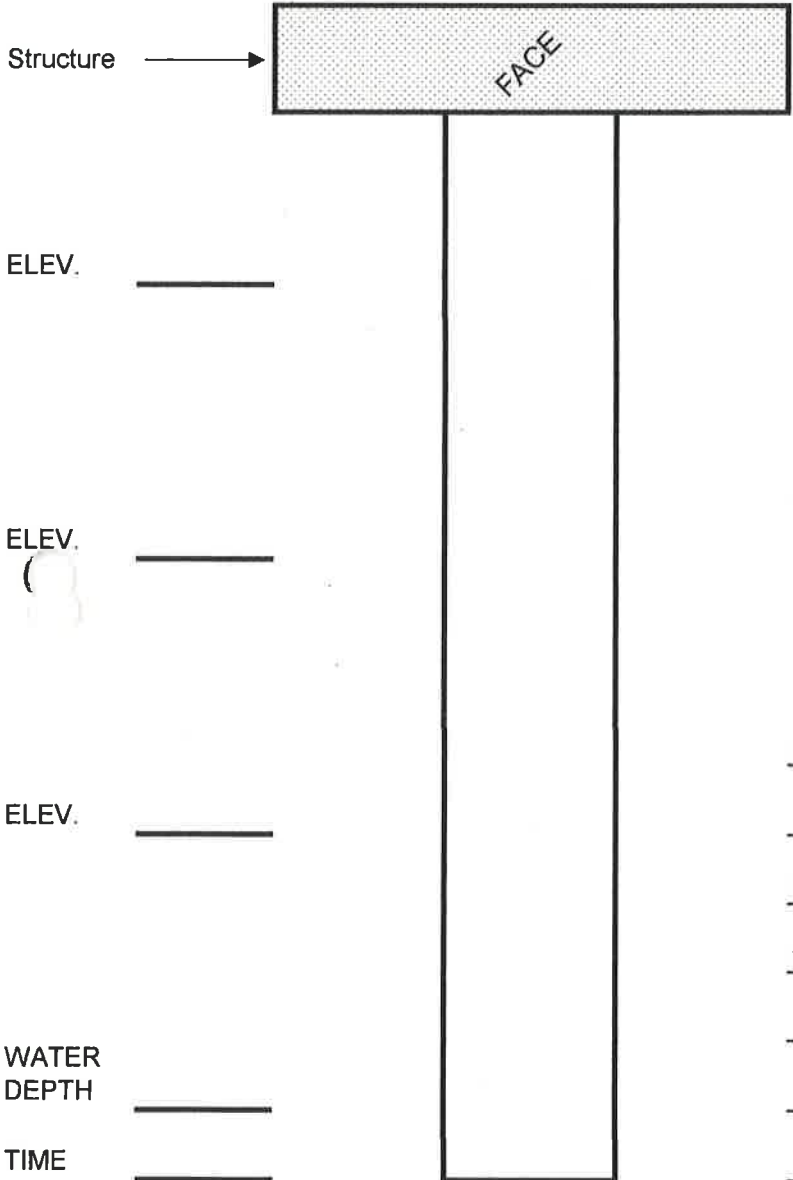
PILE # C9 Attitude: Plumb  
 JACKET: N/A LENGTH: N/A  
 TYPE: H. FORM N/A B. BAG N/A  
 GENERAL COND: Good EXP. STEEL: N/A

NOTES: Divers performed a Level I (swim-by)  
inspection on this pile. The piling was covered in both  
(soft) marine and (hard) shell growth as described above.  
Divers saw no evidence of marine boer activity and  
the piling was solid when sounded with a hammer.  
Divers saw other visible signs of defects, except as  
may be noted hereafter.

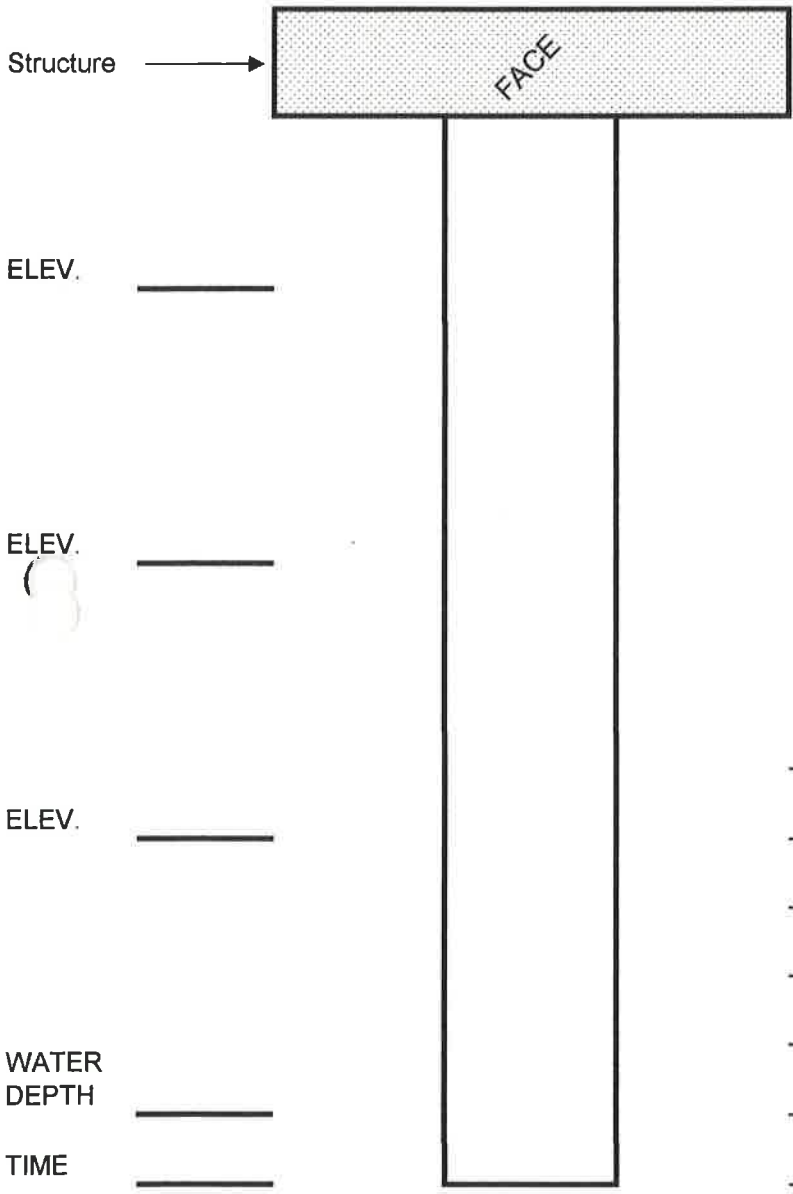
PILE # C12 Attitude: Plumb  
 JACKET: N/A LENGTH: N/A  
 TYPE: H. FORM N/A B. BAG N/A  
 GENERAL COND: Good EXP. STEEL: N/A

NOTES: Divers performed a Level I (swim-by)  
inspection on this pile. The piling was covered in both  
(soft) marine and (hard) shell growth as described above.  
Divers saw no evidence of marine boer activity and  
the piling was solid when sounded with a hammer.  
Divers saw other visible signs of defects, except as  
may be noted hereafter.

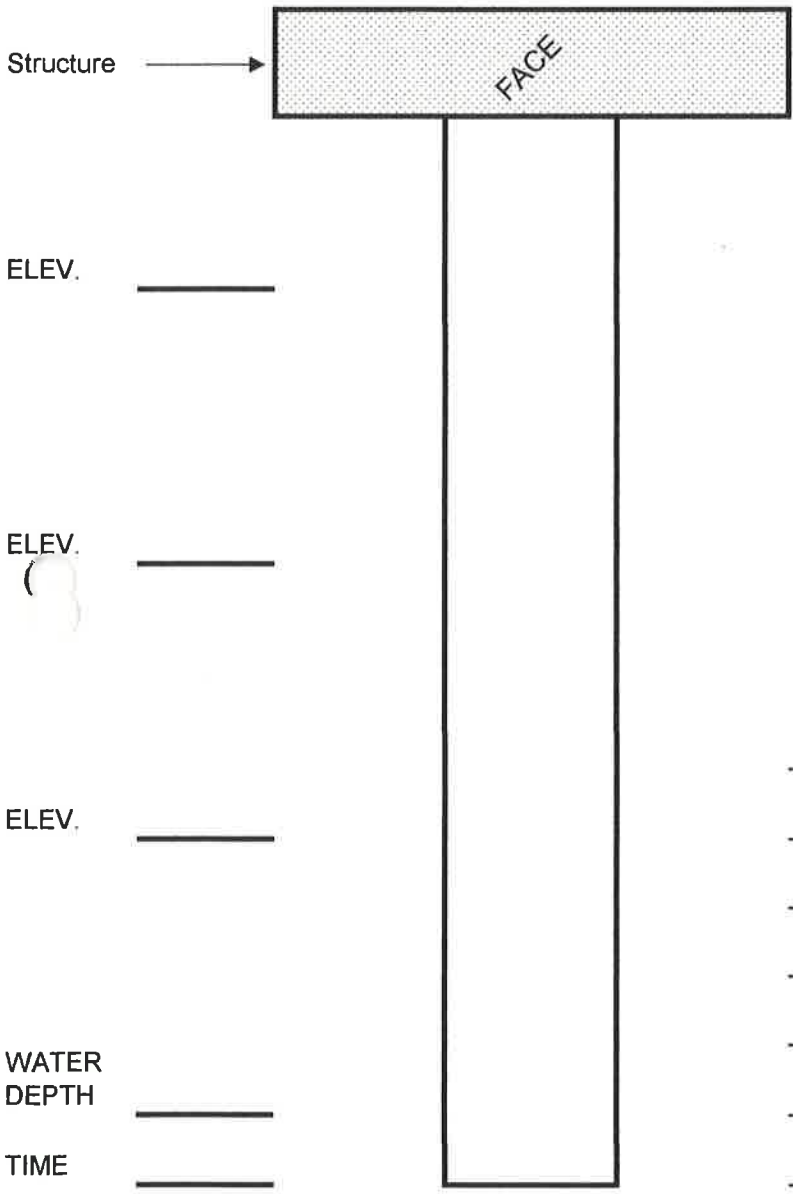
PILE # C13 Attitude: Plumb  
 JACKET: N/A LENGTH: N/A  
 TYPE: H. FORM N/A B. BAG N/A  
 GENERAL COND: Good EXP. STEEL: N/A

NOTES: Divers performed a Level I (swim-by)  
inspection on this pile. The piling was covered in both  
(soft) marine and (hard) shell growth as described above.  
Divers saw no evidence of marine boer activity and  
the piling was solid when sounded with a hammer.  
Divers saw other visible signs of defects, except as  
may be noted hereafter.

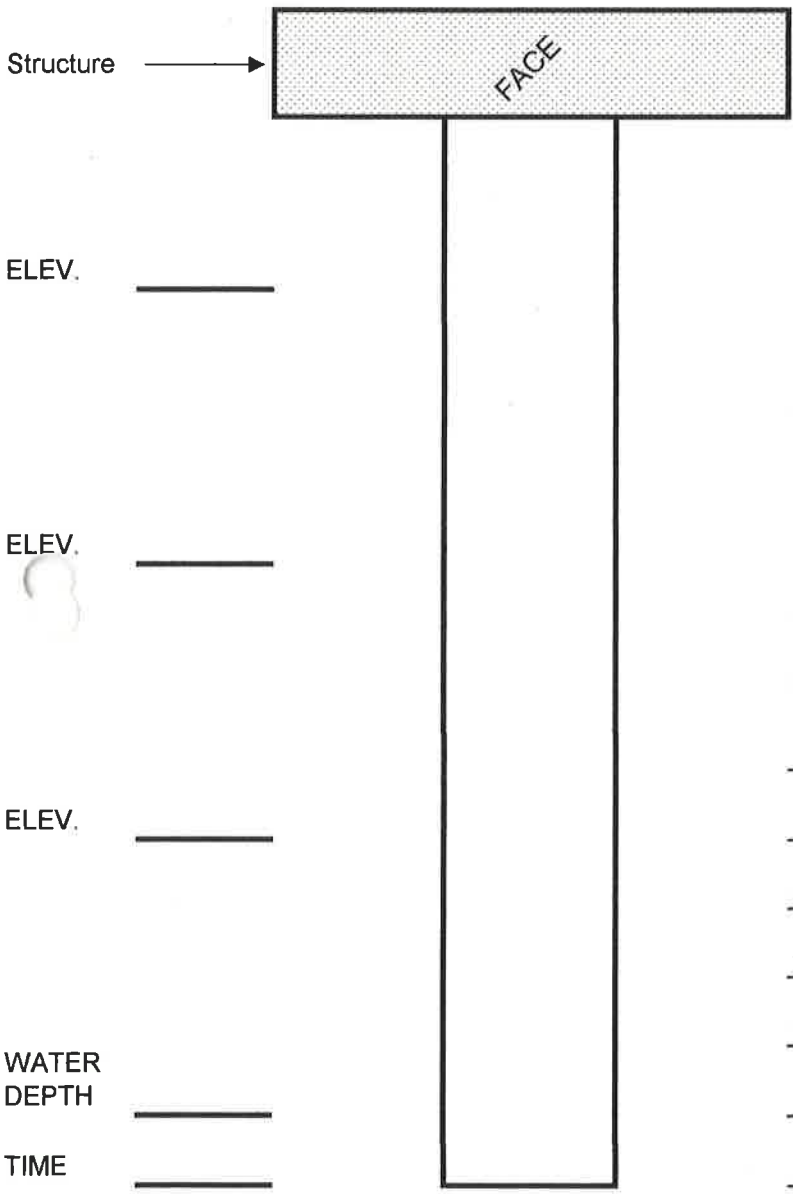
PILE # C15 Attitude: Plumb  
 JACKET: N/A LENGTH: N/A  
 TYPE: H. FORM N/A B. BAG N/A  
 GENERAL COND: Good EXP. STEEL: N/A

NOTES: Divers performed a Level I (swim-by)  
inspection on this pile. The piling was covered in both  
(soft) marine and (hard) shell growth as described above.  
Divers saw no evidence of marine boer activity and  
the piling was solid when sounded with a hammer.  
Divers saw other visible signs of defects, except as  
may be noted hereafter.

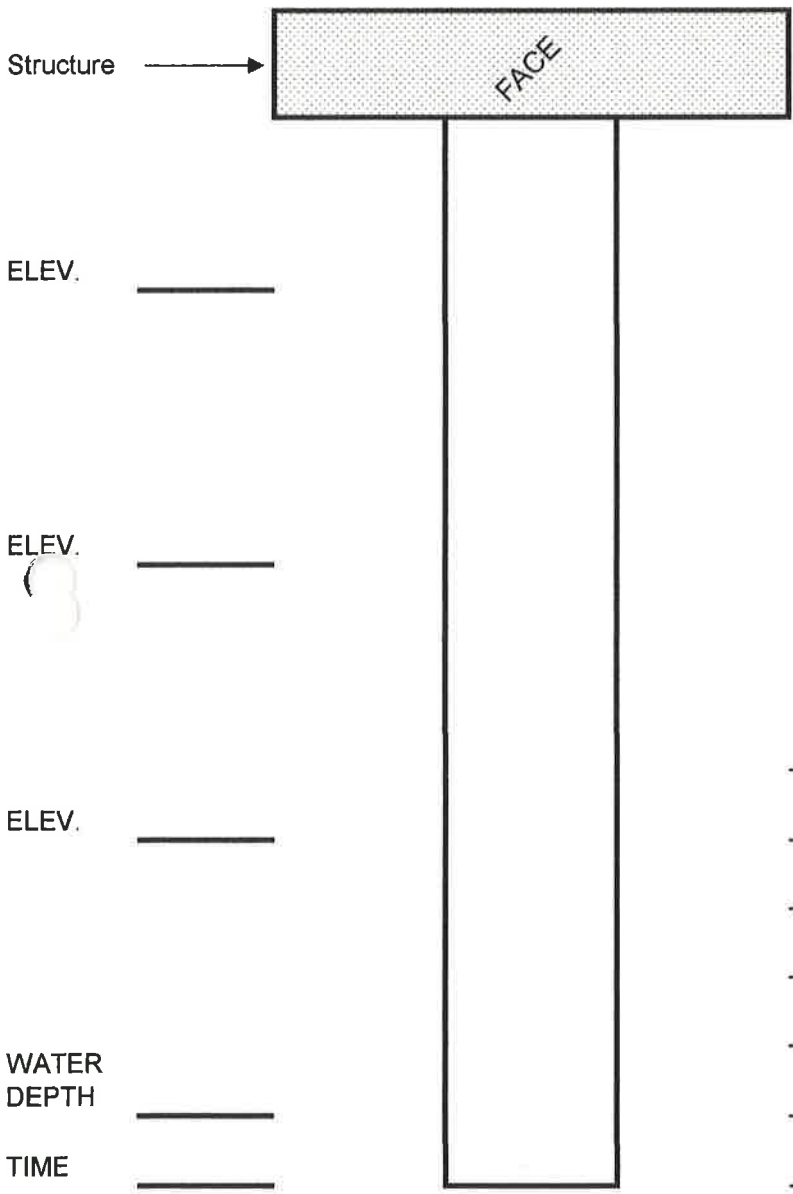
PILE # C17 Attitude: Plumb  
 JACKET: N/A LENGTH: N/A  
 TYPE: H. FORM N/A B. BAG N/A  
 GENERAL COND: Good EXP. STEEL: N/A  
 SOFT GROWTH: HARD GROWTH:  
 TZ: \_\_\_\_\_ % TZ: \_\_\_\_\_ %  
 BTZ: 100 % BTZ: 40 %

NOTES: Divers performed a Level I (swim-by)  
inspection on this pile. The piling was covered in both  
(soft) marine and (hard) shell growth as described above.  
Divers saw no evidence of marine boer activity and  
the piling was solid when sounded with a hammer.  
Divers saw other visible signs of defects, except as  
may be noted hereafter. Diver located a 1/2" diameter  
hole less than 1" deep a couple of feet below the

waterline. The hole was solid all around, without rot.

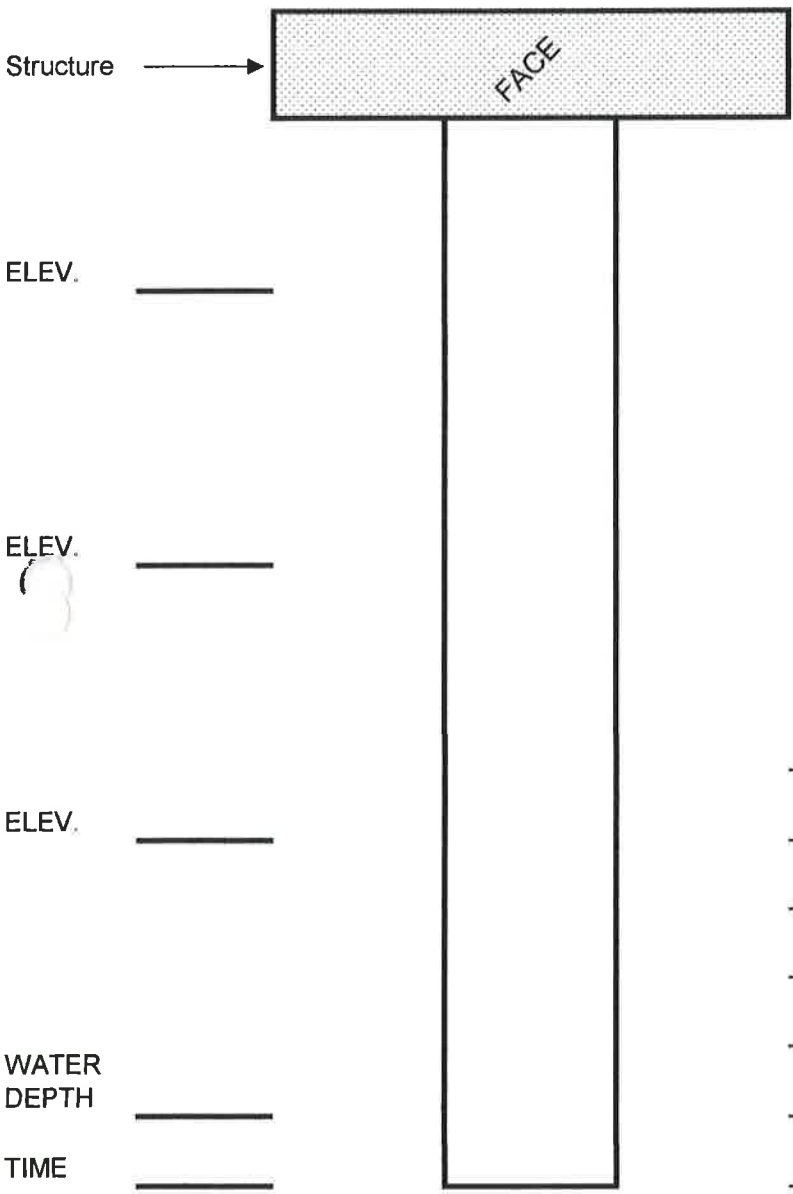
PILE # D6 Attitude: Plumb  
 JACKET: N/A LENGTH: N/A  
 TYPE: H. FORM N/A B. BAG N/A  
 GENERAL COND: Good EXP. STEEL: N/A

NOTES: Divers performed a Level I (swim-by)  
inspection on this pile. The piling was covered in both  
(soft) marine and (hard) shell growth as described above.  
Divers saw no evidence of marine boer activity and  
the piling was solid when sounded with a hammer.  
Divers saw other visible signs of defects, except as may  
be noted hereafter.

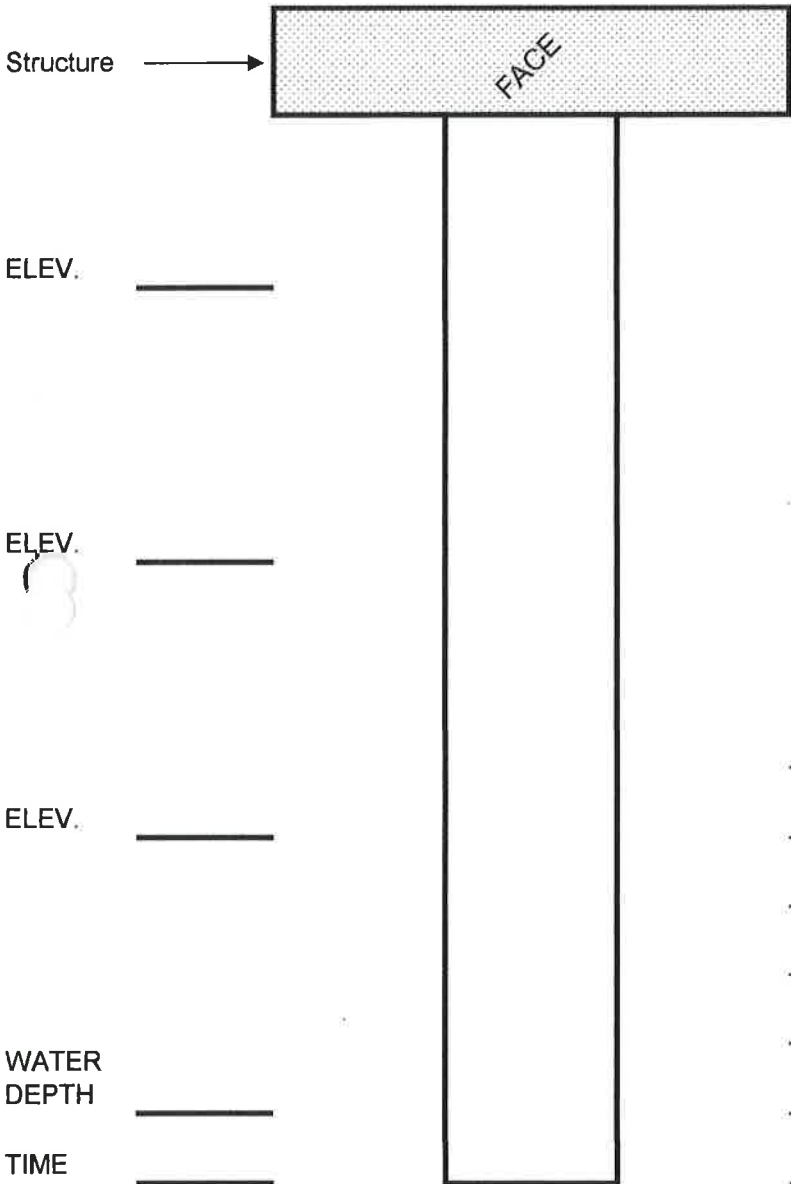
PILE # D11 Attitude: Plumb  
 JACKET: N/A LENGTH: N/A  
 TYPE: H. FORM N/A B. BAG N/A  
 GENERAL COND: Good EXP. STEEL: N/A

SOFT GROWTH: HARD GROWTH:  
 TZ: \_\_\_\_\_ % TZ: \_\_\_\_\_ %  
 BTZ: 100 % BTZ: 20 %

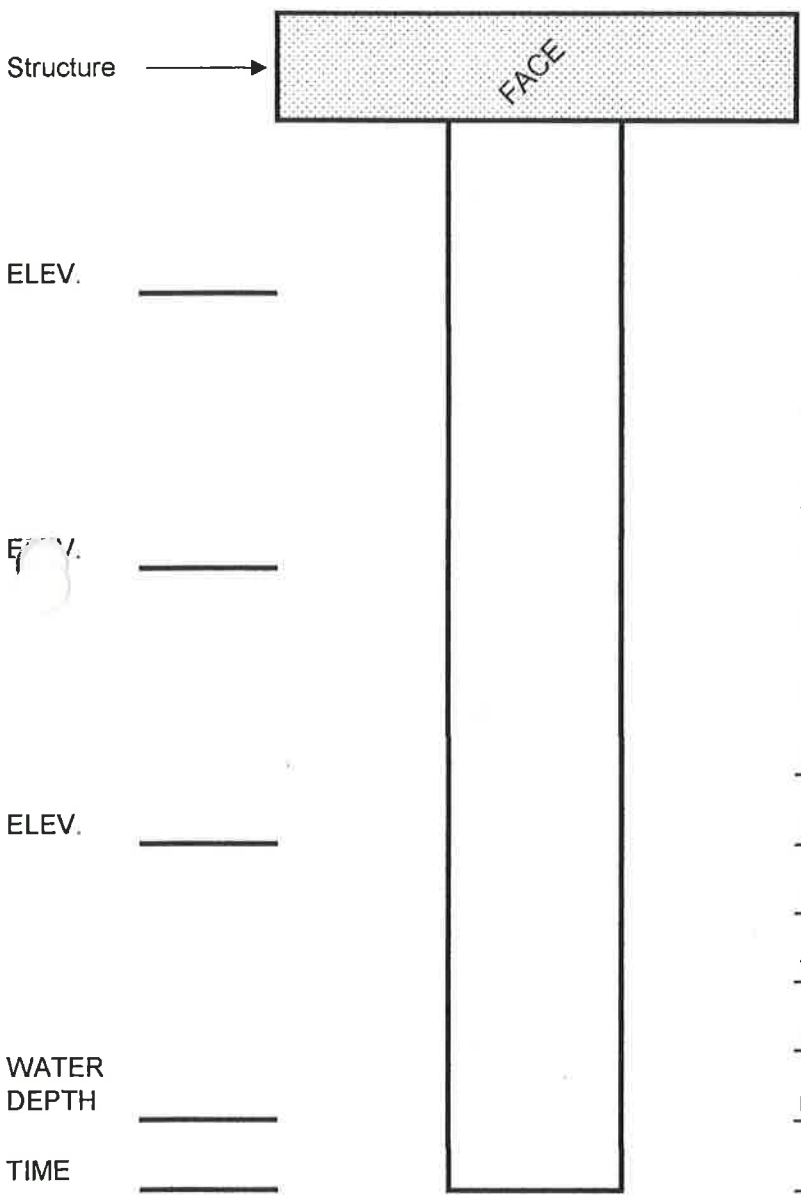
PILE # E7 Attitude: Plumb  
 JACKET: N/A LENGTH: N/A  
 TYPE: H. FORM N/A B. BAG N/A  
 GENERAL COND: Good EXP. STEEL: N/A  
 SOFT GROWTH: TZ: \_\_\_\_\_ % HARD GROWTH: TZ: \_\_\_\_\_ %  
 BTZ: 100 % BTZ: 50 %

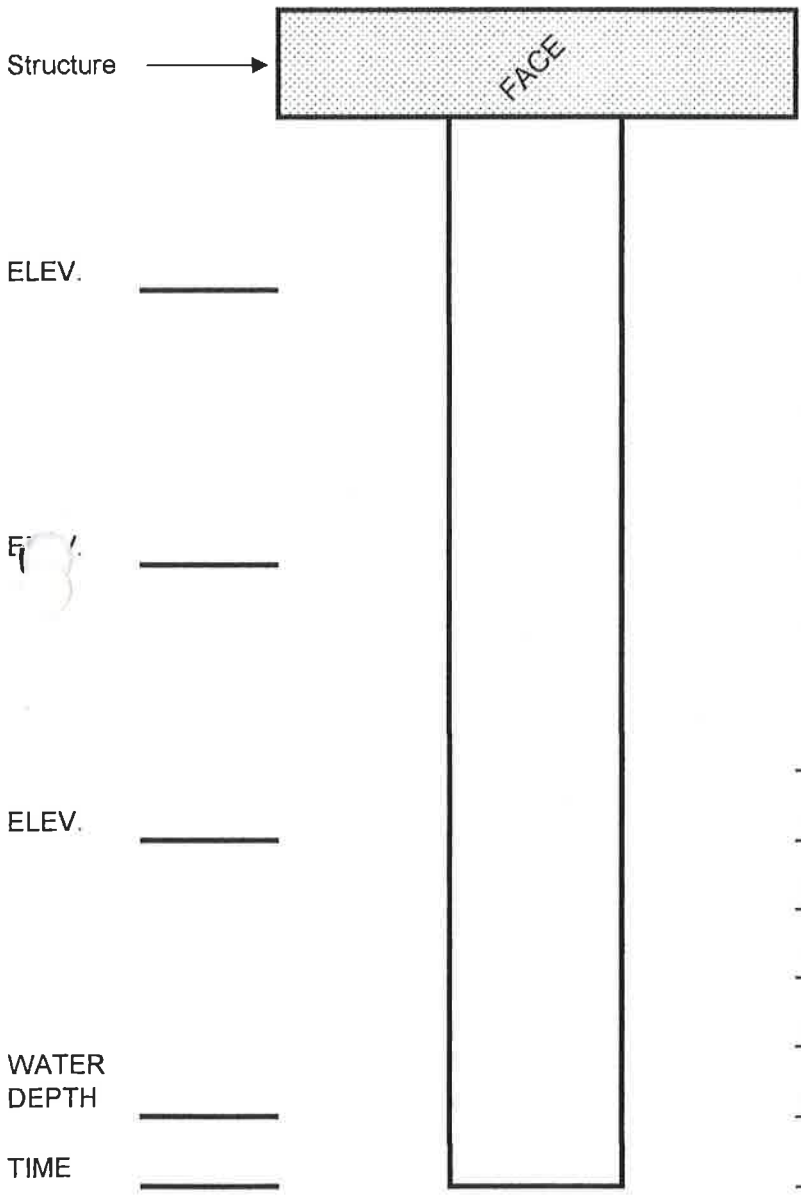
PILE # E12 Attitude: Plumb  
 JACKET: N/A LENGTH: N/A  
 TYPE: H. FORM N/A B. BAG N/A  
 GENERAL COND: Good EXP. STEEL: N/A  
 SOFT GROWTH: HARD GROWTH:  
 TZ: \_\_\_\_\_ % TZ: \_\_\_\_\_ %  
 BTZ: 100 % BTZ: 50 %
