MARINER'S WALK OWNER'S ASSOCIATION, INC. RULES & REGULATIONS INCLUDING INTERIOR RENOVATION POLICY

MARINER'S WALK RULES & REGULATIONS

I was asked to evaluate the floor condensation issue at Mariner's Walk. Following are my observations and recommendations.

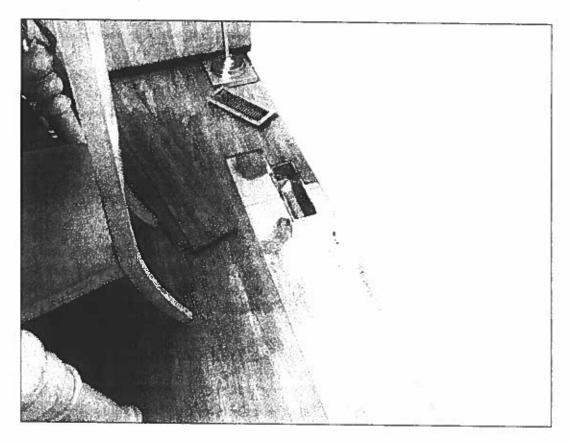
Recently, I have been made aware of condensation issues occurring at 1st floor locations. Yesterday, Mr. Vincent and I visited Unit 6C. Small sections of the wood flooring were removed for inspection. Areas of previous mold growth were observed. The bright tan material adjacent to the vent is ¼" plywood underlayment.

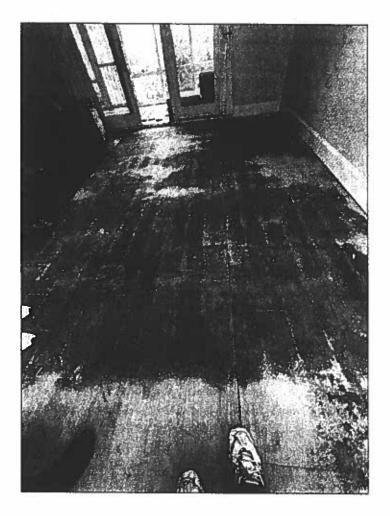
The following photograph of Unit 6C was forwarded to me in December 2022.

The staining on the underlayment is readily apparent. I was told that the wood product was known as LVP or Luxury Vinyl Plank. The product contains a rubberized backing on the bottom side.

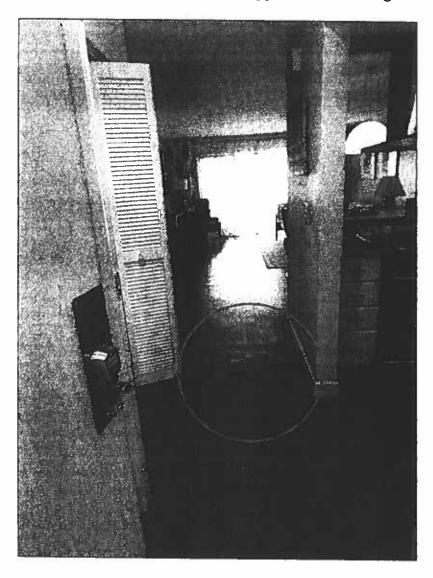
Similarly, we visited 5B. The material under the flooring is a mat similar to a carpet pad. The deterioration is apparent in the foreground.

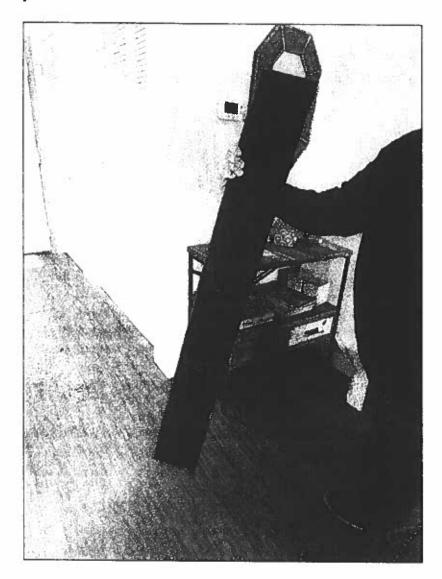
The following photograph is the rubber backing on the underside of the plank.

The problem arises when a new flooring material is placed with an impermeable or semi-impermeable layer is installed. In warm, moist environments such as coastal South Carolina, water vapor penetrates the floor sheathing and flooring and is subsequently removed by the HVAC system. When an impermeable or semi-impermeable layer is installed within the flooring matrix, the flow of water vapor is impeded, and condensation can occur. That appears to be happening at Mariner's Walk. Once this process begins, it will continue to occur but at accelerated rates. The threat is
