MARINER'S WALK OWNER'S ASSOCIATION, INC. RULES & REGULATIONS AND INTERIOR RENOVATION POLICY

I was asked to evaluate the floor condensation issue at Mariner's Walk. Following are my observations and recommendations.

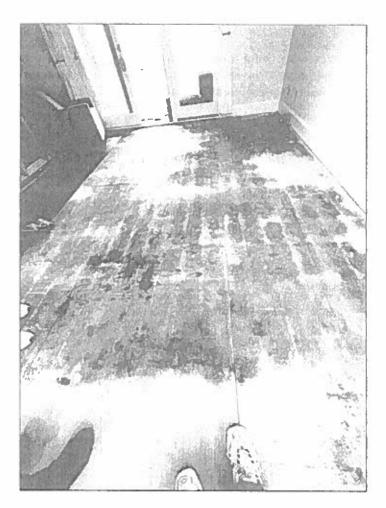
The following photograph of Unit 6C was forwarded to me in December 2022.

The staining on the underlayment is readily apparent. I was told that the wood product was known as LVP or Luxury Vinyl Plank. The product contains a rubberized backing on the bottom side.
